CALIFORNIA PUBLIC UTILITIES COMMISSION
Safety and Enforcement Division
Electric Safety and Reliability Branch

Incident Investigation Report

Incident Number: E20180118-01

Utility: Southern California Edison Company (SCE)

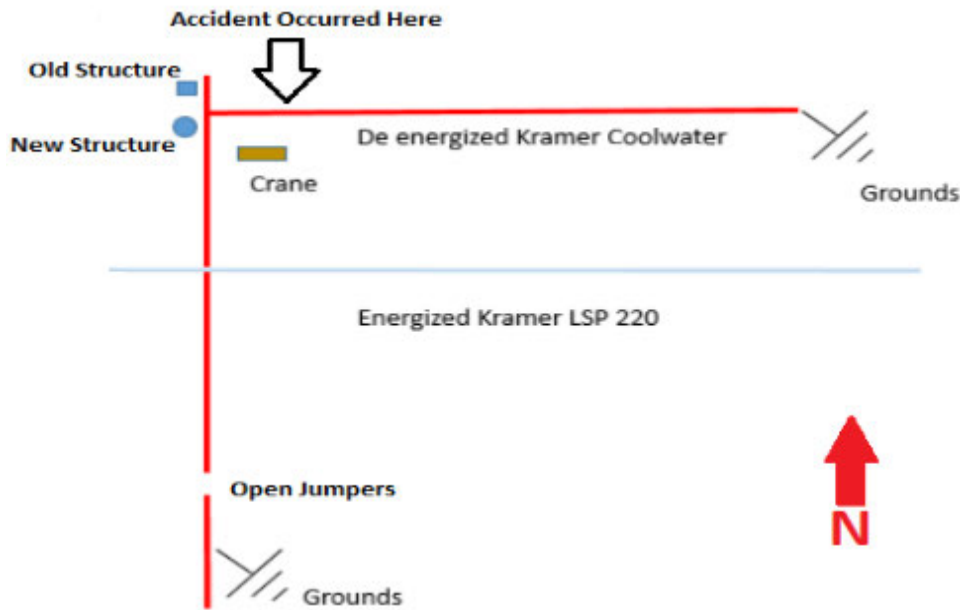
SCE staff de-energized the Kramer-Coolwater circuit on January 12, 2018, at 6:20 AM so that HWI staff could proceed with the conductor relocation process. De-energization is an important safety precaution because contact with energized high-voltage conductors can present a safety hazard to workers. Although the Kramer-Coolwater circuit was successfully de-energized, the nearby Kramer LSP 220 kV circuit remained energized. The Kramer LSP circuit ran parallel to the Kramer-Coolwater circuit in this area, about 300 feet to the south. See Figure 1.

Figure 1: A bird's-eye diagram of the worksite. The Kramer-Coolwater circuit, in red, had been de-energized. The Kramer LSP circuit, in light blue, remained energized and ran parallel to the Kramer-Coolwater circuit.

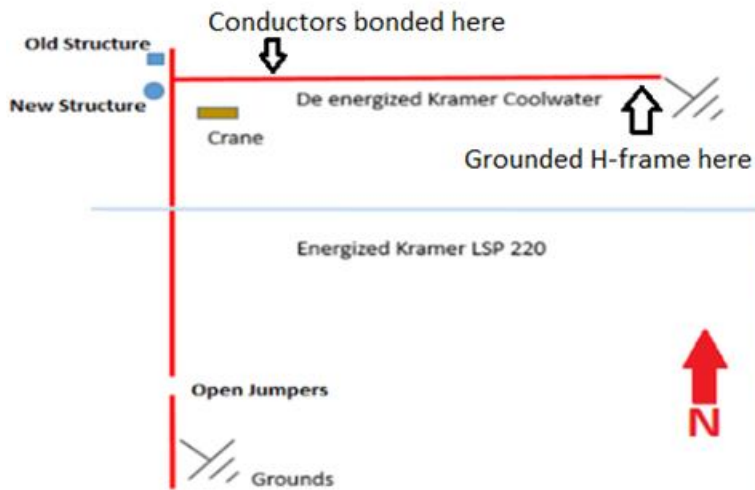
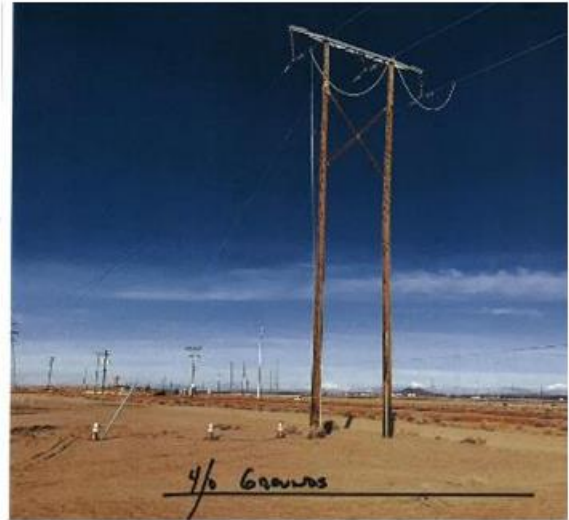
HWI journeyman linemen [REDACTED] and [REDACTED] installed the grounding devices, which included bonds and a grounding plate, for the project sometime between January 12 and January 18, 2018. Mr. [REDACTED] and Mr. [REDACTED] bonded the de-energized conductors together near the old lattice steel tower and grounded the circuit at only one point, an H-frame east of the work site. See Figure 2. They used a grounding plate to ground the conductors near the H-frame. The plate was bonded to the de-energized conductors of the Kramer-Coolwater circuit and buried approximately 10 feet deep in the soil next to the H-frame.

Figure 2: The grounded H-frame to the east of the incident location. The conductors were bonded and grounded here. This was the only point at which the conductors were grounded. This photograph was taken by [REDACTED] about two hours after the incident occurred.

SCE's Overhead Grounding Manual requires that worked conductors be grounded on both sides of the workspace while working from an elevated work platform or an induction hazard is present. My investigation revealed that the subject de-energized conductors were only grounded on one side of the workers, to the east.

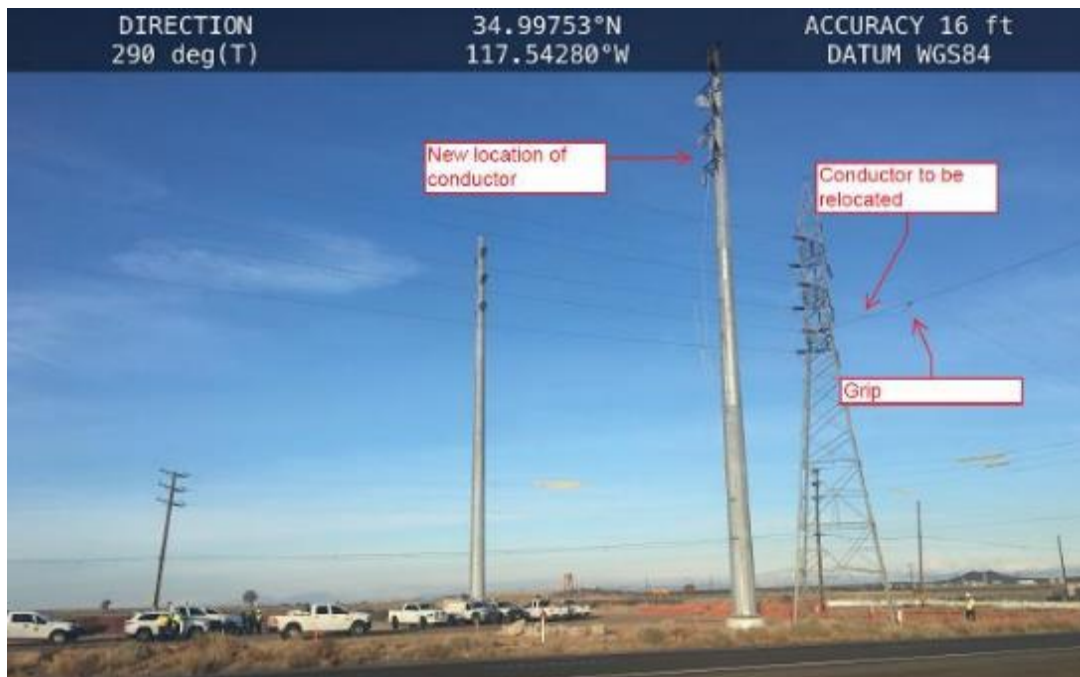
On January 18, the day of the incident, the grounding devices were in place and HWI staff planned to begin moving the three de-energized conductors of the Kramer-Coolwater circuit from the old lattice steel structure to the new steel pole. See Figure 3. They performed a tailboard meeting that morning before work began. The crew discussed the work to be performed and potential hazards that may arise. The tailboard record did not reflect that the crew had discussed the induction hazard presented by the Kramer LSP during that meeting.

Figure 3: The scene of the incident on the day it occurred. The bucket truck was near the steel lattice tower. Although the conductors were bonded together here, none of the structures in this photograph were grounded.

On the morning of January 18, 2018, HWI staff had successfully moved the first two conductors (top and middle) of the Kramer-Coolwater circuit from the old structure to the new one. The bond had protected the men in the elevated work platform during these two operations. Around 10:30 AM, HWI linemen [REDACTED] and [REDACTED] were working on the elevated work platform and had successfully attached the rigging to the third and final conductor to be moved. Mr. [REDACTED] removed the bond from the conductor, and for unknown reasons, he grabbed the conductor with his right hand and sustained his fatal injuries through electric shock. Mr. [REDACTED] should not have grabbed the conductor after removing the bond. It is likely that he was attempting to further adjust the rigging on the conductor and had forgotten that the bond had been removed. If the bond had been connected, it could have protected him from electrocution as it had while attaching the rigging to the first two conductors.

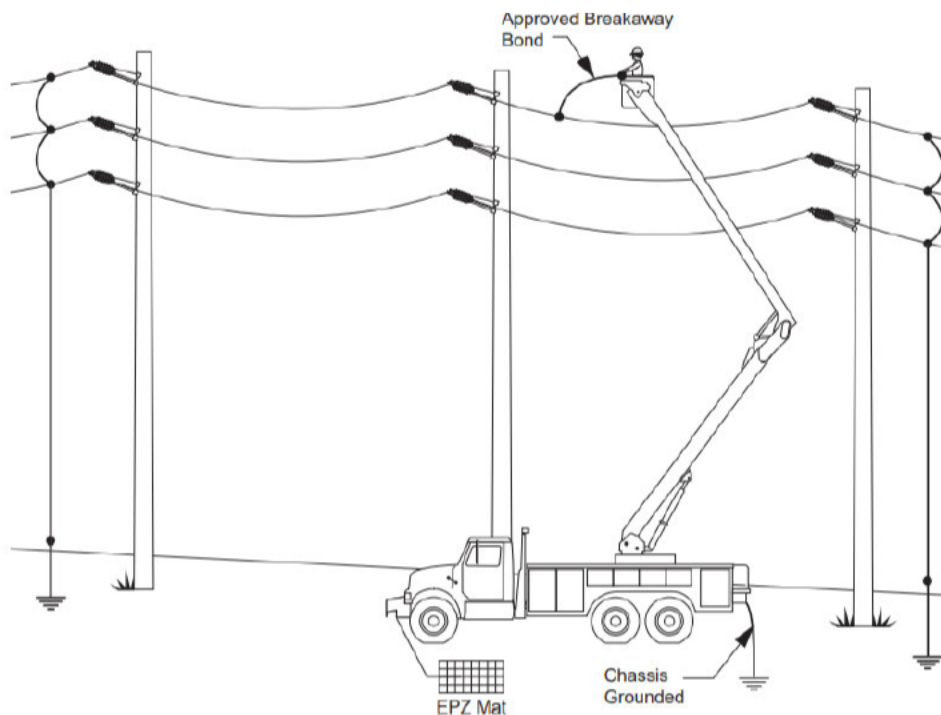
SCE requires special grounding schemes when an induction hazard is present. SCE's Overhead Grounding Manual dictates that the conductors must be grounded at a minimum of two places to ensure safety: one set of grounds shall be placed on either side of the worksite and an additional bond should connect the conductor to the elevated work platform while the work is being performed². See Figure 4 for a diagram of how a work site should be grounded in this situation, and the Appendix for a detailed explanation of why a minimum of two sets of grounding devices are necessary to mitigate the electrocution hazard presented by induction.

Figure 4: A figure from SCE's Overhead Grounding Manual showing how conductors should be grounded when linemen are working on a transmission circuit from a bucket truck when an induction hazard is present. SCE's Overhead grounding manual requires grounding devices be installed on both sides of the worksite.

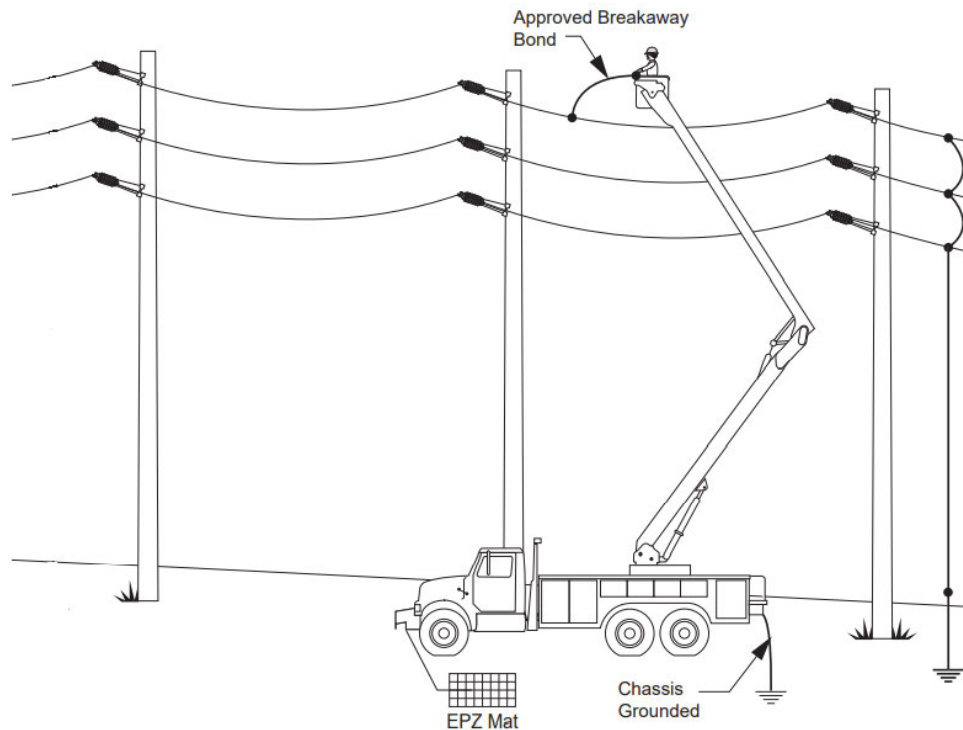
HWI's grounding plan contained only two of the three elements required by SCE's Overhead Grounding Manual. The circuit was grounded to the east of the worksite, and the workers used a bond between the elevated work platform and the conductor, but a second grounding device was not connected to the conductors west of the worksite as shown in Figure 5. If a second grounding device had been connected to conductors west of the workspace, the extent of Mr. ██████'s injuries could have been greatly reduced or eliminated. SCE explained the importance of grounding on both sides of workers when an induction hazard is present in a December 16, 2021 letter in response to an SED inquiry regarding the incident:

Figure 5: A simplified diagram of HWI's grounding scheme at the worksite. Compared SCE's grounding diagram above in Figure 4, HWI's scheme left out the grounding device to the left of the elevated work platform. The bond connecting the platform to the conductor had also been detached by HWI staff at the time the incident occurred.

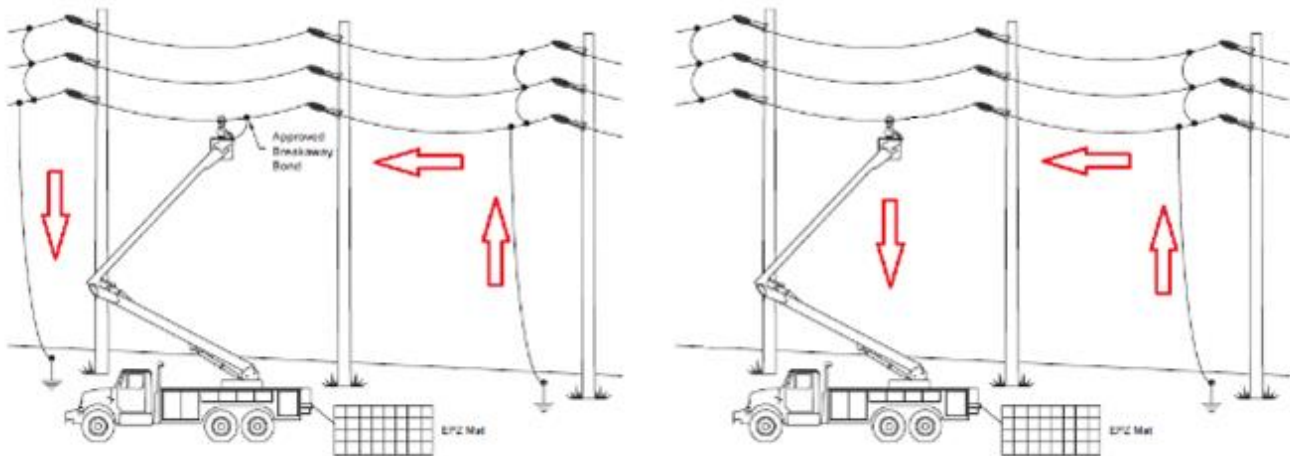
Figure 6: The figure above shows the path the induced current will take in two different grounding situations. On the left is diagram of a properly grounded worksite, and on the right is an improperly grounded one similar to how the worksite at Kramer Junction was grounded. The red arrows indicate the path the current takes.

In the properly grounded figure on the left, the current flows from the earth, up to the conductors, across and past the worker, and back down into the earth on the other side. If the worker were to touch the conductor in this situation, only a miniscule amount of current would pass through him. This is because the worker has a far higher electrical resistance than either set of grounds.

In the improperly grounded figure on the right, only one set of grounds is present. In this situation, the current flows from the earth, up to the conductors, across, through the worker, and into the ground by way of the bucket

truck. The worker has a high electrical resistance, but the current still passes through him because there is no other path for it to take.
