CALIFORNIA PUBLIC UTILITIES COMMISSION
Safety and Enforcement Division
Electric Safety and Reliability Branch

Incident Investigation Report

Incident Number: E20201026-01

Location of Incident: East Santiago Canyon Road
Silverado, CA
County: Orange

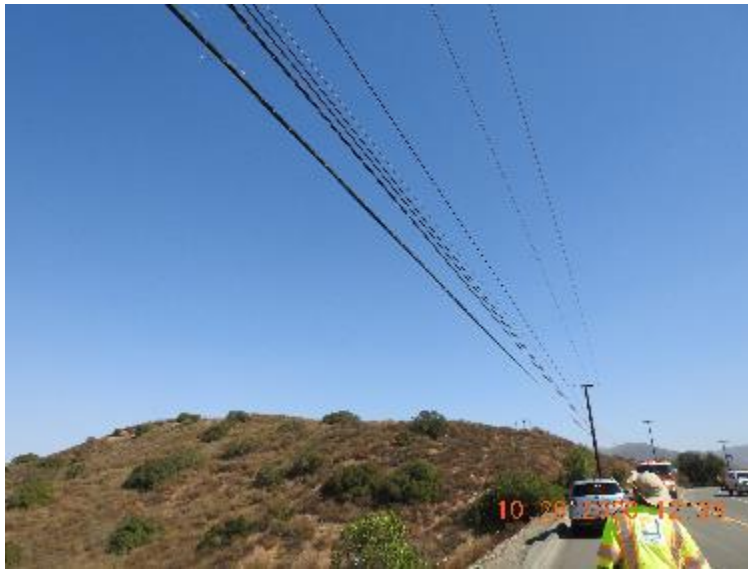
The span between the Subject Poles consisted of the following facilities, from top to bottom as shown in the photograph below (Figure 1):

- Three SCE 12 kV primary conductors.
- One T-Mobile communication conductor with associated messenger cable and lashing wire.
- One AT&T Mobility communication conductor with associated messenger cable and lashing wire.
- One Verizon communication conductor with associated messenger cable and lashing wire.
- One Cox communication conductor with associated messenger cable and lashing wire.
- One AT&T California communication conductor with associated messenger cable and lashing wire.

Figure 1: The incident span between the Subject Poles

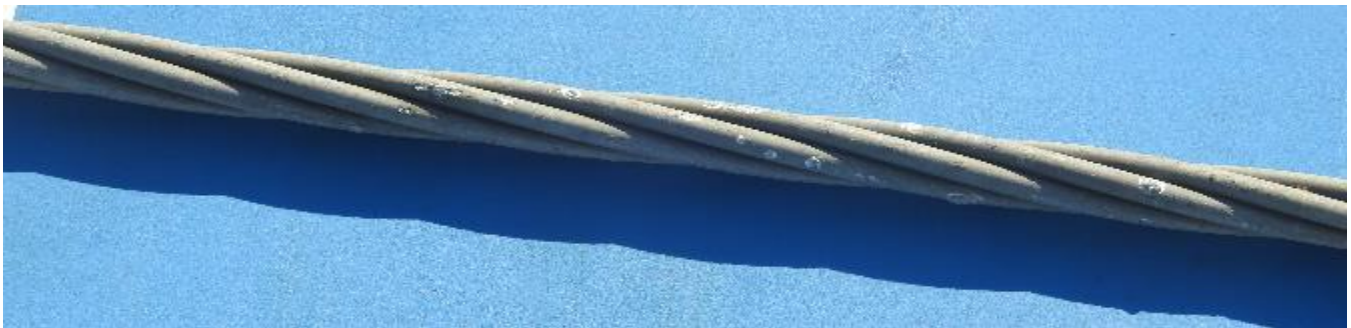
At approximately 169 feet from the west end originating from Subject Pole 1419541E, there was evidence of damage and discoloration on SCE’s southmost conductor (Figure 3). Similar damage was also visible on SCE’s southmost conductor at approximately 196 feet (Figures 4 and 5) and at 154 feet on SCE’s middle conductor (Figure 6).

Figure 3: Damage at 169 feet on SCE’s southmost conductor

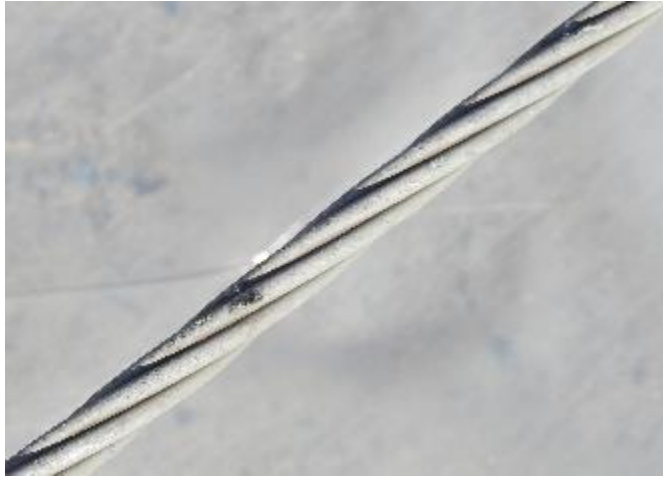
Figure 4: Damage at 196 feet on SCE's southmost conductor

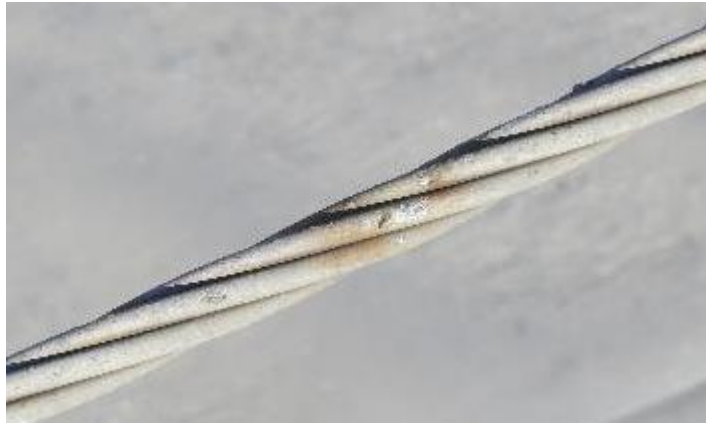
Figure 5: Damage at 196 feet on SCE's southmost conductor

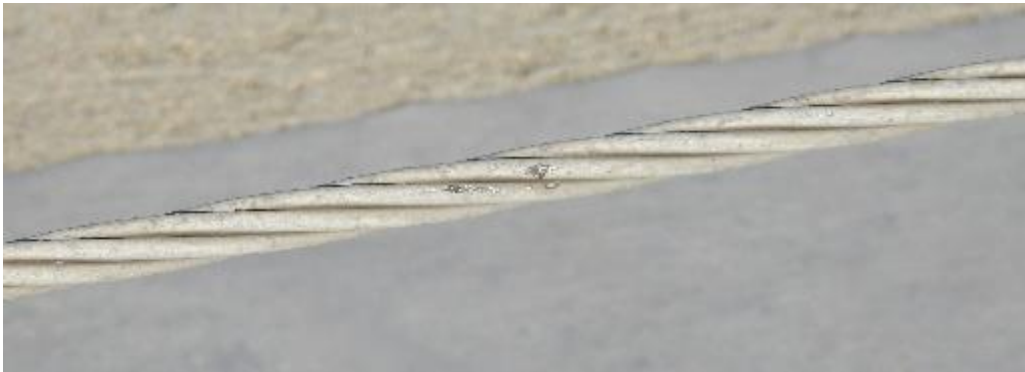
Figure 6: Damage at 154 feet along SCE's middle conductor

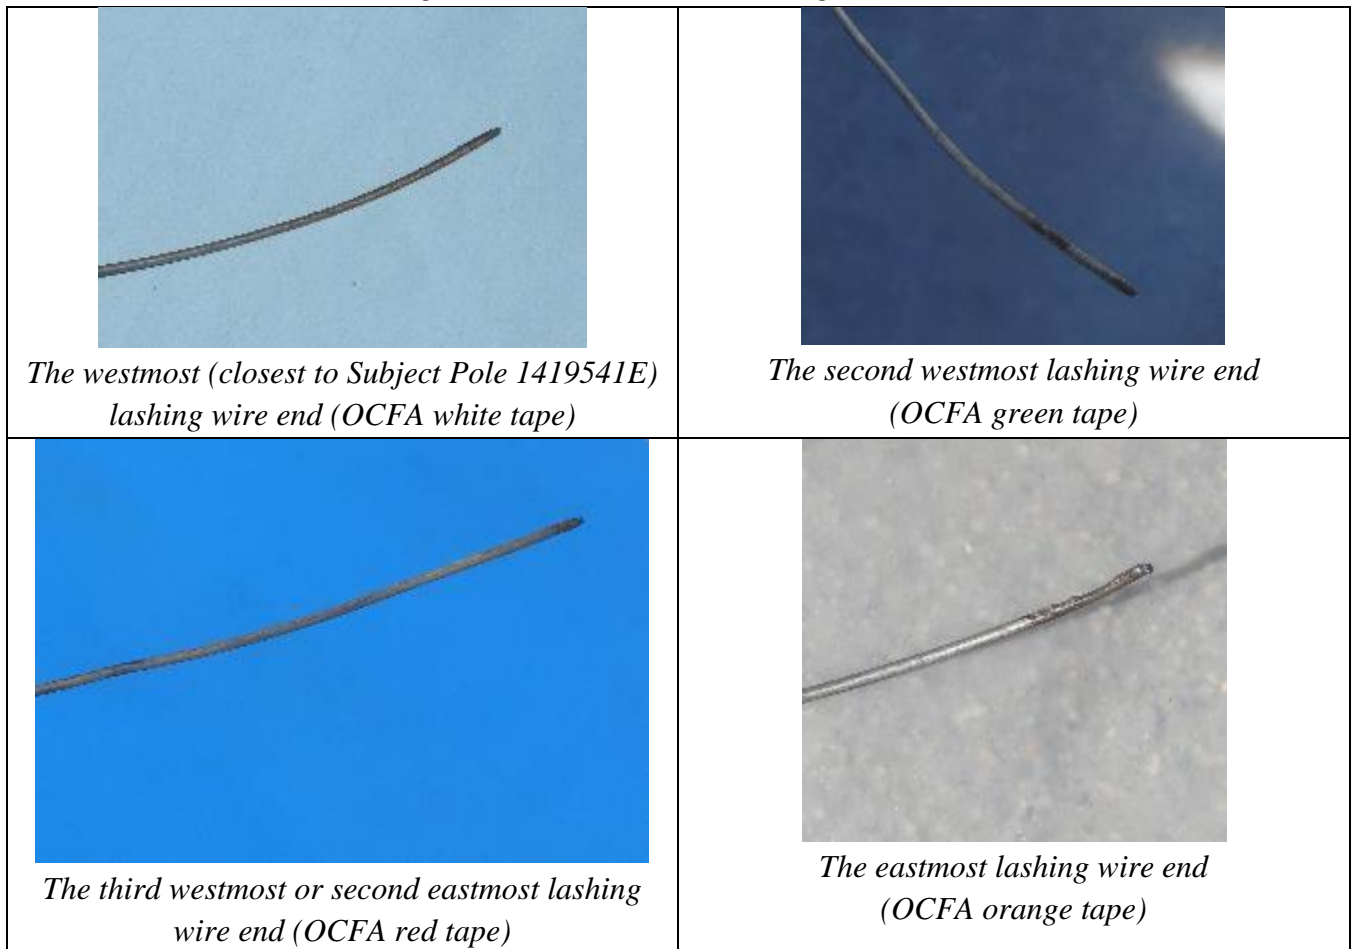
T-Mobile's conductor had four sections of damaged lashing wire. Two lashing wires separated, each into two dangling wires, for a total of four dangling lashing wires at four separate locations along the conductor. OCFA taped each of the dangling lashing wires with a colored tape to secure and identify the lashing wire and the conductor from which it originally dropped. Additionally, a third section of the lashing wire parted at mid-span, but remained nearly in position and did not drop down. All four dangling section ends of the damaged lashing wire exhibited evidence of discoloration and damage (Figure L4). The third section of the lashing wire that parted away did not dangle also showed signs of discoloration and damage on the ends of the wire and on the nearby messenger cable. This occurred approximately 180 feet from the west end of the conductor where other damage is visible (Figure 7).

Figure L4: Four T-Mobile lashing wire ends

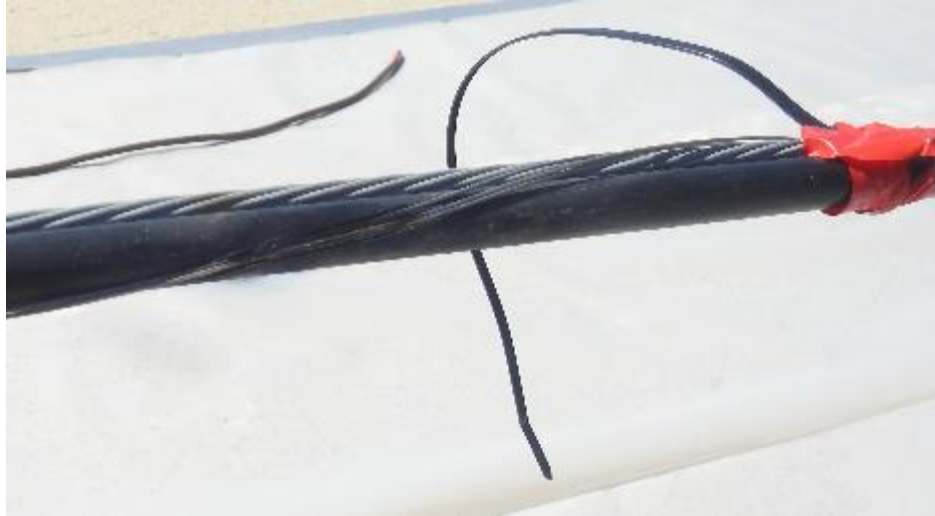
Figure 7: Additional damage near where the third lashing wire parted

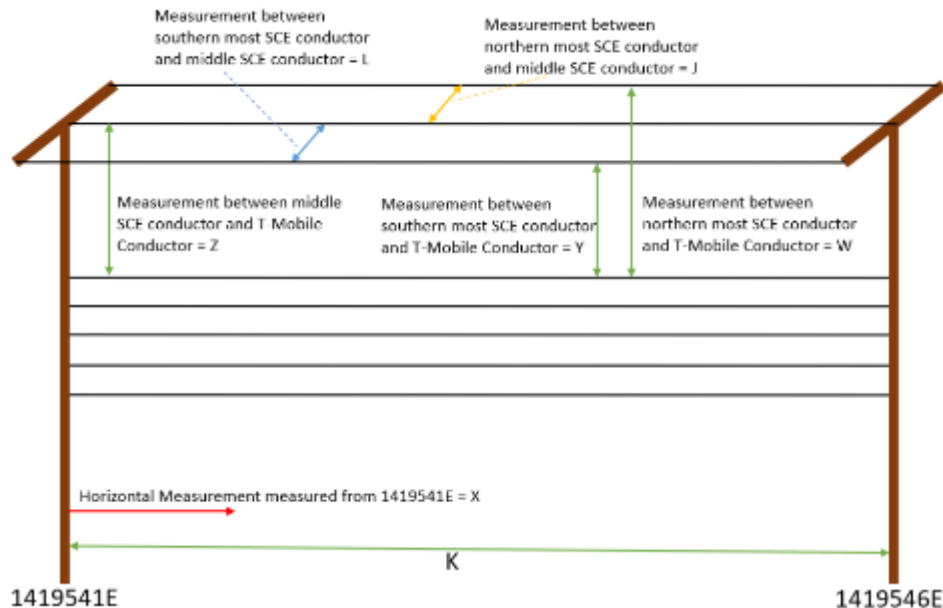
Figure 10: Diagram SED provided to obtain measurements from SCE

The LIDAR measurements provided by SCE indicated that the clearance between SCE’s middle conductor, at its closest vertical separation, and T-Mobile’s conductor was **66 inches** (5.5 feet). At the closest point, SCE’s southmost conductor and T-Mobile’s conductor had a vertical clearance of **57.6 inches** (4.8 feet).²¹

GO 95 requires a minimum clearance of 72 inches between 12 kV conductors and communication conductors, this clearance is based on temperature of 60° F and no wind. However, GO 95, Rule 38 does not allow a clearance reduction by more than five percent in a Tier 3 HFTD because of temperature and loading. A five percent reduction in the required minimum vertical clearance would be equal to a separation of **68.4 inches** (5.7 feet).
