The Safety and Enforcement Division (SED) of the California Public Utilities Commission conducted a **General Order (G.O.) 112-F Comprehensive Operation and Maintenance Inspection of Southern California Gas Company (SoCalGas)'s NW South Coast Distribution Districts** (Inspection Unit) on May 3 through May 7 and May 10 through May 14, 2021, for calendar years 2017 through 2020. SED conducted records review and field inspection of pipeline facilities in the Crenshaw and Santa Monica Distribution Districts.

**2021 South Coast Distribution Area Inspection
5/03/2021 to 5/14/2021**

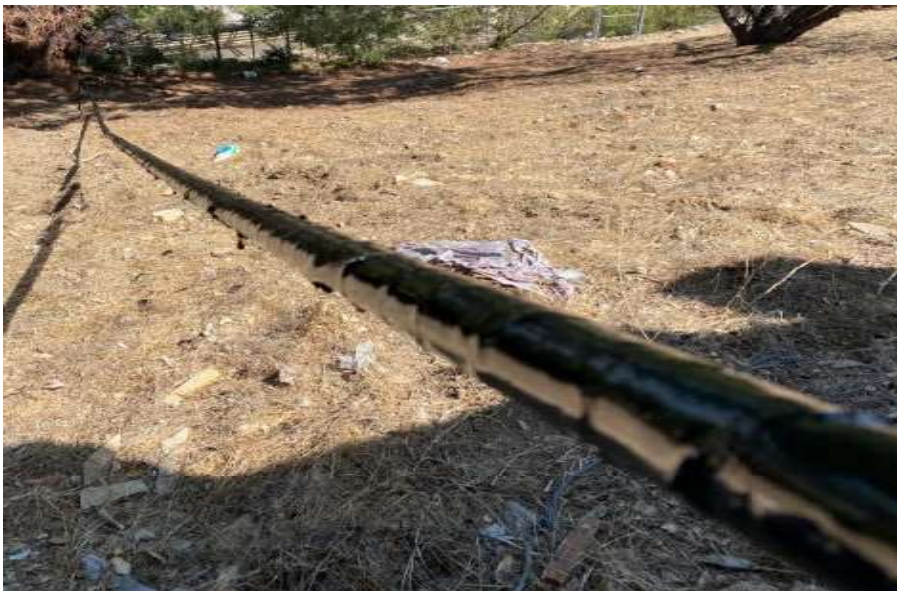
Issue Summary: During the field inspection of the South Coast facilities, SED observed that exposed pipe at/or near [REDACTED] Mulholland Dr., Los Angeles had cracked pipe wrap and showed signs of atmospheric corrosion at several spots.

SED finds SoCalGas in violation of G.O. 112-F, Reference Title 49 CFR, Part 192, §192.479(b) for failing to adequately protect its pipeline from atmospheric corrosion.

SoCalGas disagrees with SED's statement that the pipe showed signs of atmospheric corrosion. The pipe was found to have surface rust that was addressed by re-wrapping the pipe.

SoCalGas acknowledges that the wrap on this service was cracked and sent a crew out to re-wrap the pipe on 09/16/21 on order 5200002797780. The picture below shows the completed work:

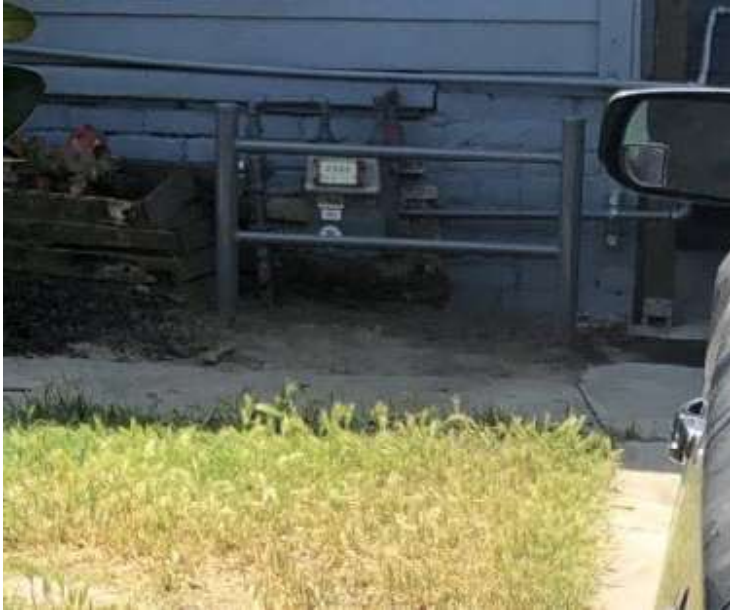
Issue Summary: Meters and service regulators located at [redacted] & [redacted] 55th Place, [redacted] 57th St, are exposed to vehicular traffic. Also, a Meter-Set-assembly (MSA) at 3564 Federal Ave, Los Angeles, located in a pit (curb box) was partially buried in the dirt. To ensure that MSAs and service regulators are protected from vehicular traffic damage, SoCalGas should take appropriate actions, repair, and maintain the facilities to demonstrate compliance with Title 49 CFR, Part 192 Sections 192.353(a) & Part 192.355(b)(3).

SoCalGas acknowledges that the meter and service regulator located at [redacted] W. 55th Street, which is SoCalGas's address of record, not [redacted] 55th Place, was exposed to vehicular traffic. A meter guard was installed at [redacted] W. 55th St. on 05/26/21, on order 540000452392. A picture of the meter guard is shown below:

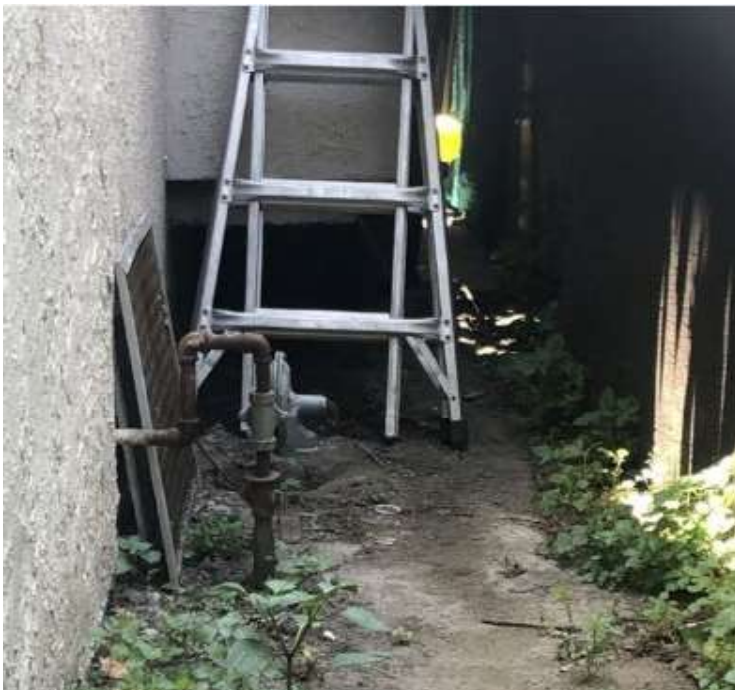
SoCalGas would disagree with SED's assessment that the meter set assembly at [REDACTED] W. 55th, which is SoCalGas' address of record, not [REDACTED] 55th Place, is exposed to vehicular traffic. The meter set assembly is an underset on a side of the house with no vehicular or pedestrian traffic in the area. A picture of the meter set assembly location is shown below:
