PUBLIC UTILITIES COMMISSION

EA2022-1012

SUBJECT: Electric Distribution Audit of PG&E's Fresno Division

PG&E FRESNO DIVISION
ELECTRIC DISTRIBUTION AUDIT FINDINGS
November 14-18, 2022

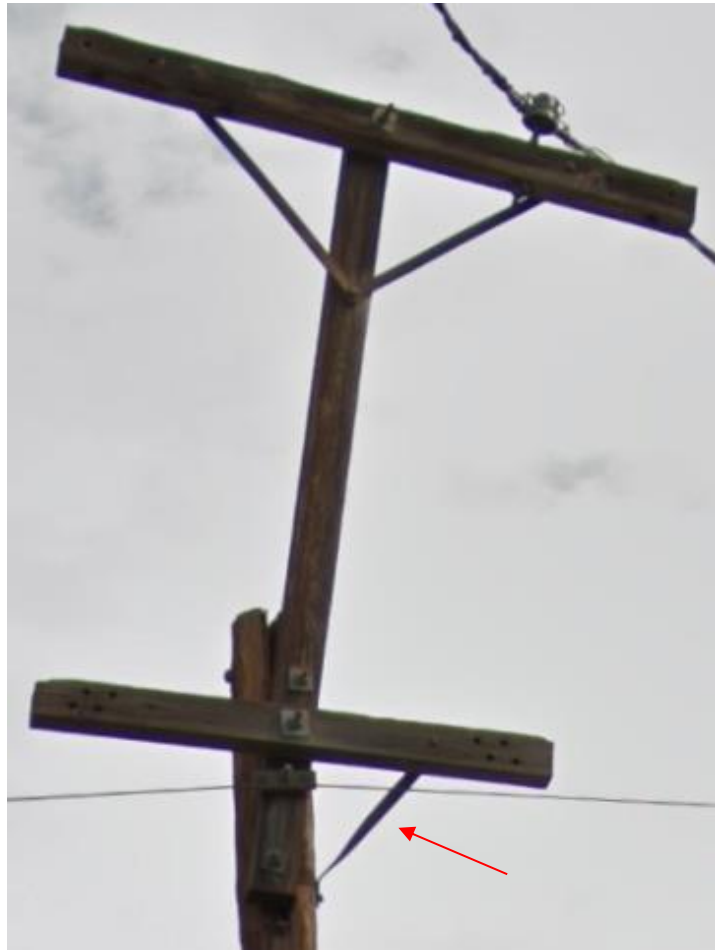
Figure 1: Pole Top Extension

“Lines or parts thereof shall be replaced or reinforced before safety factors have been reduced (due to factors such as deterioration and/or installation of additional facilities) in Grades “A” and “B” construction to less than two-thirds of the safety factors specified in Rule 44.1 and in Grade “C” construction to less than one-half of the safety factors specified in Rule 44.1. Poles in Grade “C” construction that only support communication lines shall also conform to the requirements of Rule 81.3–A.. In no case shall the application of this rule be held to permit the use of structures or any member of any structure with a safety factor less than one.”

- 9.1. Pole SAP # 100798222 (Location 17) at 412 4th St, Clovis: Secondary service supported on pole top extension installed in 1985 on AT&T owned pole. Pole top extension is crooked and crossarm brace is bent (See Figure 1).
