## PUBLIC UTILITIES COMMISSION

EA2023-1167

**SUBJECT:** Electric Audit of Merced Irrigation District

**MERCED IRRIGATION DISTRICT**  
**ELECTRIC AUDIT FINDINGS**  
**October 9 – October 12, 2023**

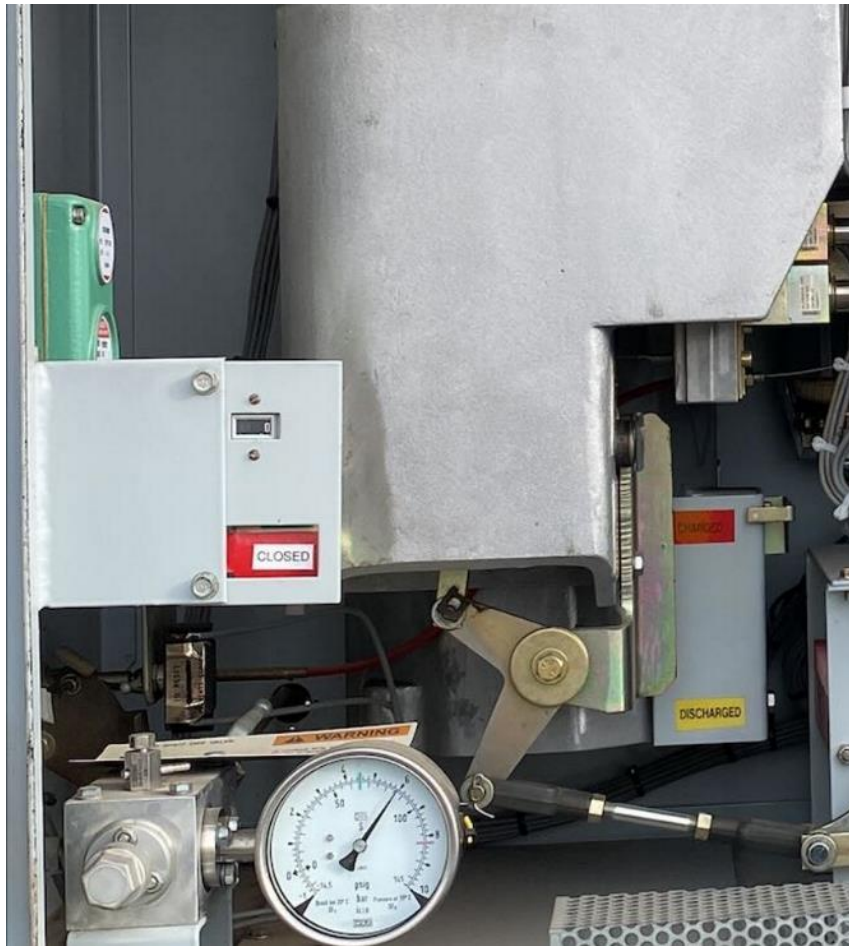
### Cooper Substation

1. Circuit Breaker 700 had a faded counter.

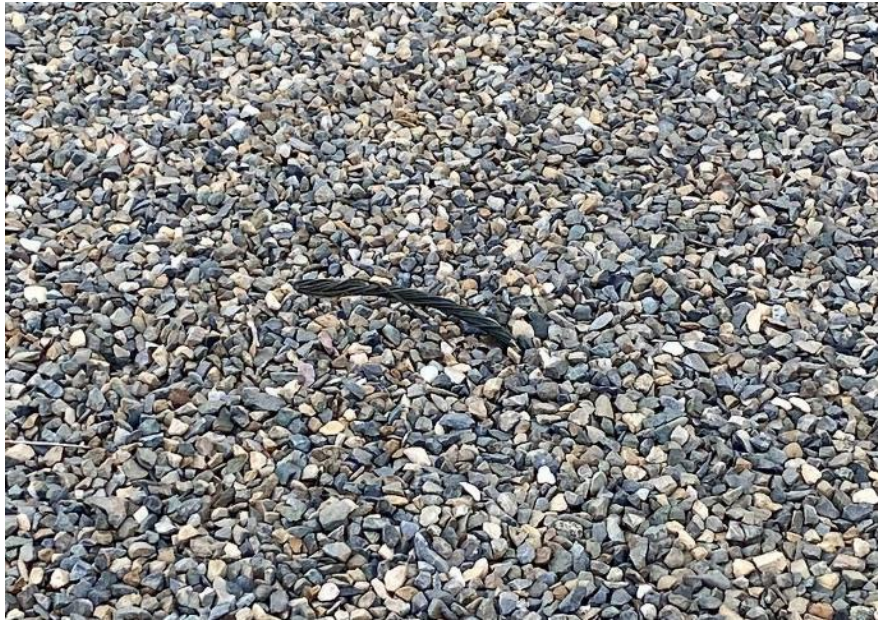
## Pioneer Substation

2. Grounding wire was sticking out of ground grid.

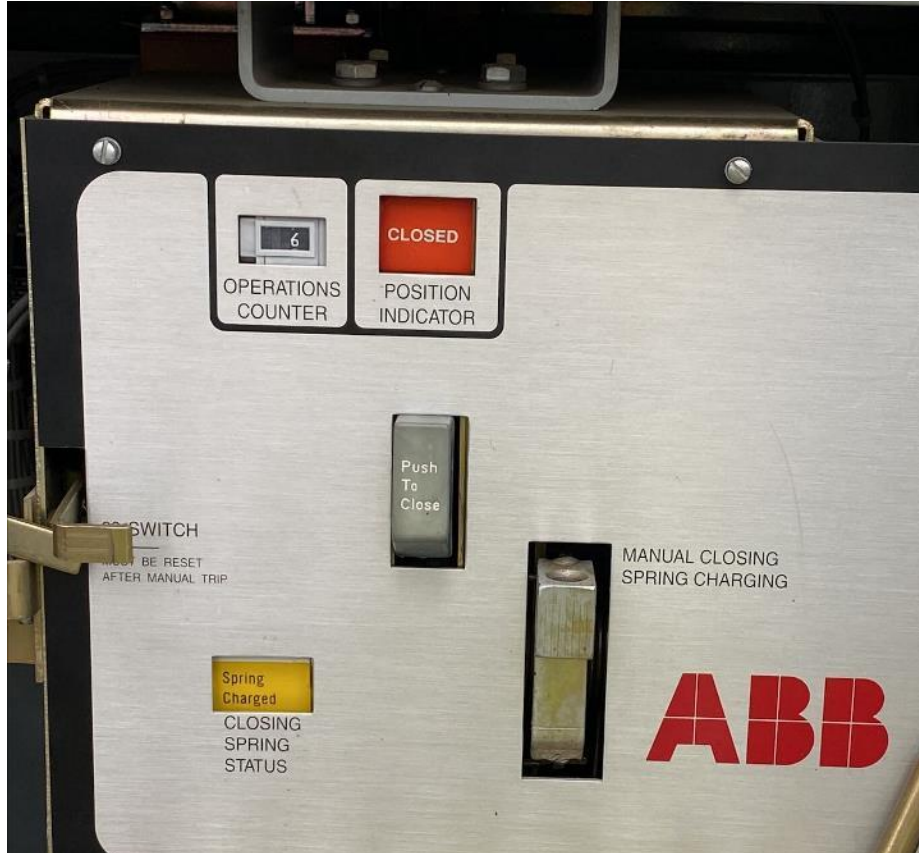
3. VCB 11 had a faded counter.

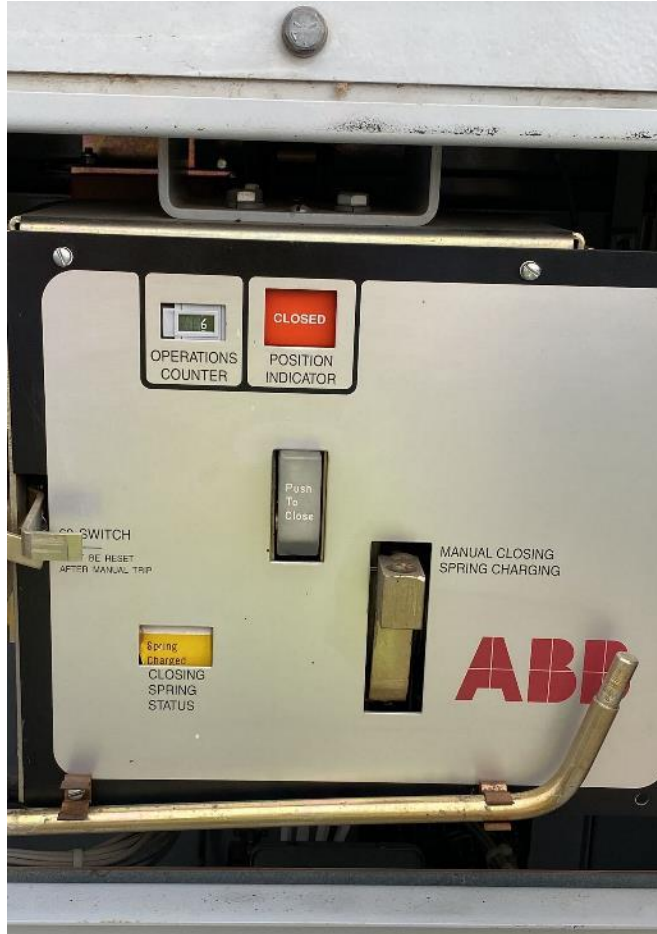
4. VCB 5 had a faded counter.

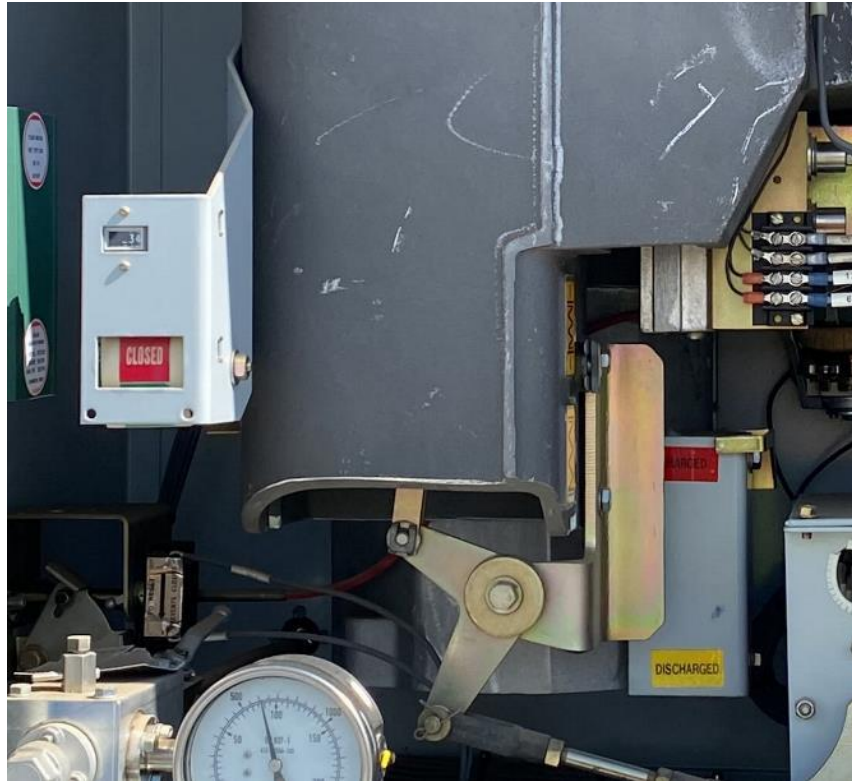
## Castle Substation

5. Circuit Breaker 710 has a faded counter.

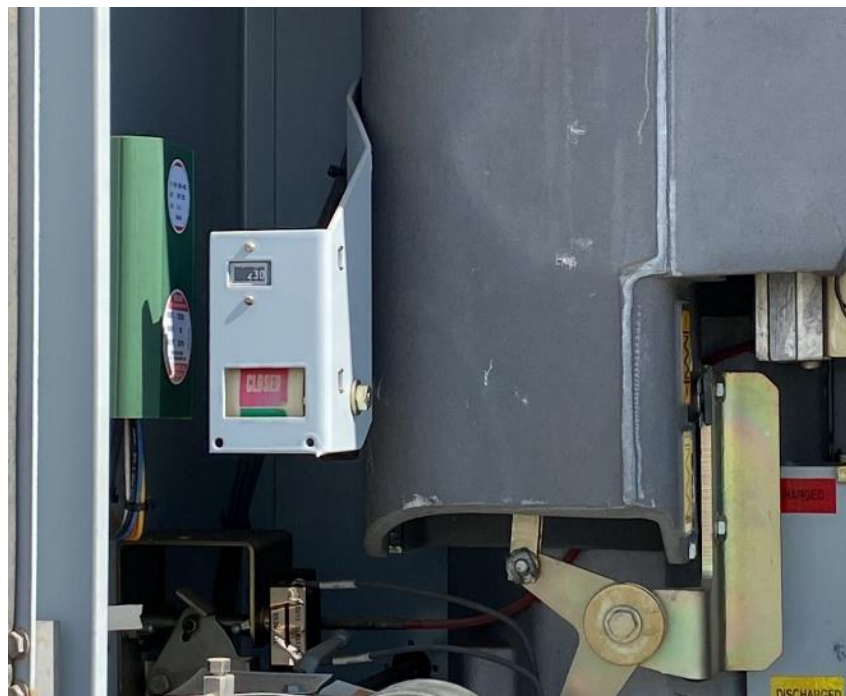
6. Circuit Breaker 700 had a faded counter.

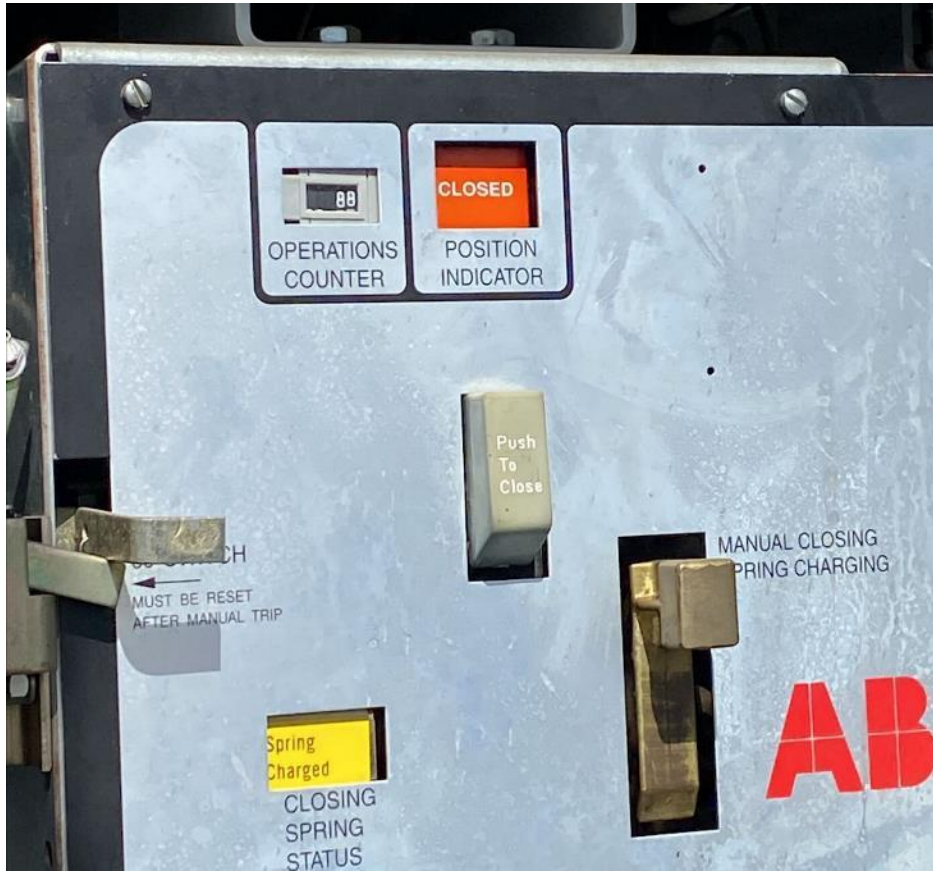
7. Circuit Breaker 4 had a faded counter.
