## PUBLIC UTILITIES COMMISSION

**SUBJECT: Generation Audit of AES Alamos, Long Beach Legacy Units – Audit Number GA2023-03ALBL**

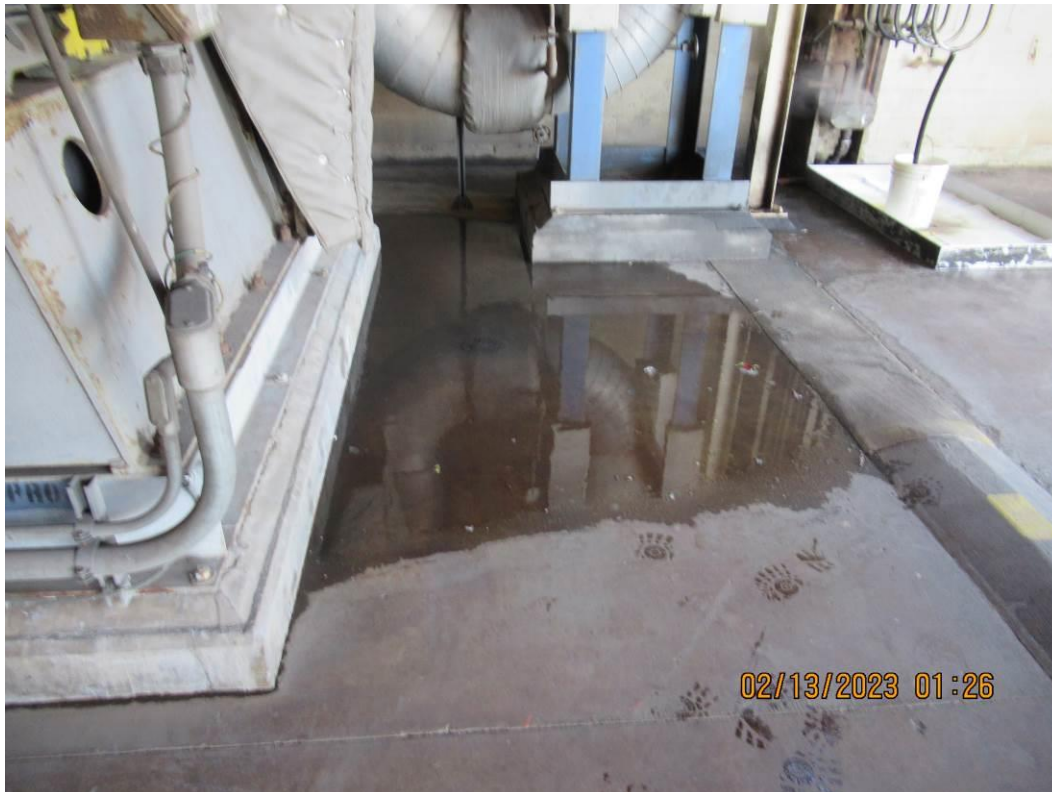
ESRB staff observed a large pool of standing water due to a clogged drain near the Unit 4 Selective Catalytic Reduction fans. ESRB recommended for Plant staff to unclog the drain as soon as possible. Standing water can result in hazards that include slipping hazards.

Figure 1: Standing water because of clogged drain

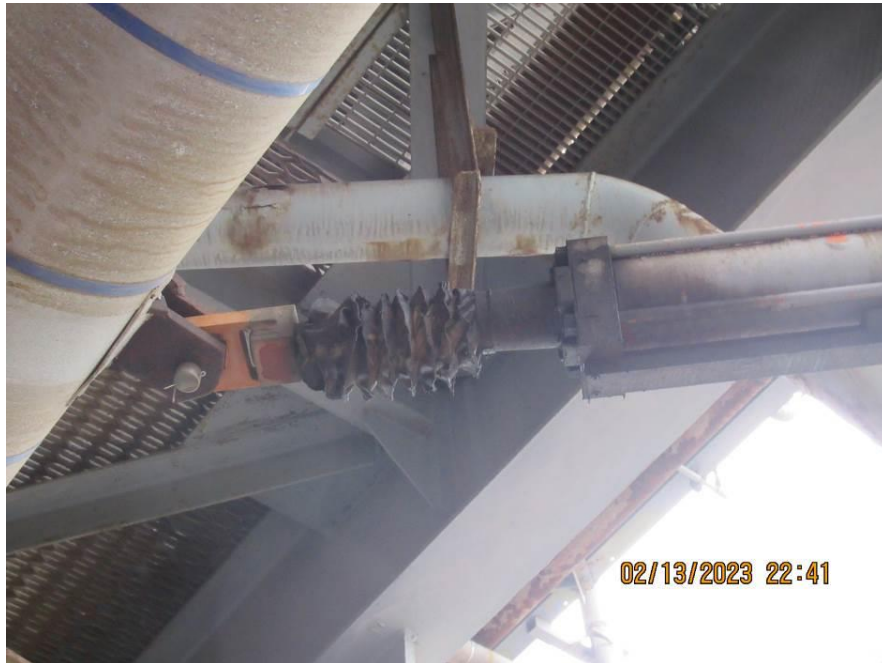
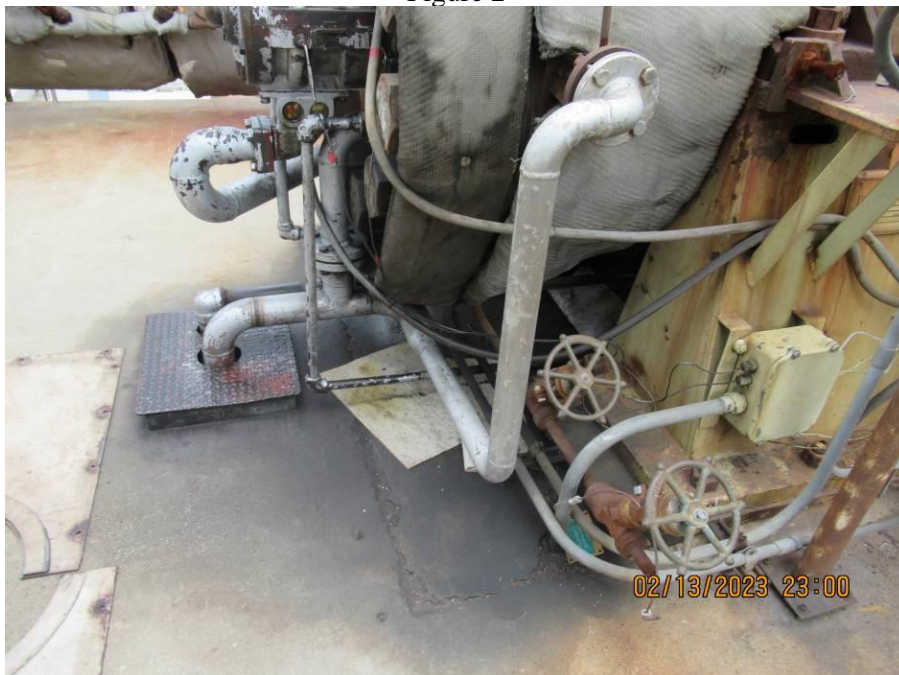
ESRB staff observed a leak from the Unit 4 chemical mixing tank overflow pump, steam leaks near sealed steam regulator PS-49 and main stop valve east. Staff also observed oil leaking from a High Energy Pipe (HEP) support on Unit 5 Level 3 and the Unit 5 Lube Oil Feed Pump North. There was also an air leak from Unit 3 level 5 primary and secondary control solenoid and the Unit 5 level 3 air supply for the nitrogen oxide system.

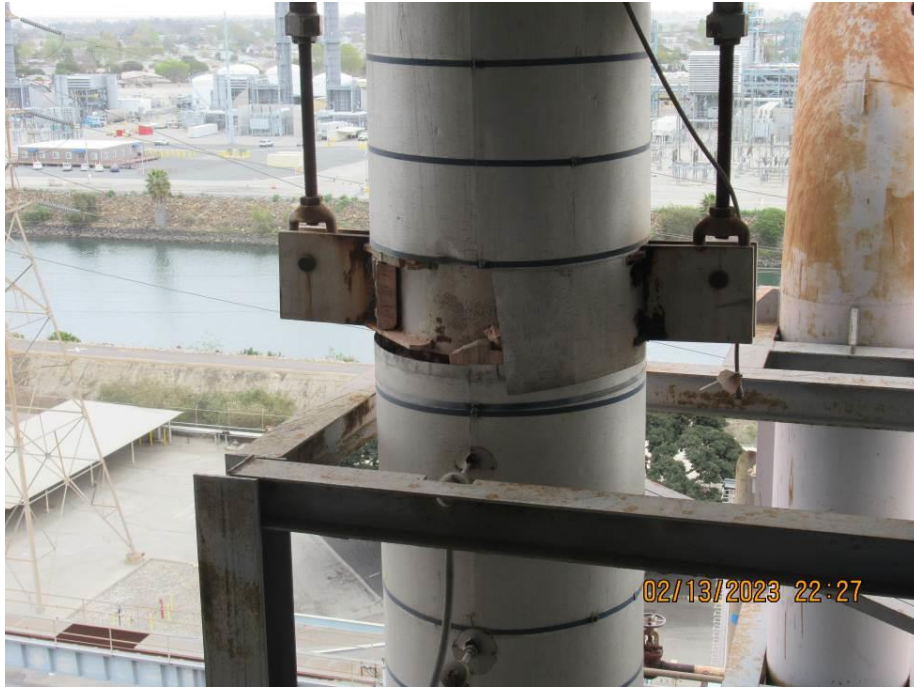
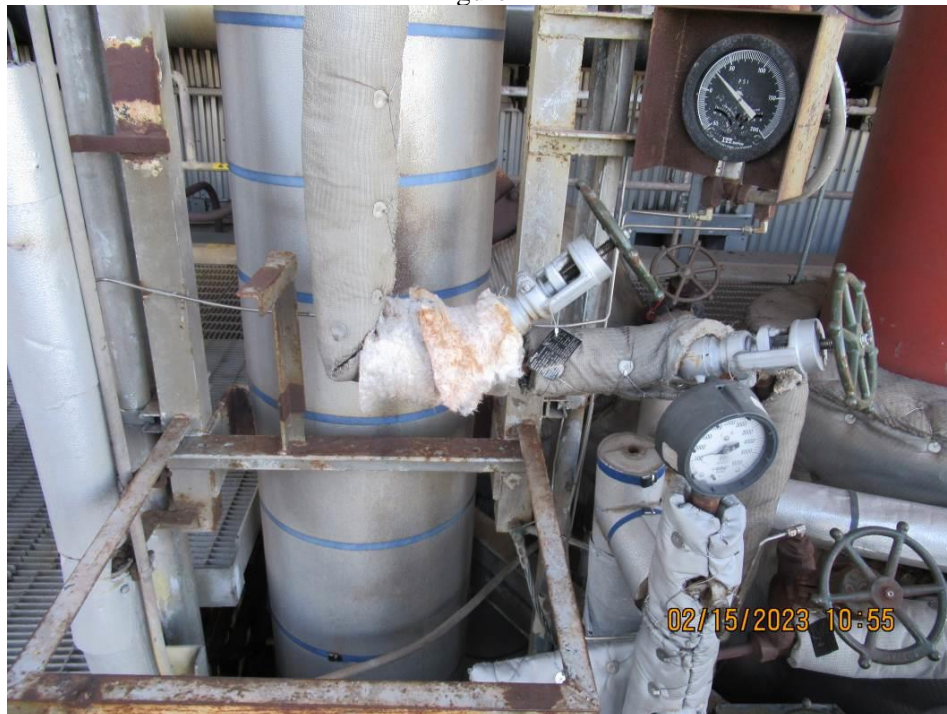
ESRB staff observed damaged insulation on the main steam line for Unit 5 at level 6, as well as on the Unit 3 3-C Boiler Circulation Pump. Damaged insulation can result in accelerated heat gain or loss and can result in corrosion under insulation.

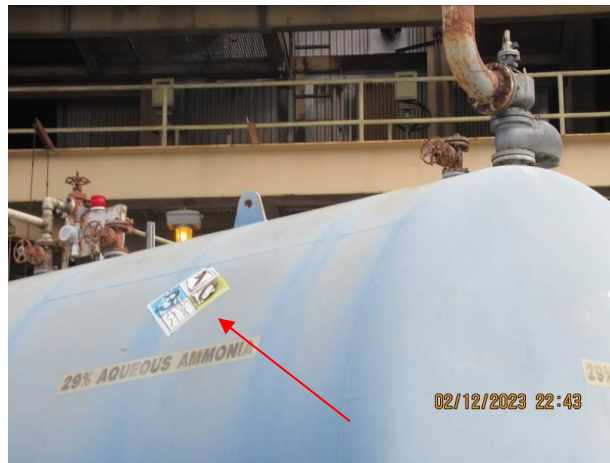
ESRB staff observed damaged NFPA sign (the fire diamond) on the ammonia storage tanks for Unit 3 and 4. Also, the flammable storage cabinets were missing the fire diamond with appropriate rating numbers and a self-closing mechanism. The numbers are important to provide information related to hazards.

Figure 6: Damaged NFPA sign (fire diamond)

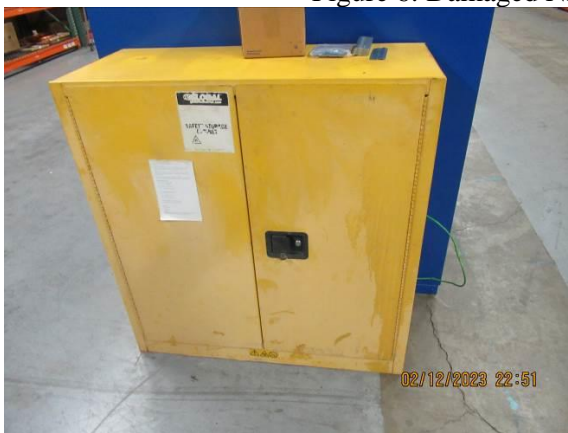
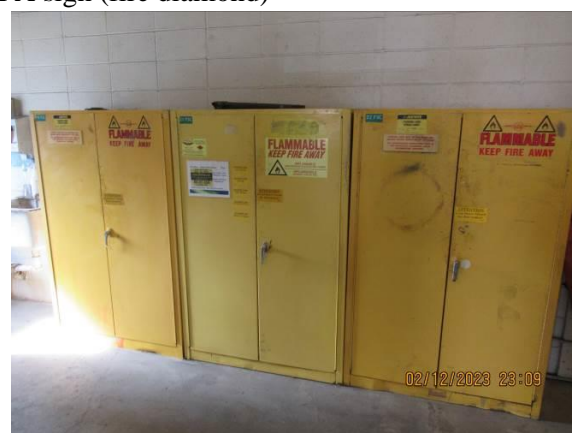
Figure 7 & 8: NFPA Fire diamonds missing on the flammable storage cabinets

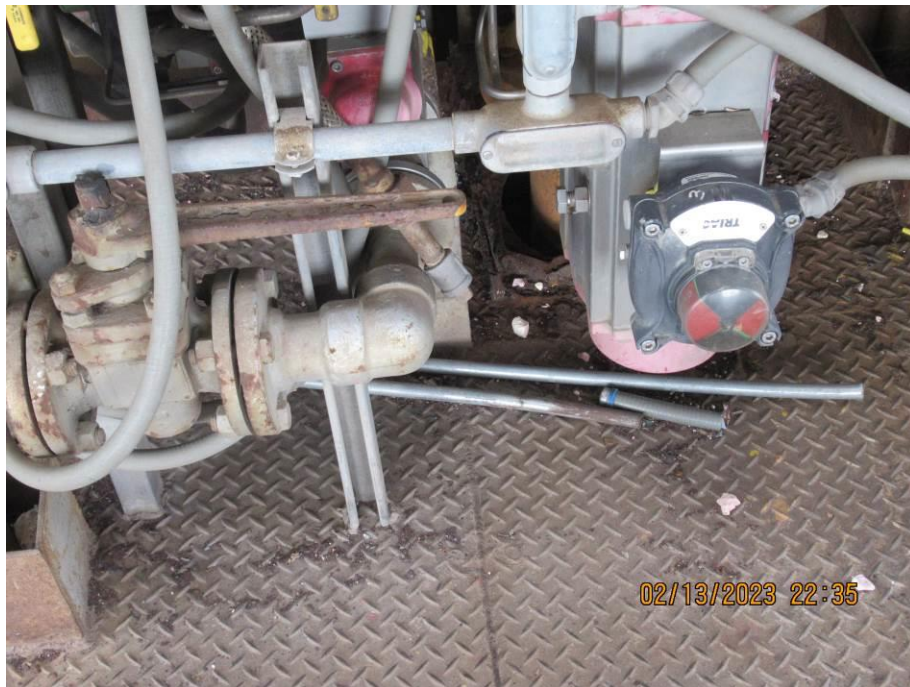
Figure 9

ESRB staff observed some debris that was not cleaned up near equipment at Unit 5 5S burner. This can result in tripping hazards.

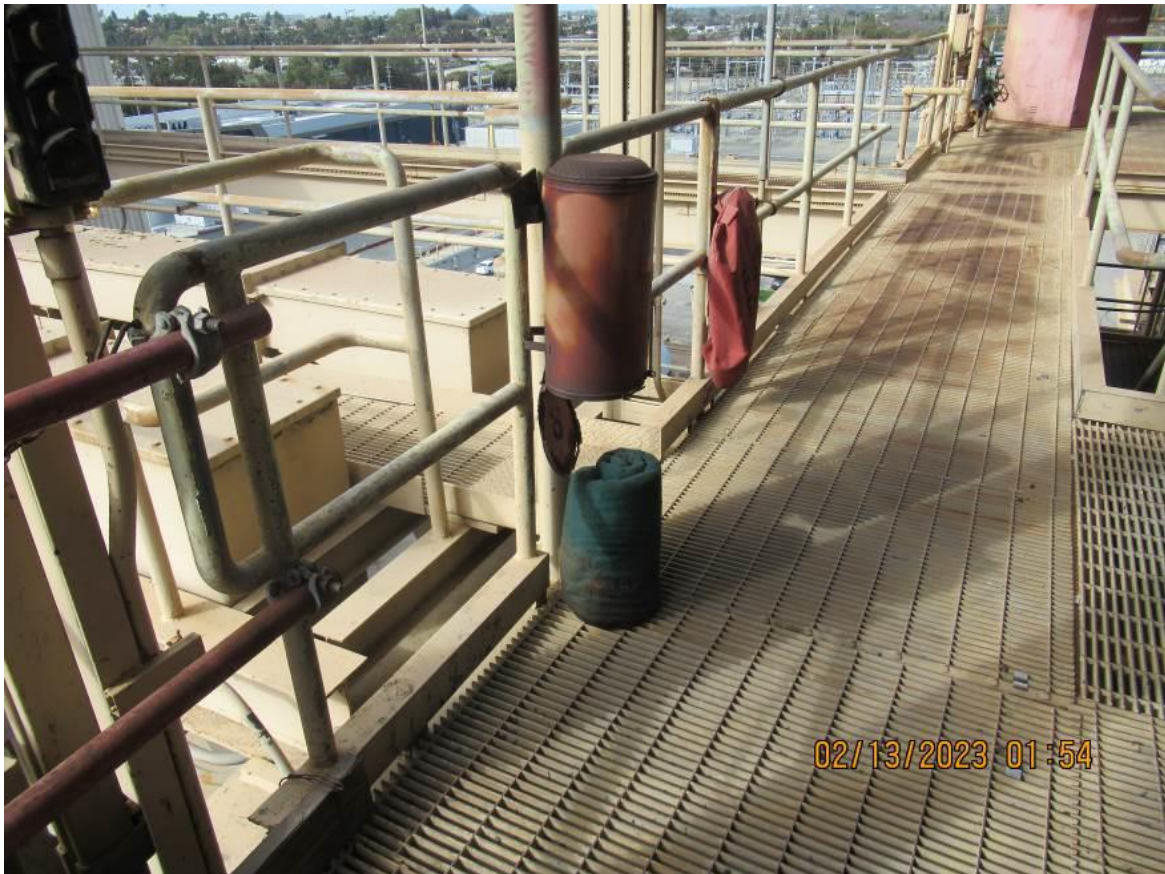
Figure 10

ESRB staff observed a fire blanket holder that was severely rusted on the bottom and could not hold the fire blanket at Unit 4 Level 6. A rusted holder will not properly protect the fire blanket from deterioration from the environment.

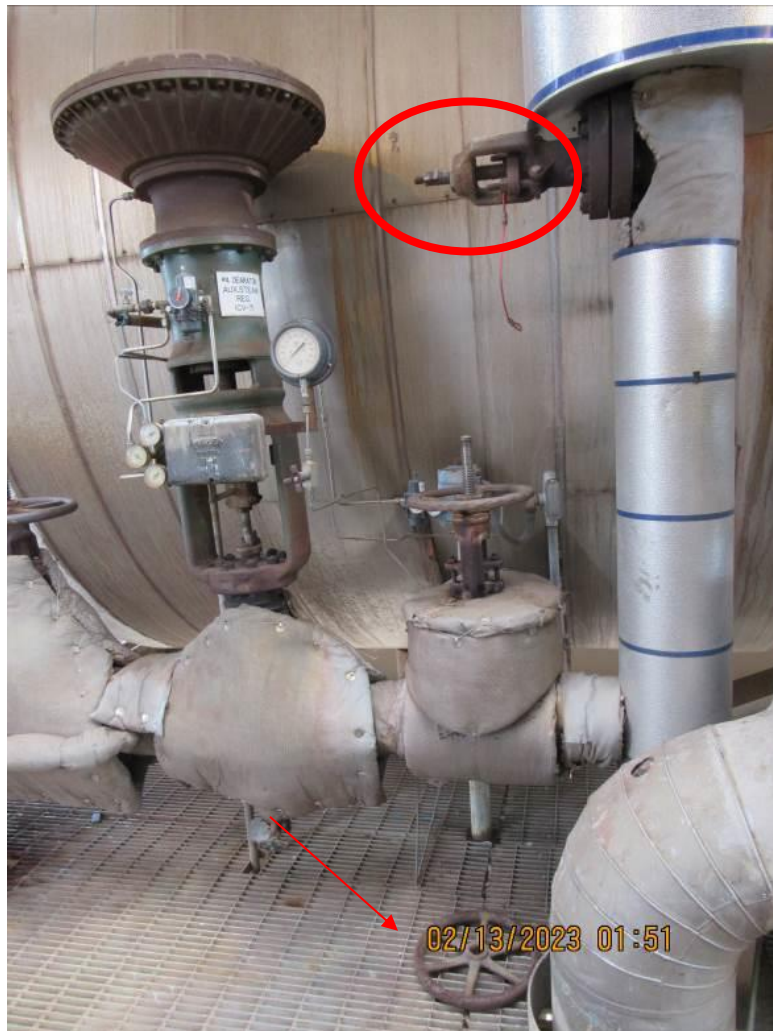
Figure 11

ESRB staff observed a valve handle on the ground that was not attached a valve near Unit 4 Deaerator Aux Steam Regulator. The detached handle prevents the valve from being operated properly and quickly.

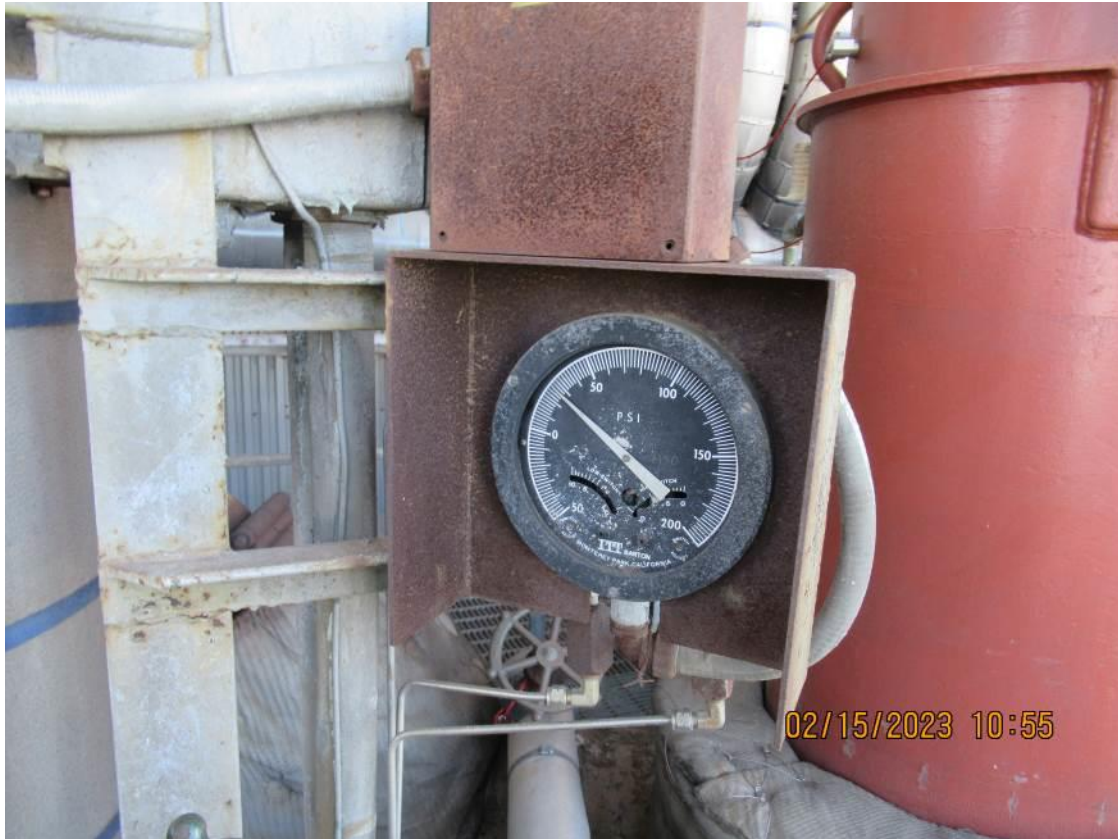
Figure 12

ESRB staff observed a defective pressure gauge that was missing a glass cover. Defective pressure gauges can result in erroneous pressure readings.

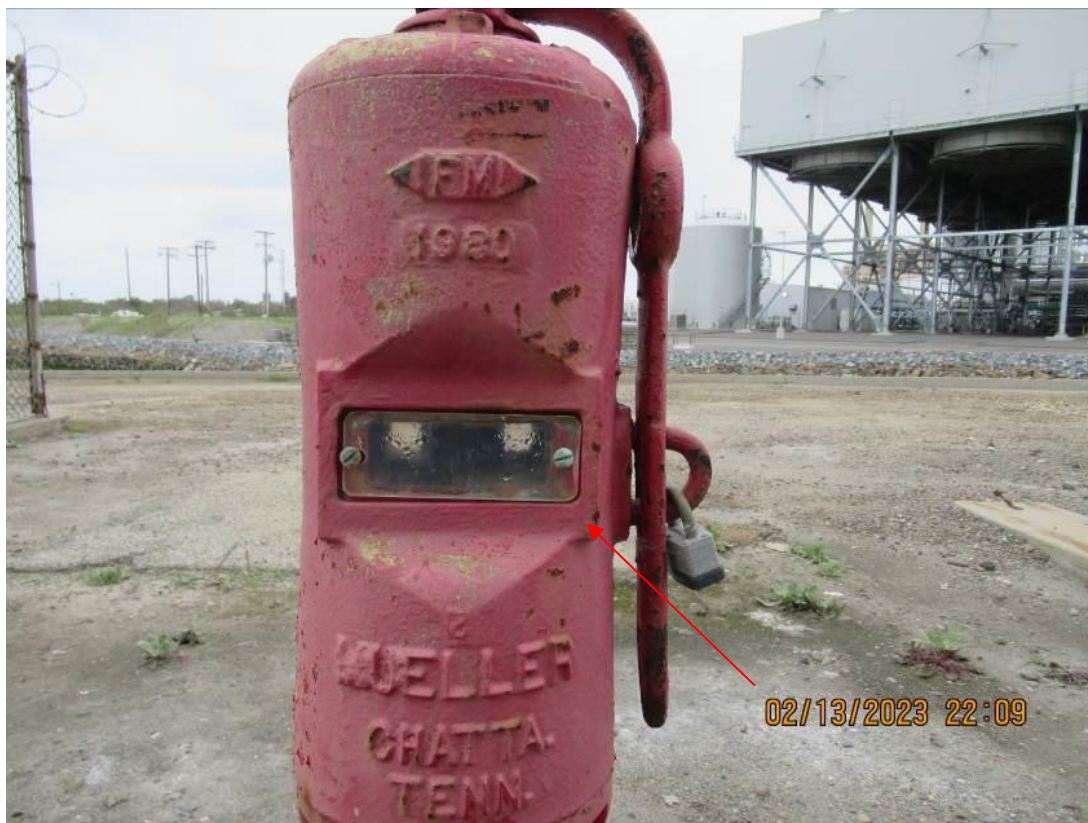
ESRB staff observed Post Indicator Valves (PIVs) 5B that was missing a position indicator. The PIV is a valve used to control the water supply to the fire sprinkler system. The PIV has a display that shows whether water is being pumped into the system (“OPEN”) or not (“CLOSED”).

Figure 13: PIV missing position indicator

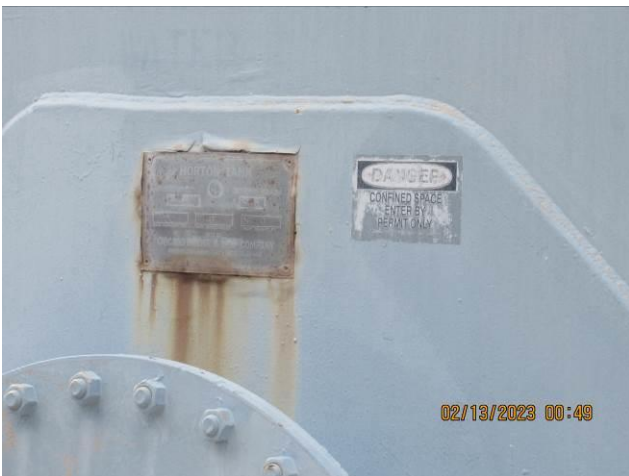
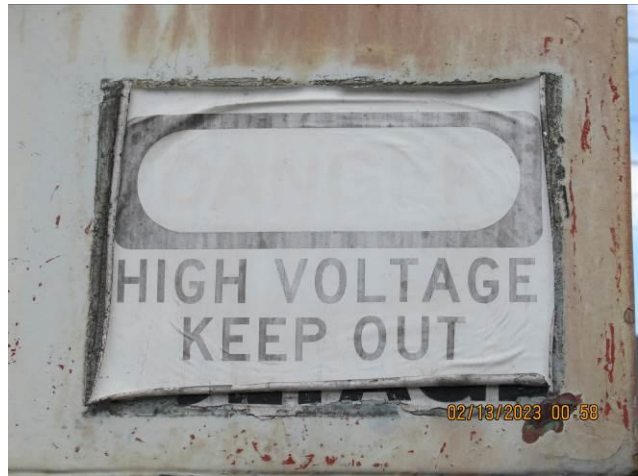
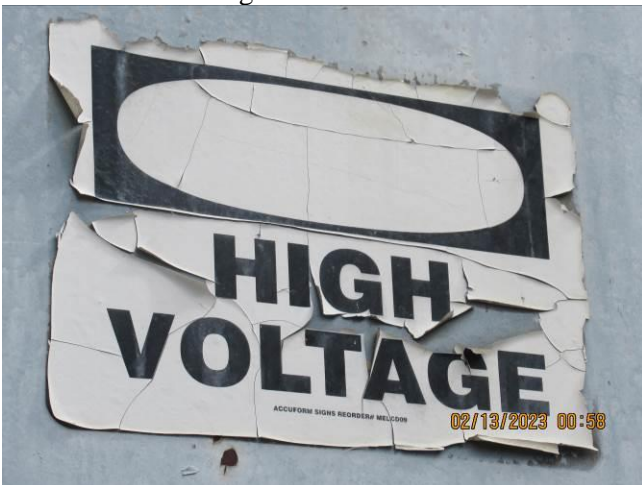
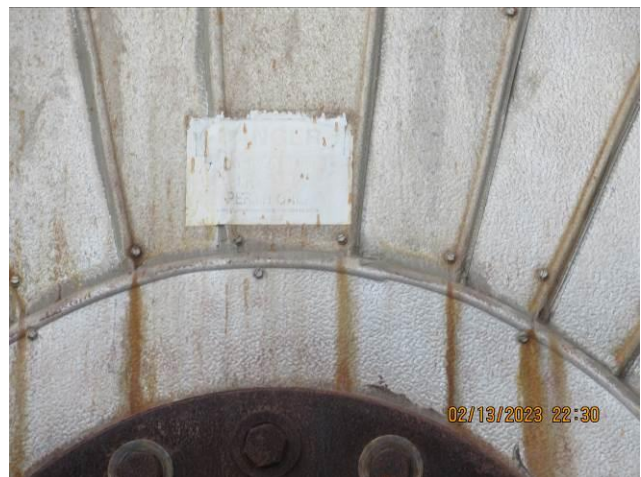
ESRB staff observed several deteriorating signs and labels, including “High Voltage” signs and “Confined Space” signs. These signs help inform employees, contractors, and visitors who may be unfamiliar with the equipment and its inherent dangers.

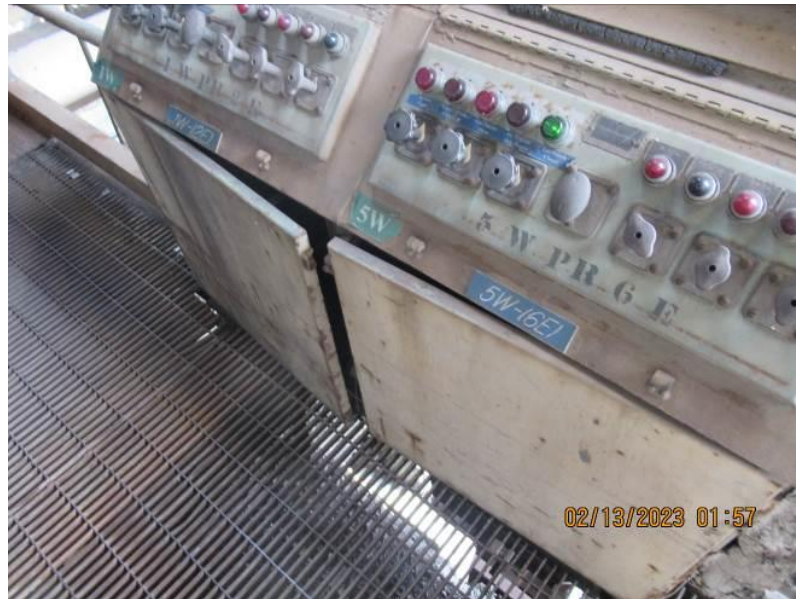
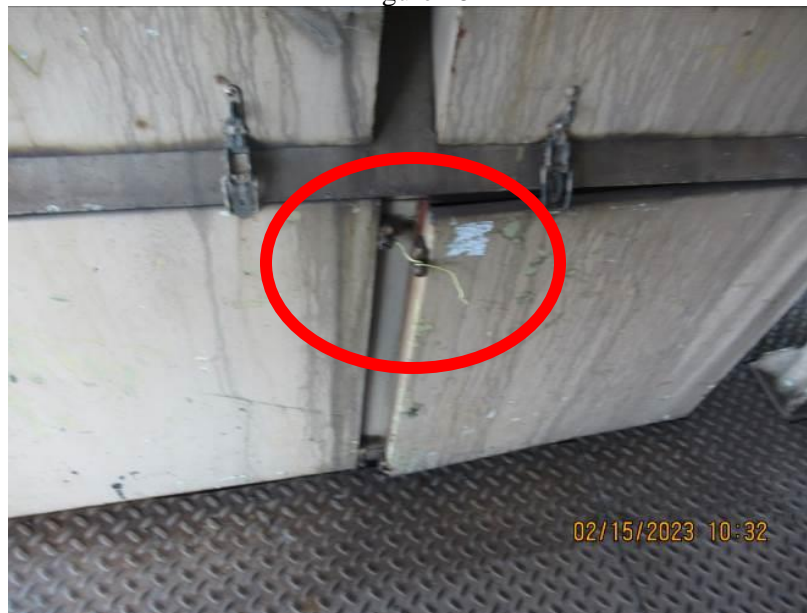
ESRB staff observed multiple burner control cabinets that doesn't close and lock. Without the locks, the cabinets are not protected from the outside environment and can lead to tripping hazards.

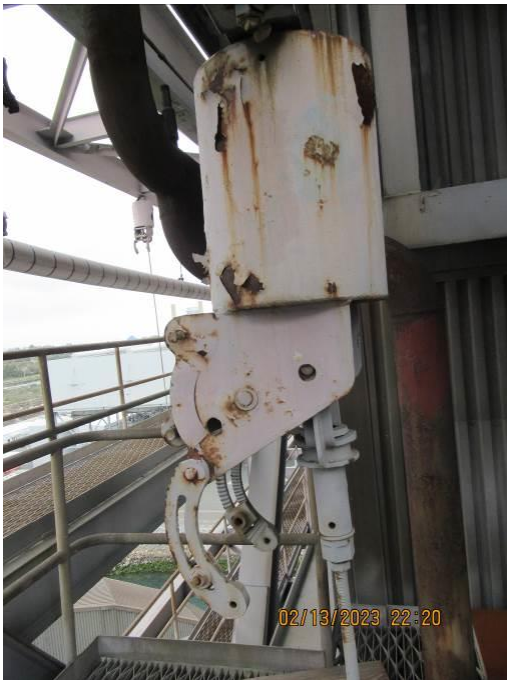
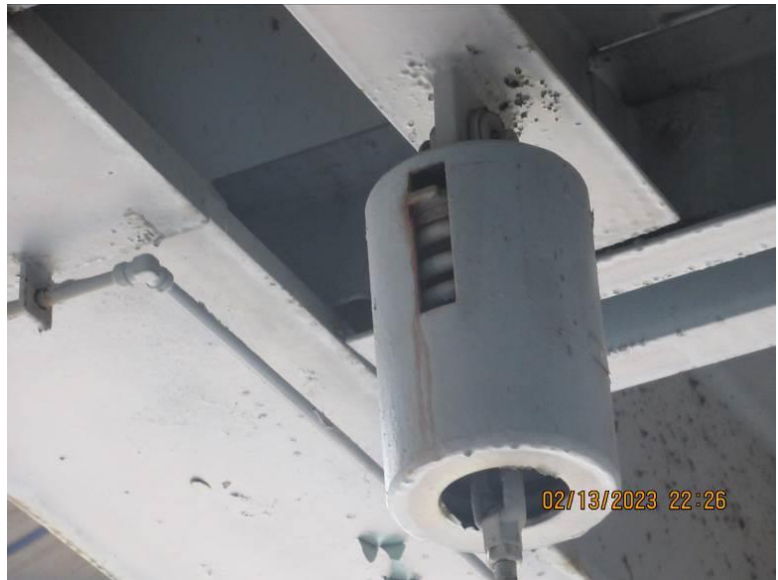
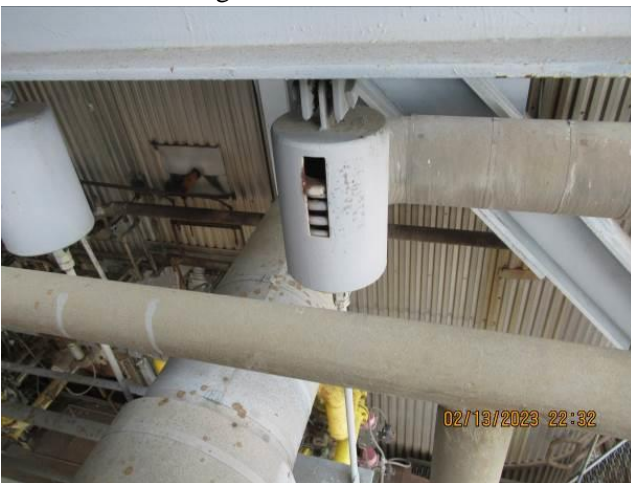
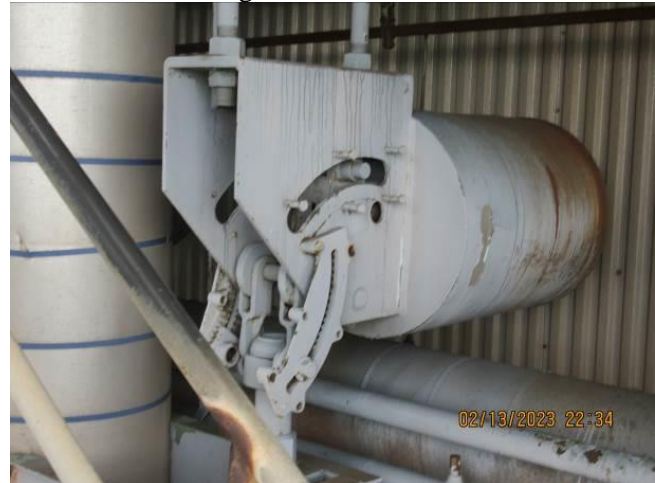
ESRB staff observed multiple unmarked HEP structures. Unmarked HEP structures do not allow Plant personnel to determine if the system is within proper operating range.
