PUBLIC UTILITIES COMMISSION

SUBJECT: Generation Audit of La Paloma – Audit Number GA2023-09LP

On behalf of the Generation Section, Electric Safety and Reliability Branch (ESRB) of the California Public Utilities Commission (CPUC), Calvin Choi and Emmanuel Salas of ESRB staff conducted a generation audit of La Paloma from June 19, 2023, through June 23, 2023.

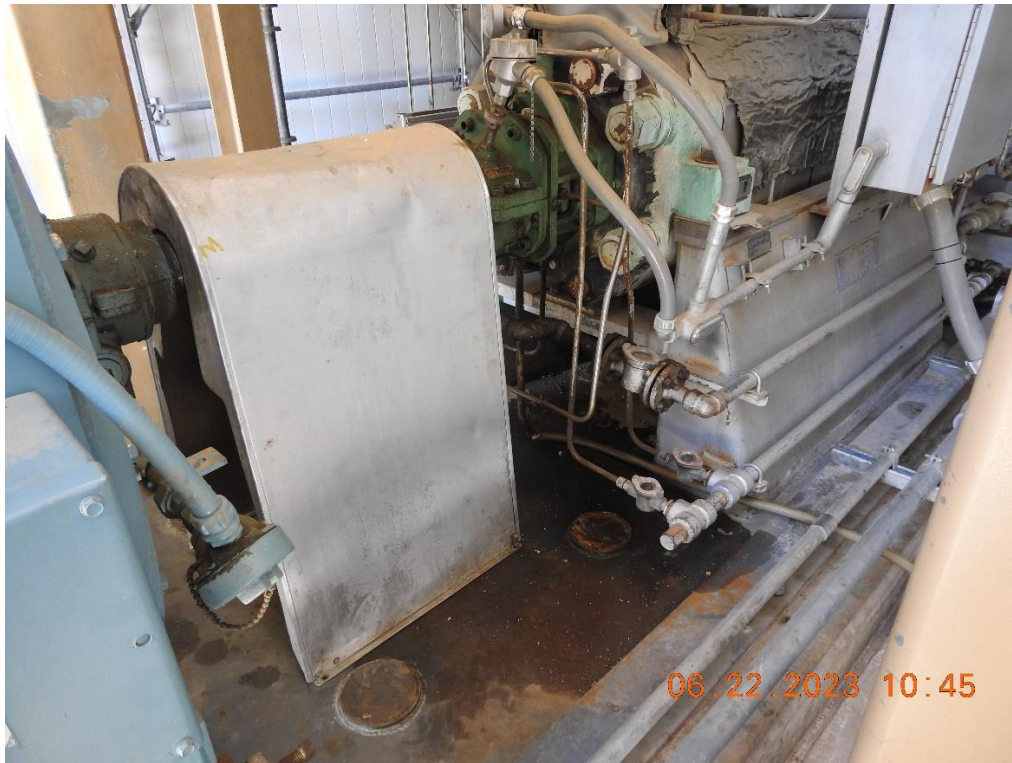
Finding 1: ESRB staff observed leakage from pipes and other equipment in different areas of the Plant.

ESRB staff observed an oil leak from the Unit 2 high-pressure (HP) boiler feedwater pump. Staff also observed air leaks from the nitrogen layup valve 41QJD10AA002, an air solenoid on Unit 3 hot reheat relief valve on the Heat Recovery Steam Generator (HRSG) deck, and HP bypass valve MAN50AA002.

Figure 1: Oil leak from Unit 2 boiler feedwater pump.

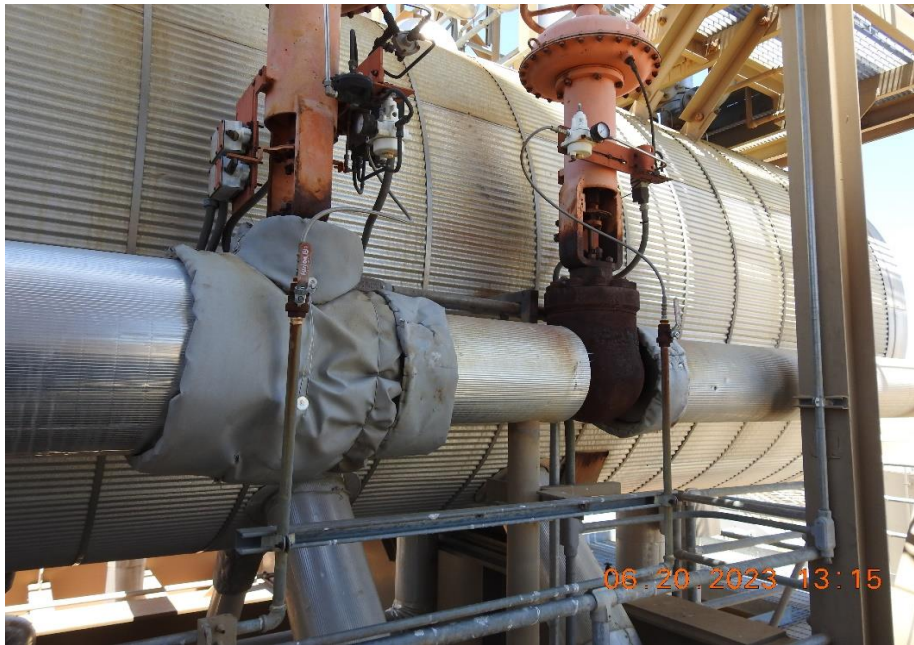
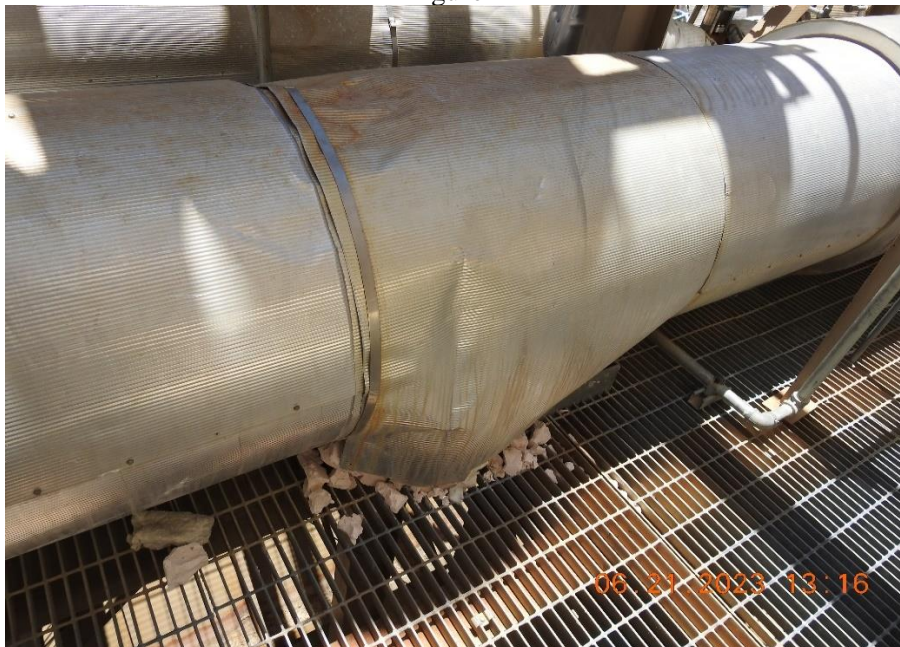
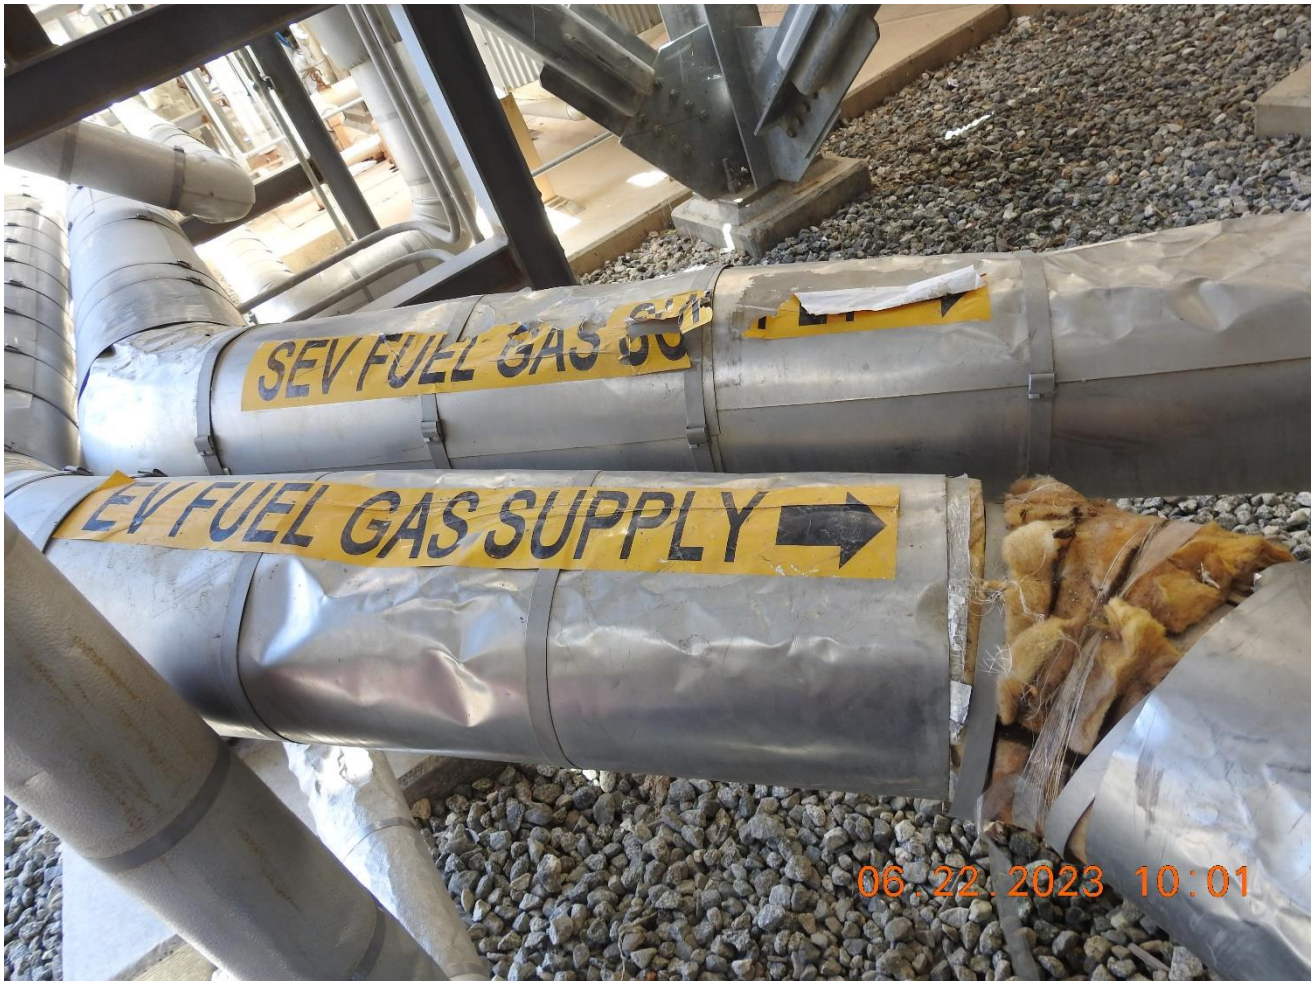
Finding 2: ESRB staff observed damaged/missing insulation across the Plant.

ESRB staff observed damaged/missing insulation on the Unit 4 HP separator recirc valve 41LCQ61AA003, near the Unit 4 HP Evap drain outlet, on the Unit 3 HRSG reheat attempt line on the HRSG deck, on the Unit 2 EV fuel gas supply line, and near Unit 1 valve actuator 18LBC50AA202. Damaged insulation can result in accelerated heat gain or loss and can result in corrosion under insulation.

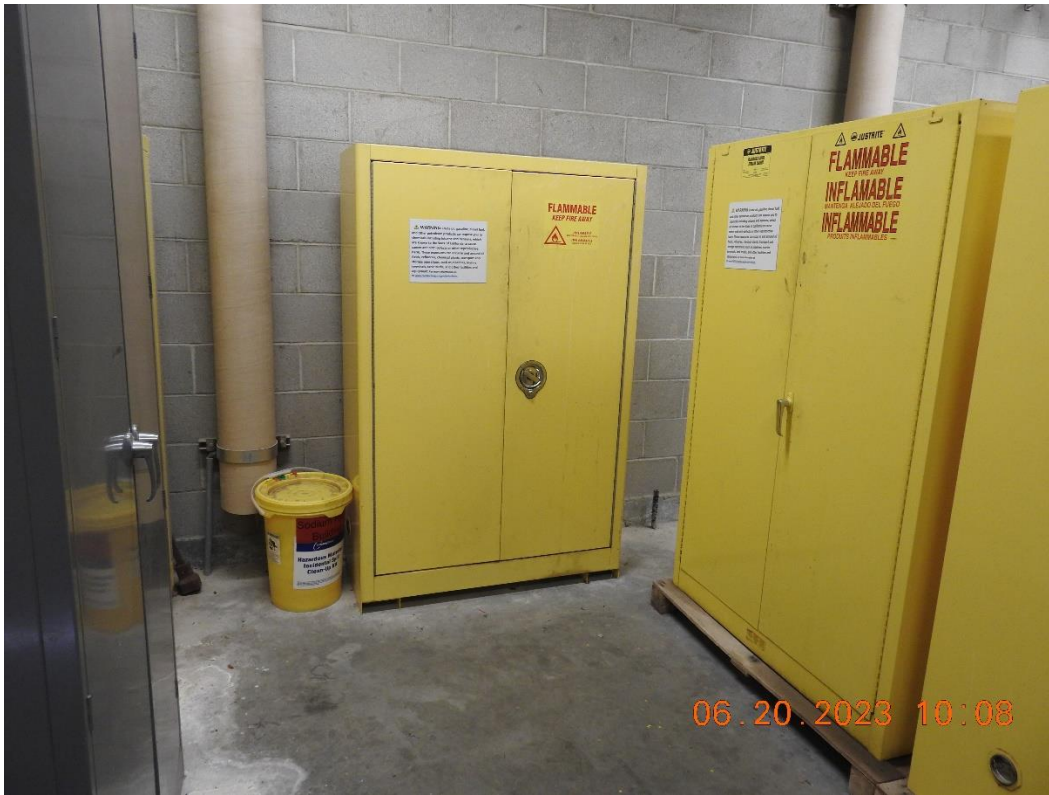
Finding 4: ESRB staff observed damaged National Fire Protection Association (NFPA) Fire diamond signs on ammonia tanks. Missing NFPA (Fire diamond) signs and self-closing mechanism on warehouse flammable storage cabinets.

ESRB staff observed missing NFPA signs (the fire diamond) on the flammable storage cabinets were missing the fire diamond with appropriate rating numbers. The numbers are important to provide information related to hazards. These signs are required to easily and quickly inform emergency personnel of the hazard level of the chemicals in the cabinets.

Figure 5: Missing NFPA Fire diamonds on the flammable storage cabinets

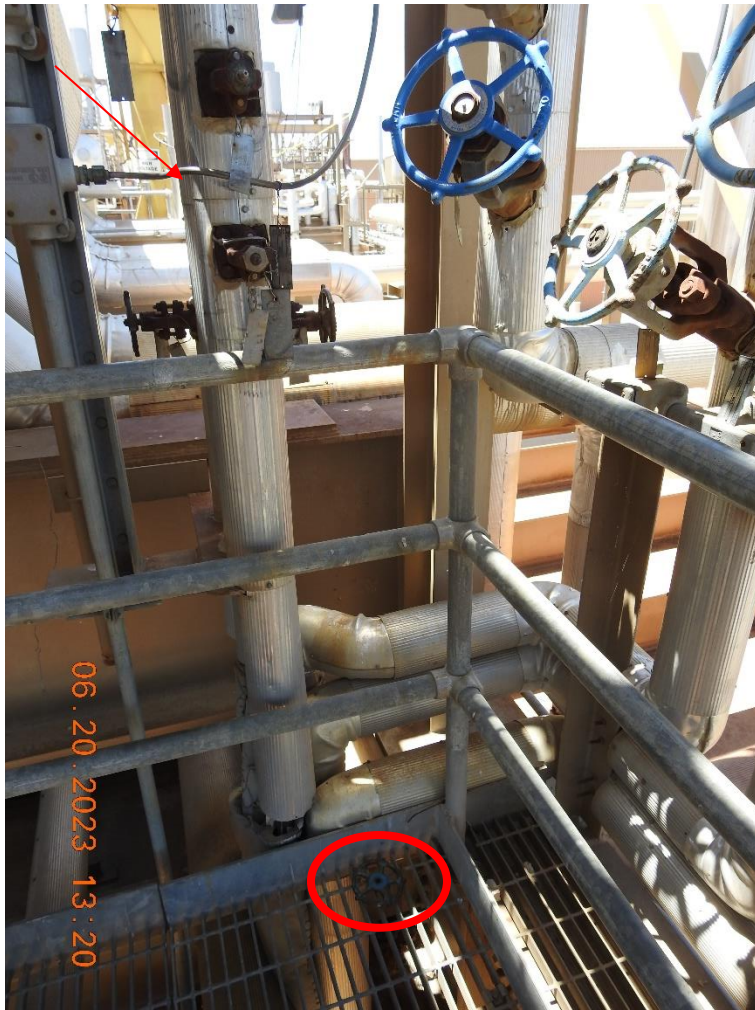
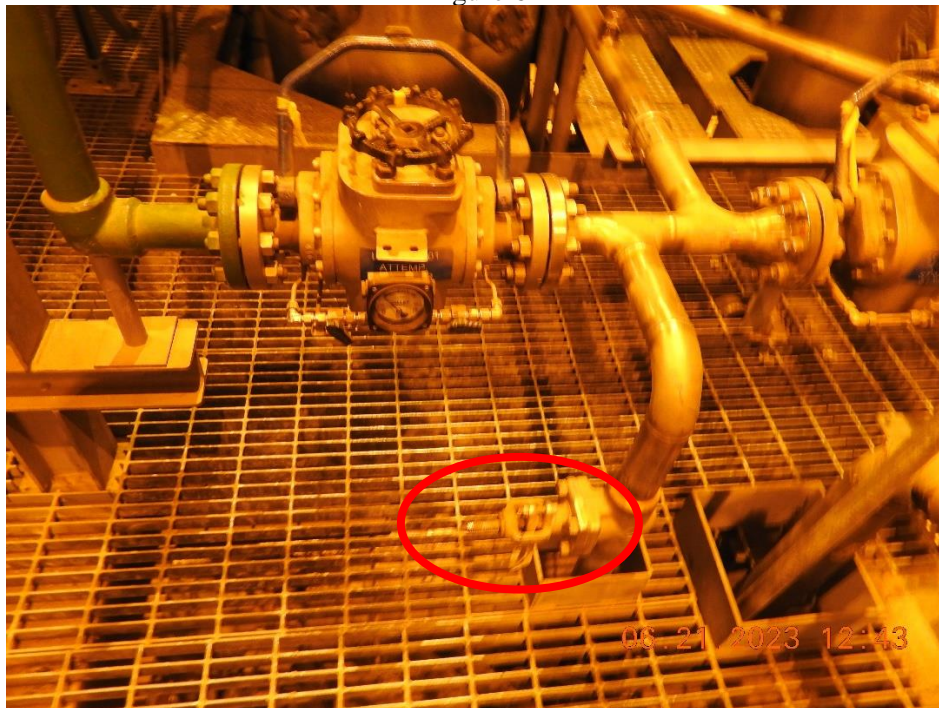
Finding 7: ESRB staff observed valve handles that were not attached to accompanying valve.

ESRB staff observed valve handles on the ground that were not attached to a valve near Unit 4 feedwater economizer vents and near LCE10AT001 Attemp Strainer. The detached handle prevents the valve from being operated properly and quickly.

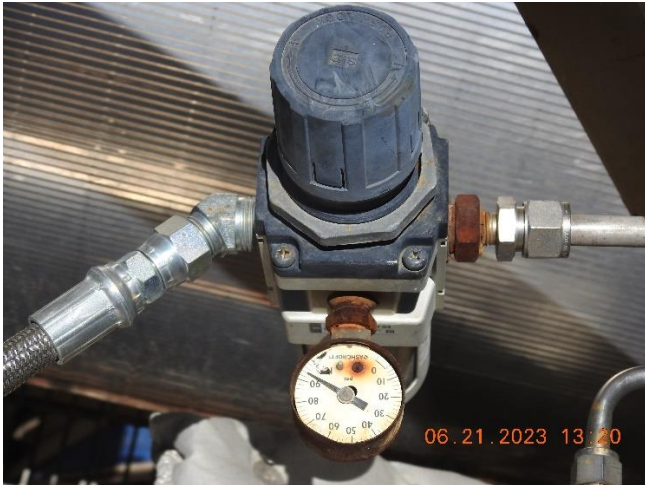
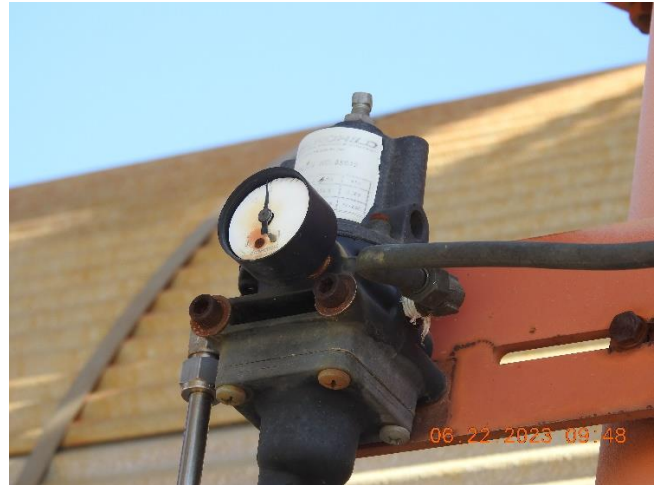
Finding 8: ESRB observed damaged gauges.

ESRB staff observed damaged gauges on Unit 3 Reheat Attemp Solenoid and on Regulator 21LCQ61AA003. Defective pressure gauges can result in erroneous pressure readings.

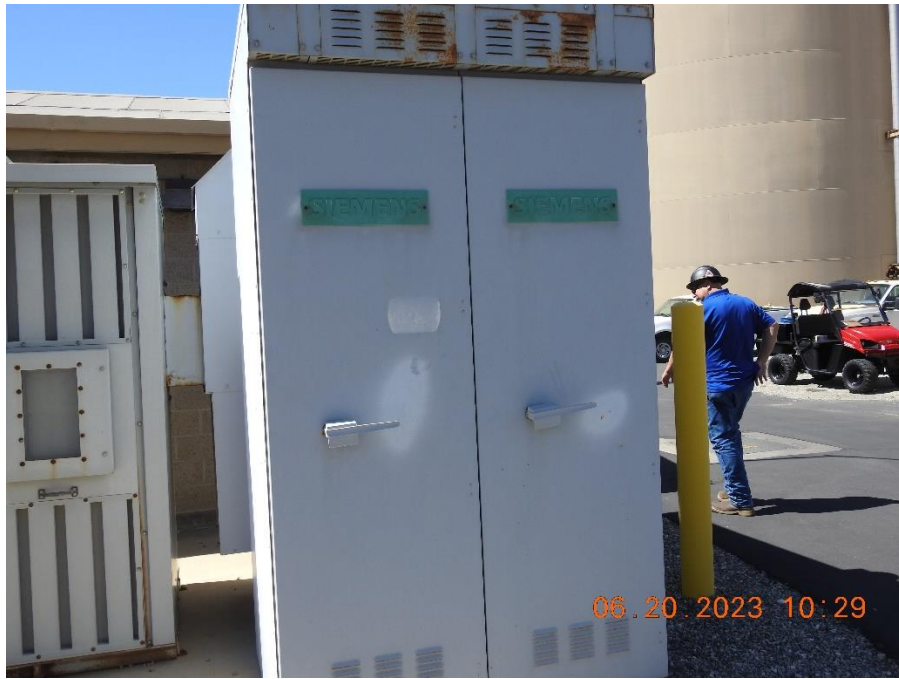
Figure 10

Finding 10: ESRB observed missing High Voltage (HV) signs on electrical equipment.

ESRB staff observed missing HV signs on Unit 1/3 power feed electrical equipment. These signs are required to inform employees, contractors, and visitors who may be unfamiliar with the equipment and its inherent dangers.
