PUBLIC UTILITIES COMMISSION

GA2021-08AW

SUBJECT: Audit of Alta I-X

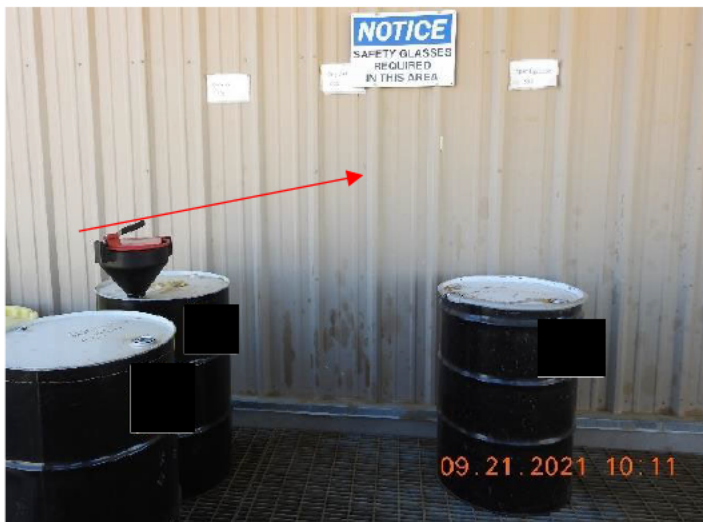
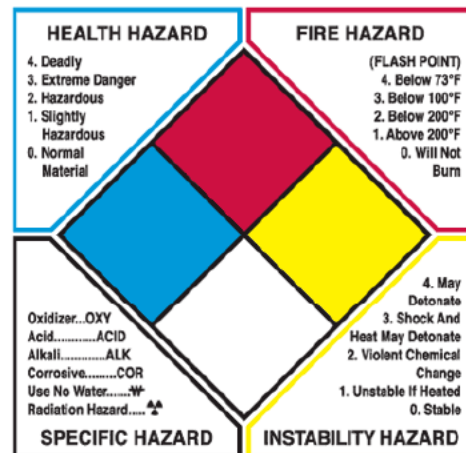
Finding 01: Missing NFPA (Fire diamond) sign in chemical storage area

ESRB Staff observed that the outdoor chemical storage area had no NFPA signs.

Signs identify designated place for each substance but no NFPA diamond in the area.

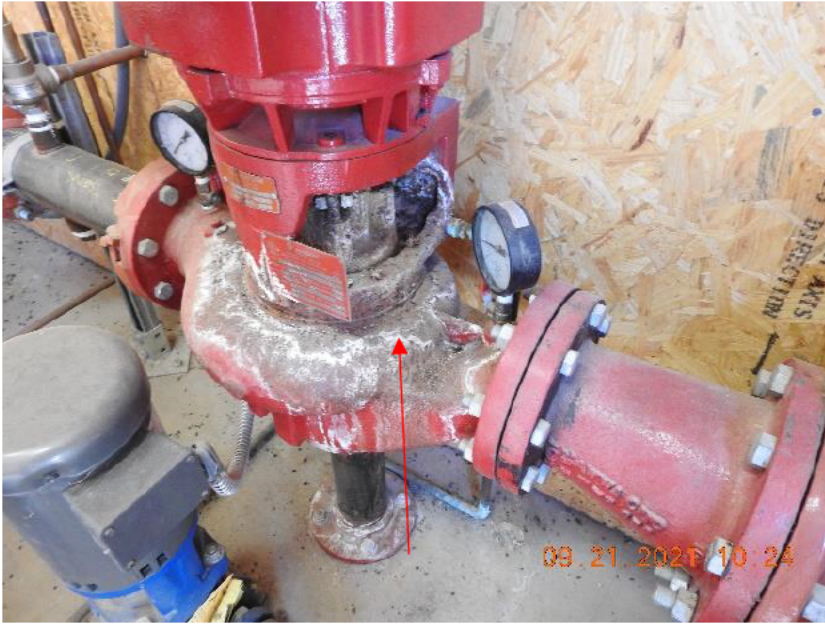
Finding 02: ESRB inspectors observed a rusted and leaking fire pump

A fire pump showed corrosion and signs of leaking. It is essential that all fire facilities are properly maintained and remain in reliable condition in case of an emergency.

Buildup around fire pump suggests water leakage over a long period of time.

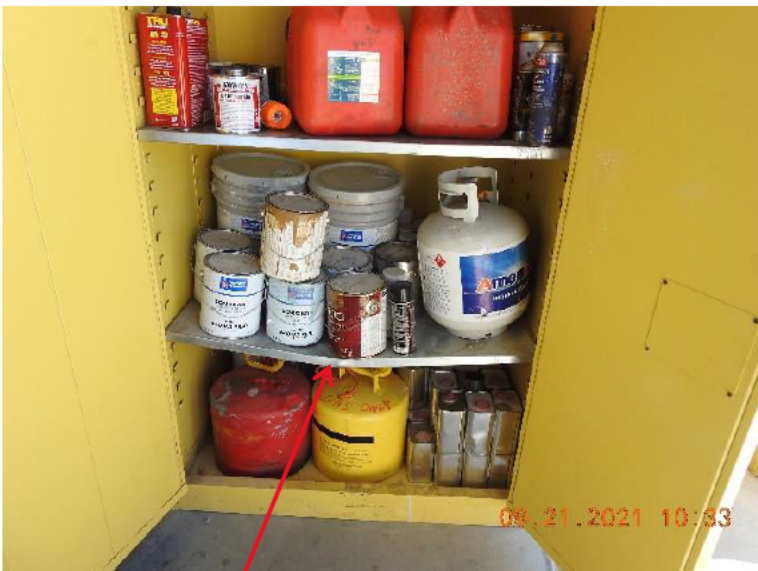
Finding 03: ESRB inspectors found Chemical storage cabinet structurally unsound

ESRB Staff found a sagging unsecured shelf within the flammable chemical storage cabinet. Flammable materials should be secured to decrease the risk of spills.

The middle shelf in the cabinet is sagging under the weight of the containers.

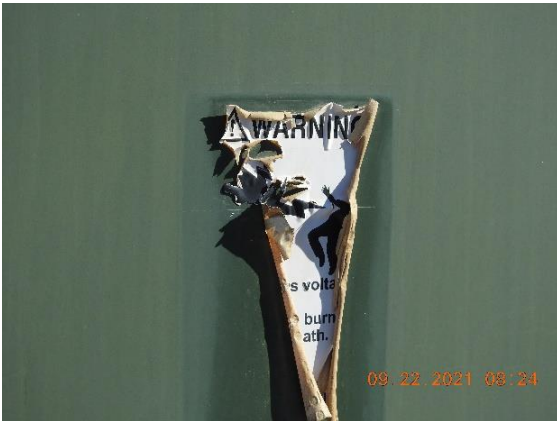
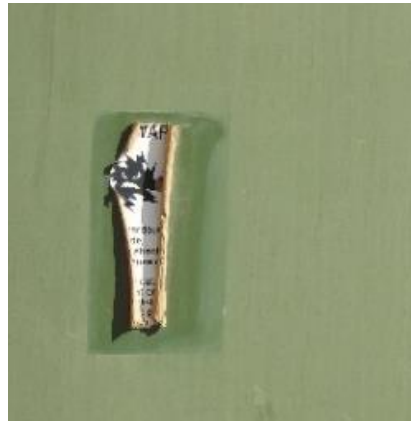
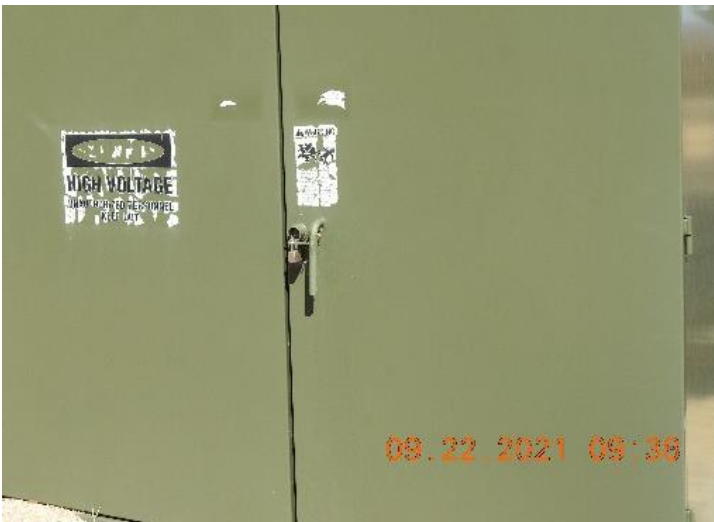
Finding 04: ESRB inspectors witnessed deteriorated High voltage stickers on transformers

ESRB inspectors found several pad mounted transformers with high voltage stickers that were deteriorated beyond recognition. External warning signs are a crucial safety device as these transformers are within an area that is open to the public.

Several deteriorated high voltage stickers on outdoor transformers.

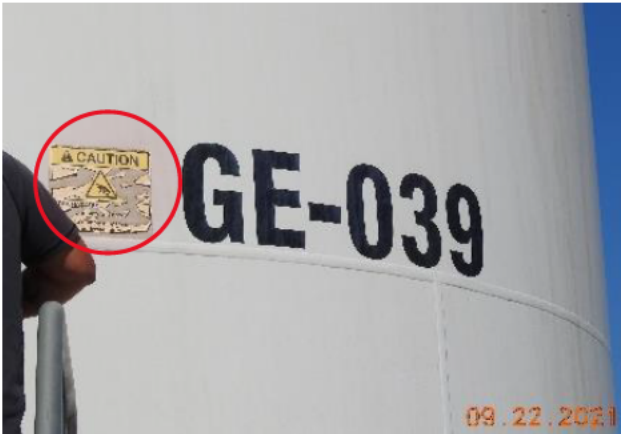
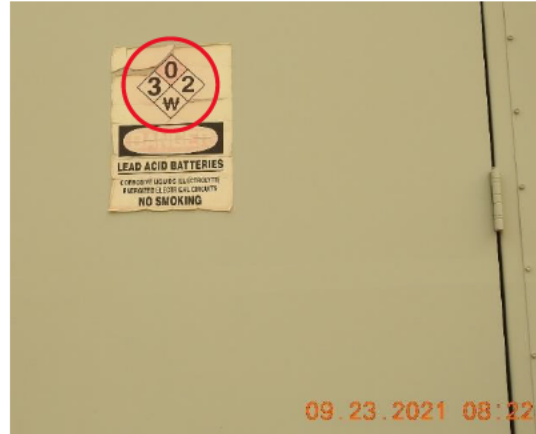
Finding 05: ESRB inspectors witnessed several safety signs deteriorated or illegible

ESRB Staff found safety signs in poor condition and in need of replacement. Signs should be legible and color coding should be clearly recognizable.

Signs showing wear and faded colors.

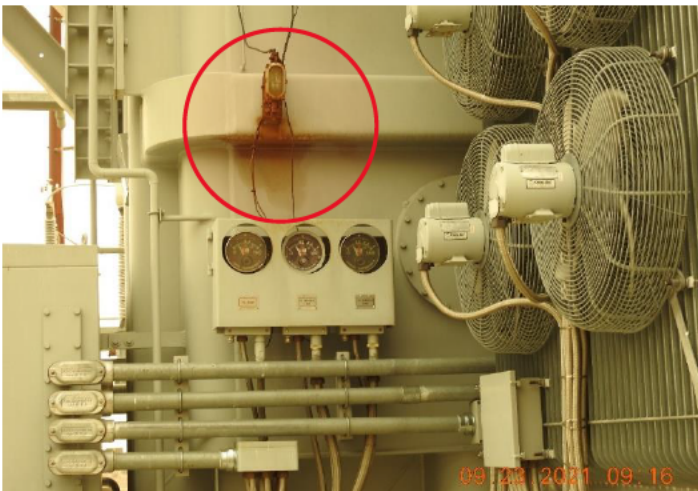
Finding 6: ESRB inspectors witnessed an equipment on transformer rusted and shows recent leaking

ESRB Staff observed rust and a relatively recent oil stain at a connection point on a substation transformer. Long term oxidation can damage the structural integrity of equipment.

Rust and oil stain on transformer.
