# Russell City Energy Center Incident Investigation

SAFETY AND ENFORCEMENT DIVISION  
ELECTRIC SAFETY AND RELIABILITY BRANCH

October 12, 2022

<b>Report Date:</b>	October 12, 2022
<b>Investigators:</b>	James Cheng, Stephen Lee, Chris Lee
<b>Incident Number:</b>	RC20210528-2
<b>Utility:</b>	Russell City Energy Company LLC
<b>Date and Time of the Incident:</b>	5/27/2021 @ 23:47 Hours
<b>Location of the Incident:</b>	3862 Depot Road, Hayward, CA 94545, Alameda County

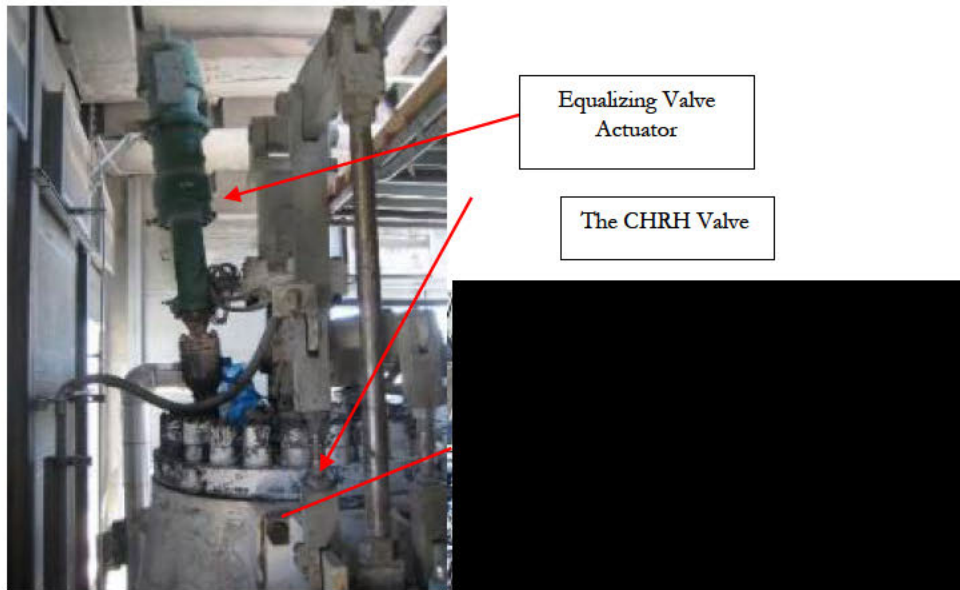
The Combined Hot Reheat Control (CHRH) valve provides steam to the intermediate pressure section of the STG. This is the valve that Structural Integrity Associates (SIA) determined had failed due to thermal seizure and allowed water to enter the STG. It is this water which caused the “water impingement event” (event). This event preceded the STG overspeed.

Figure 6. Turbine Steam Combined Hot Reheat Stop and Control Valve [REDACTED]

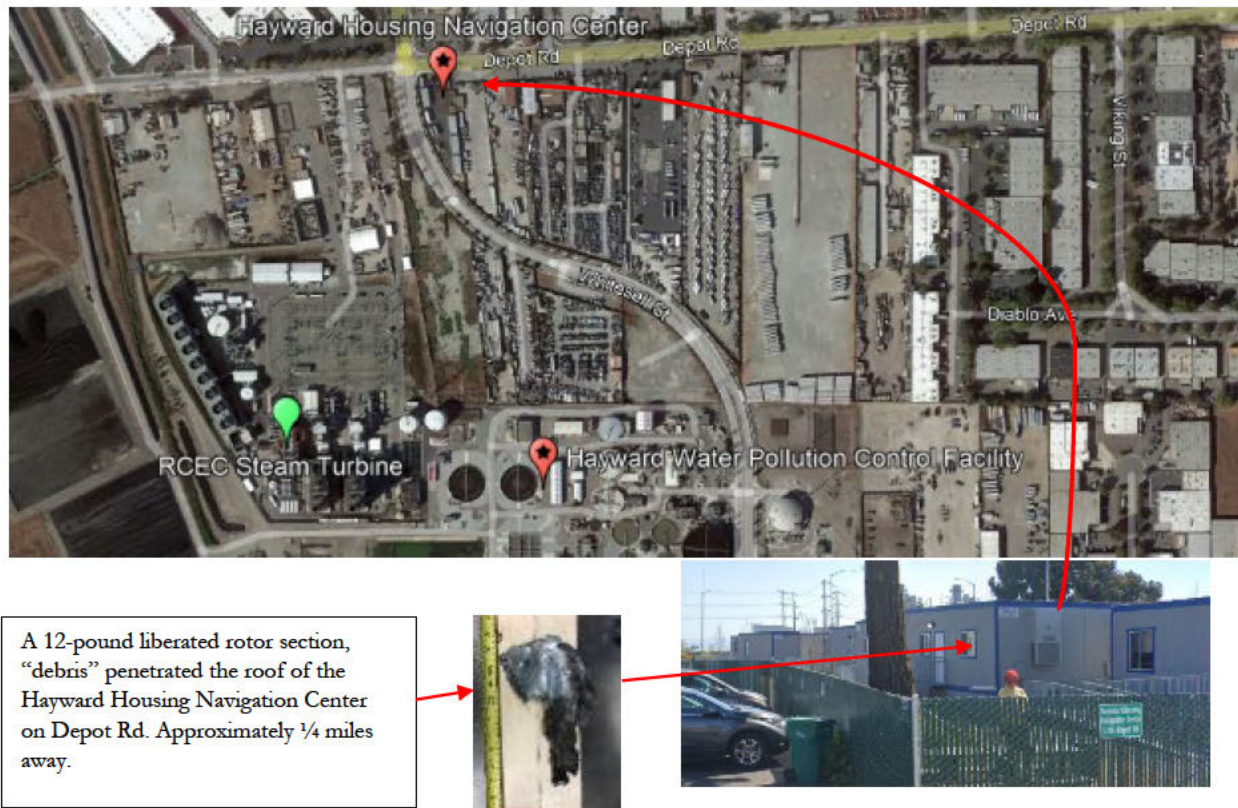
Figure 15. Debris was scattered in the adjacent Hayward Waste Pollution Control Facility and as far as a quarter of a mile away at the Hayward Housing Navigation Center.<sup>4</sup>

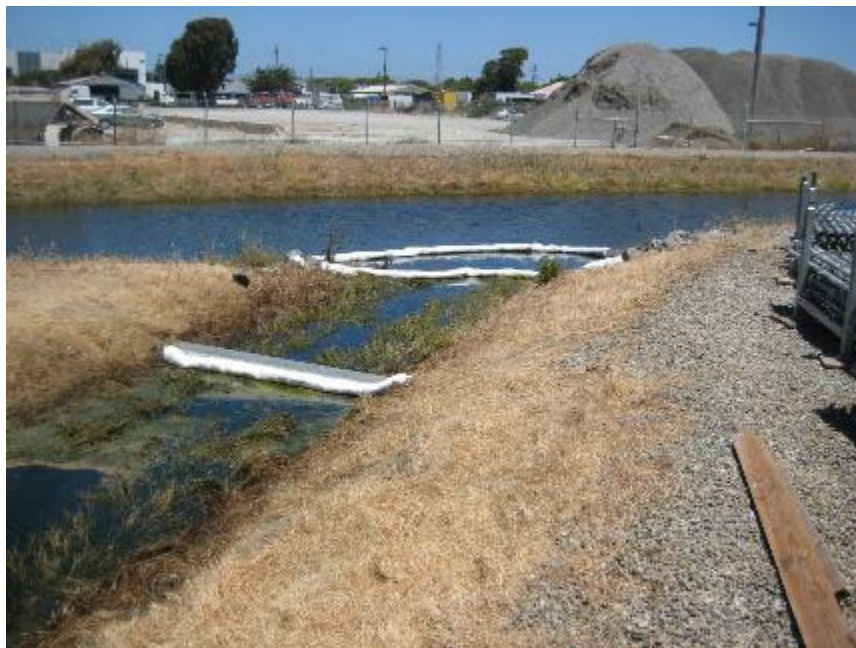
Lube oil was then carried by the fire suppression water into the drainage ditch and retention pond. An estimated 4,000 gallons of lube oil was released. Fortunately, the wind helped retain the oil booms and oil slick from exiting RCEC's Retention Pond. RCEC, LLC hired Environmental Logistics (EL), to survey the stormwater retention pond and the channel that feeds out to the San Francisco Bay. EL's biologist confirmed that no lube oil had made it offsite.

Figure 17. The storm water runoff canal and oil absorbing socks in use.

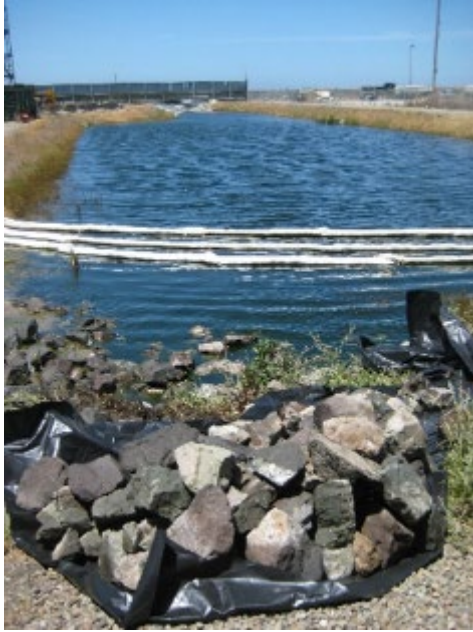
Figure 18. The water retention pond and the oil retention booms in service.

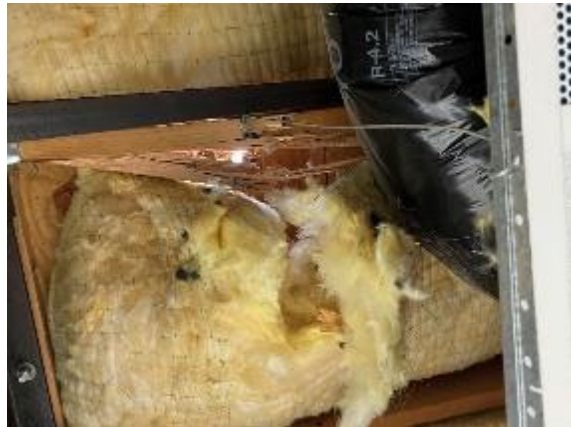
Figure 23. Navigation Center roof hole caused by debris.

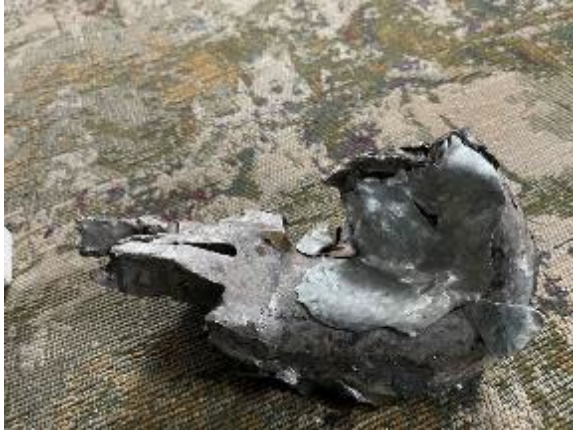
A facility for assisting unhoused individuals, the “Housing Navigation Center” had a 12-pound turbine root pierce their roof and land in a food preparation area. Fortunately, there were no fatalities or significant collateral damage. The facility was unoccupied at the time of the incident due to COVID.

Figure 24. Left: Blade root as found in the Navigation Center.

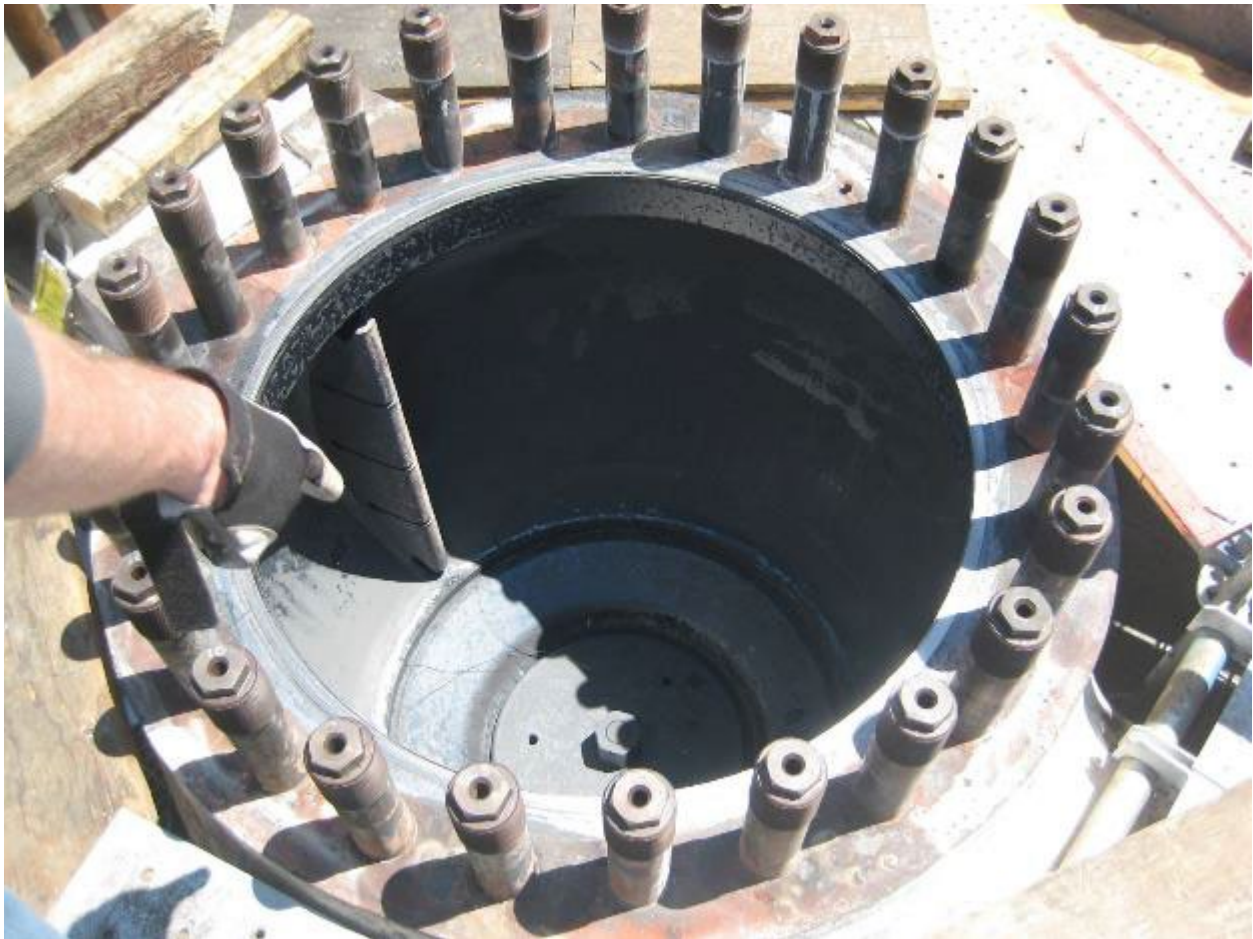
Figure 29. Combined Hot Reheat (CHRH) valve was open for inspection and analysis. A forensic analysis by Structural Integrity Associates indicate this valve played a key role [REDACTED].

SIA identified the CHRH as having suffered deformation (bending) and thermal seizure, thus allowing water and steam to enter and cause the overspeed event to occur. This conclusion was arrived at by visually inspecting the valve stem. This visual inspection ignores other possible causes for valve seizure such as water hammer or vapor lock. Results from a formal metallurgical investigation can be more precise and facilitate industry wide improvements. SED agrees with RCEC that all metals are subject to thermal and physical distortion, but some alloys are more resistant to this than others i.e., turbine blades. It also needs to determine if the valve stem is compliant with all OEM specifications. Therefore, citing GO 167-B, Section 11.3<sup>14</sup>, SED insists that

RCEC LLC's consultant, Structural Integrity Associates (SIA) completed the Materials Analysis and it was cleared May 16, 2022. The CPUC has no jurisdiction over SIA therefore, no enforcement action was recommended or taken.

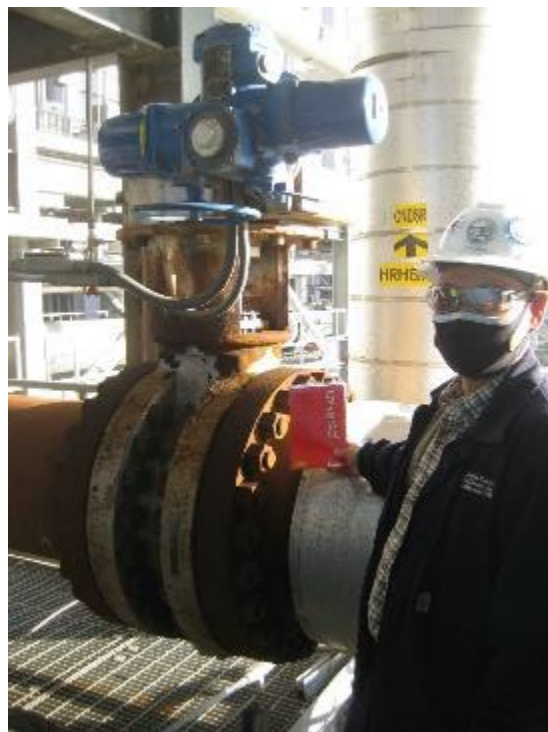
Figure 31. The Cold Reheat Valve that allowed the accumulated water to enter the Steam turbine.
