# ROOT CAUSE ANALYSIS

VIRTUAL WORKSHOP

DECEMBER 5, 2022

# The 2017 & 2018 Wildfires

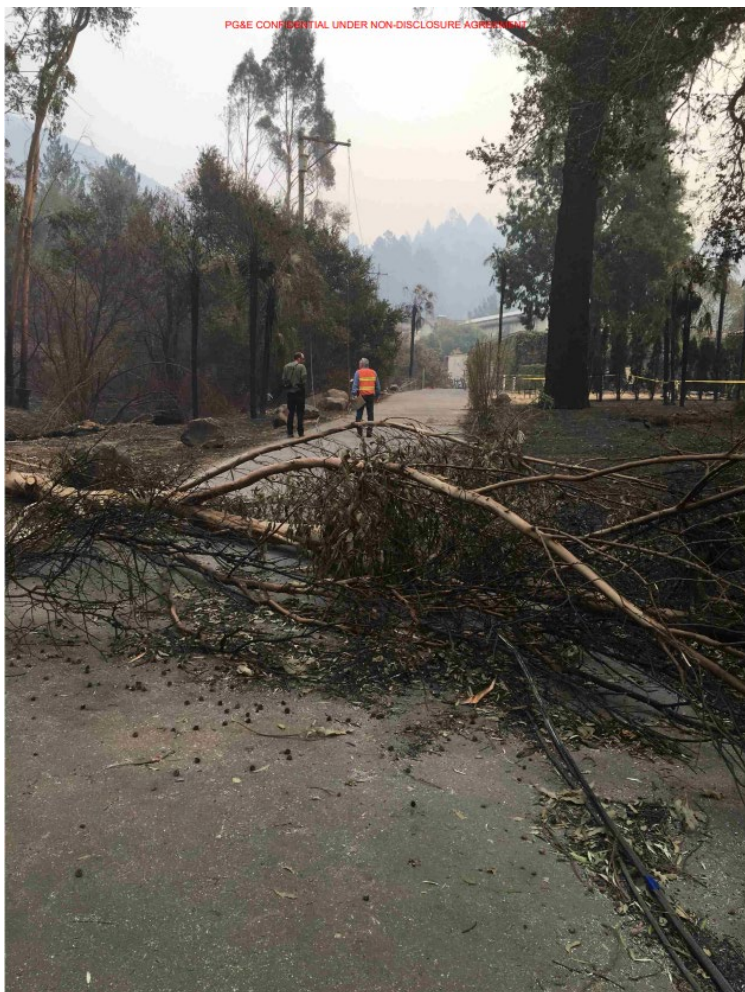
PGE-CPUC\_00016059

- ▶ Based on CPUC’s SED Incident investigation, PG&E violated General Order 95, Rule 31.1.
  - Hazardous tree not identified and abated.
  - Records of 2015 CEMA inspection not retained.
  - Work order completed late.
- ▶ The Adobe fire was not a high wind event and is considered a normal weather event. Arborists use the Beauford Wind Scale to determine the effects of wind on trees.
- ▶ The subject tree was clearly a visible hazard tree that should have been identified and abated by PG&E. The primary form and structure defects would be readily visible to a diligent inspector performing a ground-based inspection along the right-of-way, especially one trained and sensitive to the electrical contact hazards posed by this tree.

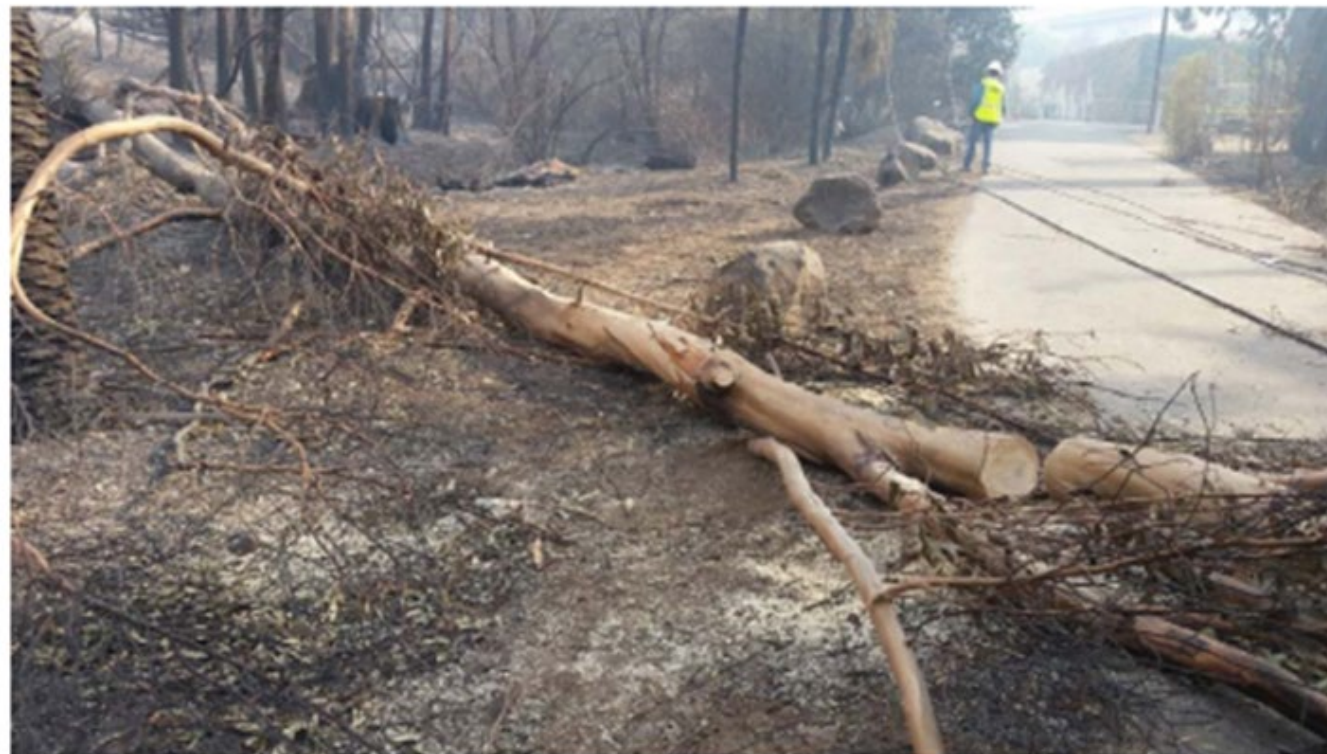
**Figure 8.** Subject Eucalyptus tree laying across the road and subject conductor spans. The tree was rooted in the top left corner of the image. (October 17, 2017)

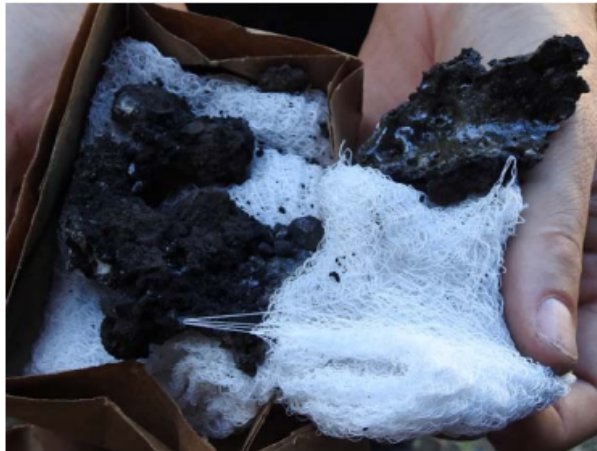
On October 12, 2018, SED staff, Wilson Tsai and Raymond Cho, met with CAL FIRE investigators in Santa Rosa to review evidence from the evidence site retained by CAL FIRE. Of the evidence reviewed and photographed, SED staff found multiple damaged electric facilities and hardware including a fulgurite-like mass, failed insulator tie wires and damaged conductors. Fulgurites<sup>33</sup> are naturally occurring masses of fused soil and/or other debris that can form when lightning discharges into the ground. In this case, a fulgurite-like mass was formed when conductors fell to the ground and discharged enough energy to fuse some of the ground material together.

Figure 10. Fulgurite-like mass found in the Adobe incident area.

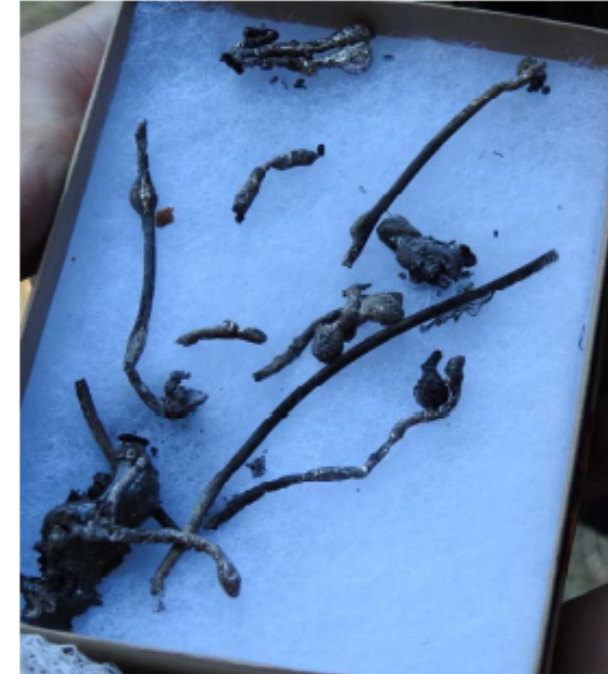
SED staff did not unwind the multiple bundles of conductor wire but reviewed the failure points. The Eucalyptus tree and fire damaged the insulating rubber material around the conductors. SED found evidence of arcing exhibited by molten metal attached to failed pieces of conductor.

High Impedence Fault  
Condition  
Possible Back Feed  
Scenario

Figure 11. Failed pieces of conductor strands and evidence of arcing.

CAL FIRE's investigation report determined that the subject Eucalyptus tree failed and fell into the three 12 kV conductors. The report notes that "(t)he electrical conductors broke and fell to the ground and onto surrounding vegetation. Several of the conductors remained energized and arced causing a vegetation fire..."<sup>34</sup>. The CAL FIRE investigator identified the grounded, energized conductors as the source of ignition.
