FILSINGER ENERGY
P A R T N E R S

PG&E
INDEPENDENT SAFETY MONITOR STATUS UPDATE
REPORT

March 29, 2024

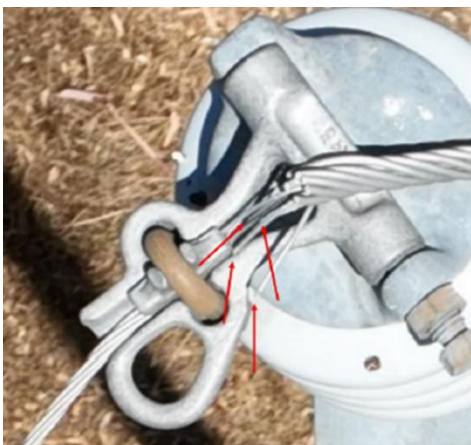
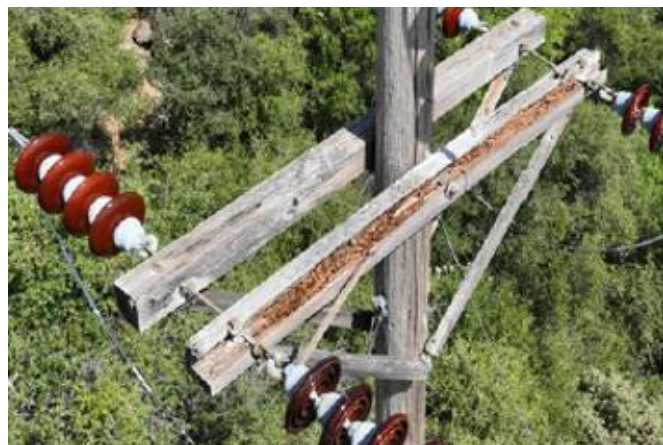
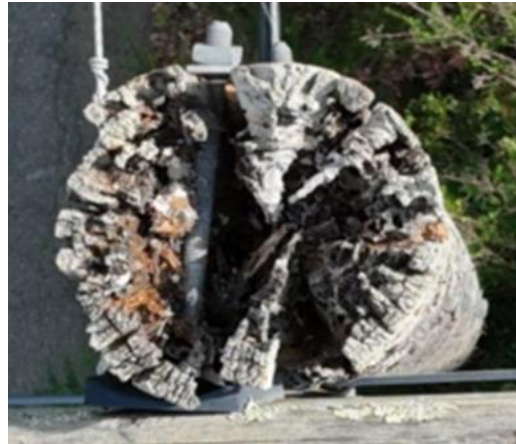
Figure 10: Examples of Defects Detectable by Aerial Inspection¹⁹

In 2023, PG&E conducted a pilot program to compare the results of side-by-side ground and aerial inspections. This pilot was conducted on approximately 12,000 poles in Extreme and Severe areas that were previously never inspected from an aerial perspective. Following this pilot program, PG&E stated that aerial inspections provided a new view of most its assets, were better at identifying conditions that correlated to actual equipment failure and were better at identifying Priority A and Priority B conditions that are challenging to see from the ground. Figure 10 provides examples of the type of equipment damage that would not have been detected in a ground inspection and that the aerial inspections can capture.

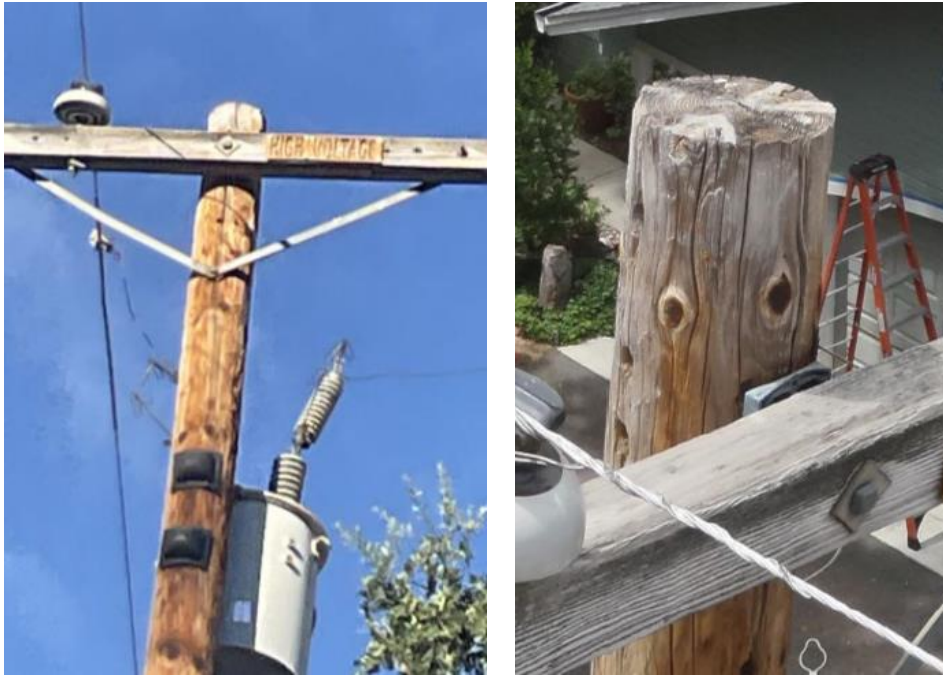
Figure 16: Aerial Cancellation of Ground Finding E Tag

By the end of 2023, PG&E had approximately 276,000 outstanding pole notifications, with approximately 118,000 of these in the HFTD. Some of these repair tags were past their required repair or replacement date by over 3 years. To address this backlog, and to determine if the original subjective inspection determinations were valid, PG&E proposed a new Comprehensive Pole Inspection (CPI) program. The CPI involves aerial inspections to provide additional information about the pole damage. As previously noted in this Q1 2024 ISM Report, PG&E indicated that some pole top and equipment conditions can be challenging to identify from a ground perspective. Figure 16 provides an example of a Priority E tag that PG&E reassessed and canceled following a new aerial inspection. In the photo on the left, PG&E noted the top of the structure, as seen from the ground, appears split. However, from the air, PG&E noted that the photo on the right shows that the crack does not penetrate deeply into the pole. Therefore, upon reassessment, PG&E recommended the tag for cancellation.

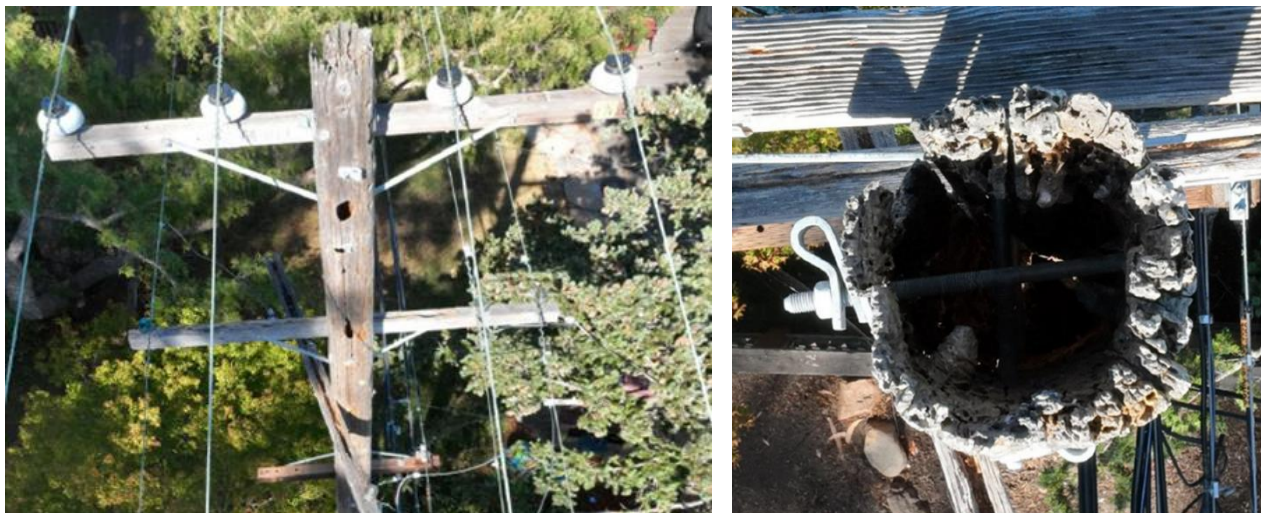
Figure 17: Aerial Cancellation of Ground Finding B Tag and Upgraded to an A Tag

Aerial inspections can also result in an increased tag priority. In Figure 17, PG&E's original ground-based inspection assigned a Priority B tag to this pole damage. However, the aerial inspection showed much more pole damage (as seen in the photo on the right). Accordingly, PG&E upgraded the tag to a priority A tag for emergency repair.

PG&E noted that if damage is confirmed with the new aerial inspection, PG&E proceeds with pole replacement; otherwise, an intrusive inspection is performed to assess the pole's interior health and strength. An intrusive test "pass" results in the notification being cancelled, while a test failure leads to pole replacement or reinforcement, depending on the damage level.

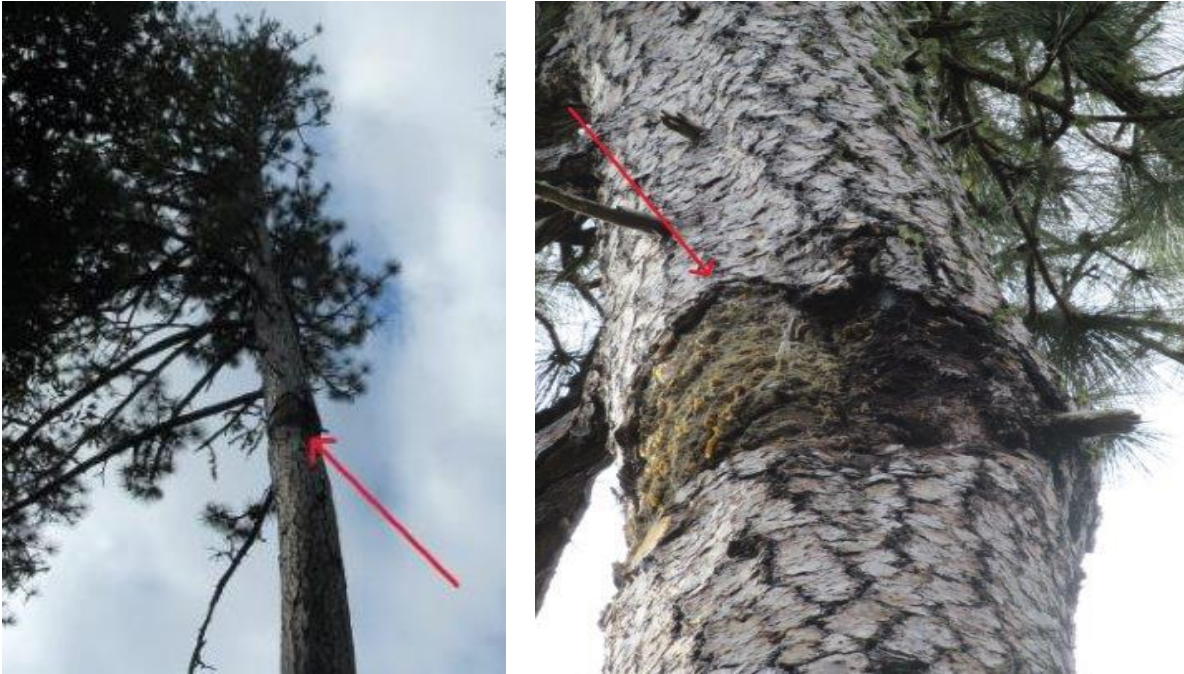
responsible for notifying PG&E; therefore, the identified work can be scheduled/completed. In the current ISM reporting period, the ISM identified one instance where it appears that PG&E did not follow this process, as shown in Figure 18. PG&E, or PG&E's contractors, pruned branches from a hazard tree with a large area of decay approximately 20 feet off the ground. The hazard tree was likely difficult to see while performing a typical routine inspection but should have been identified by tree workers based on PG&E's expectation. One data point is not enough to extrapolate if this is a widespread issue, but the ISM will continue to look for similar instances during field inspections.

Figure 18: Example of the hazard tree with a large area of decay

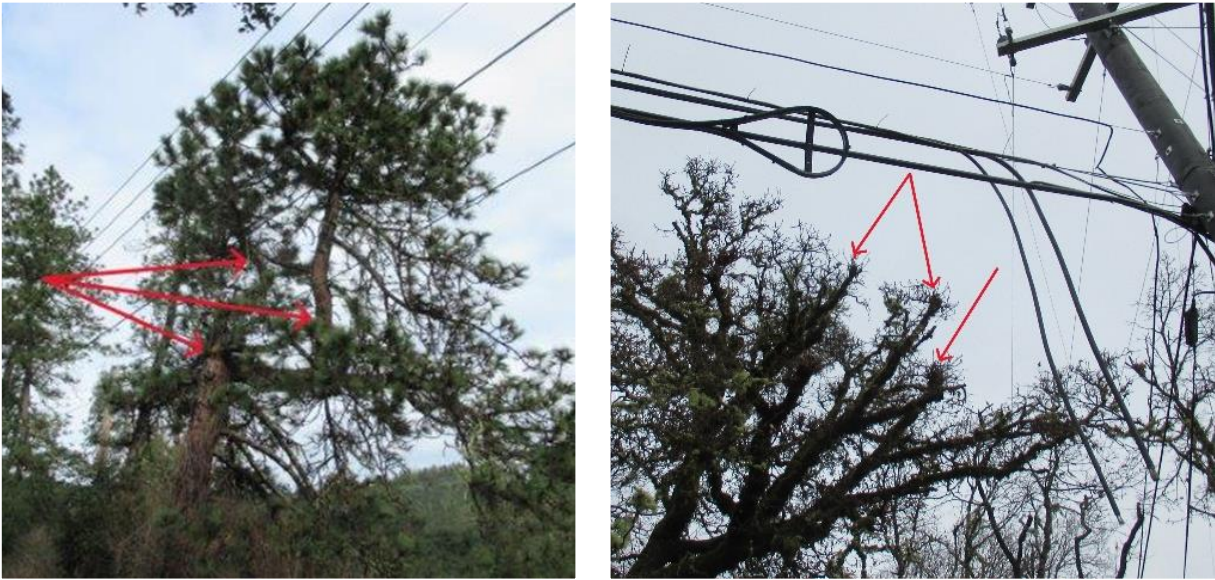
Figure 19 provides examples of non-compliant ANSI-A300/BMP pruning observed by the ISM during the current ISM reporting period’s targeted inspections.

Figure 19: ANSI-A300/BMP non-compliant²⁸

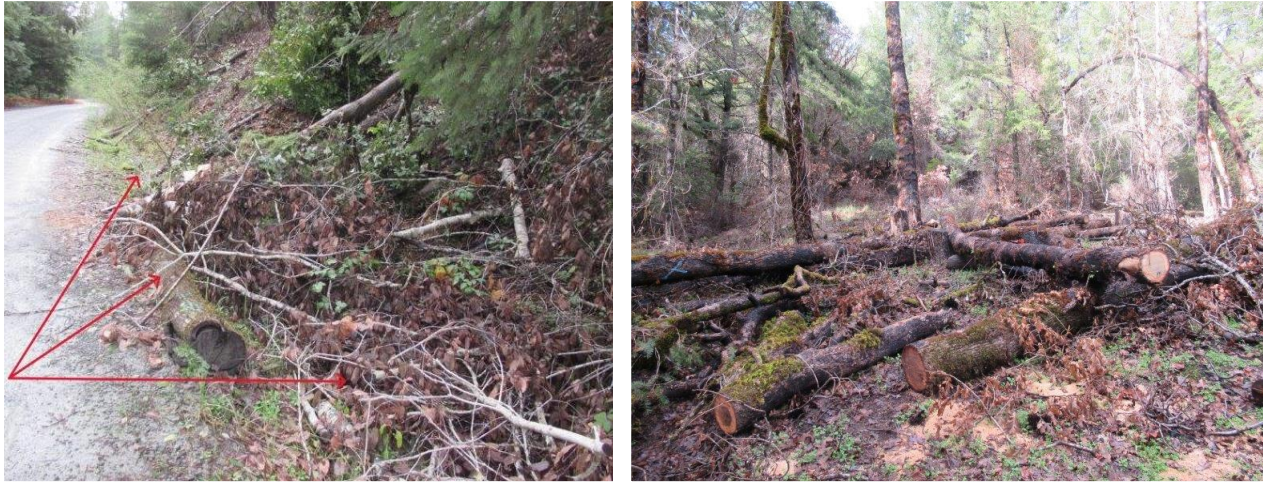
Figure 20: Inspection Area A: Wood Management "debris in road drainage" non-compliant (left). PIIR site with non-compliant Wood Management (right)

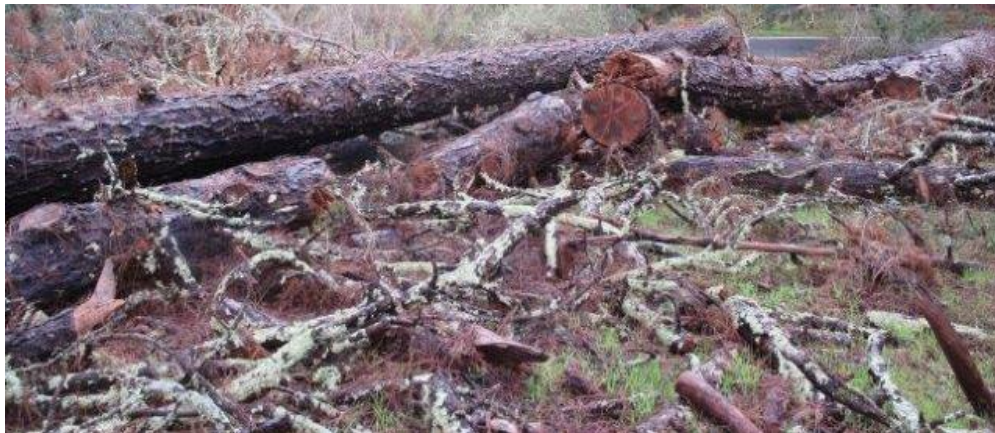
Figure 21: Inspection Area B: Non-compliant Wood Management
