CALIFORNIA PUBLIC UTILITIES COMMISSION

Incident Investigation Report

Incident Number: G 20171127-2428

Location of the Incident: 3971 Mission Street
San Francisco, CA
County: San Francisco

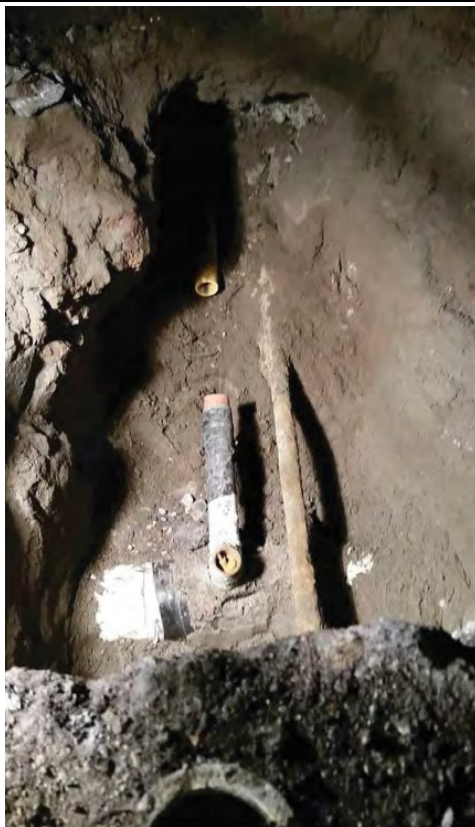
abandoned service tee shown in Figures 1 and 2. Figures 1 and 2 show that the service tee was not capped by a mechanical fitting, fusion fitting or weld cap.

Figure 1. Source of the gas leak¹

PG&E failed to properly abandon the service line to 3976 Mission Street during project 30267522X. The failure to permanently seal the still live service tee resulted in the X-Pando plug being used for longer than its typical temporary application, as well as being subject to pressures higher than the component is designed for, especially after the uprate project in 2013. Therefore, SED finds PG&E in violation of Title 49 CFR § 192.621(a)(1).

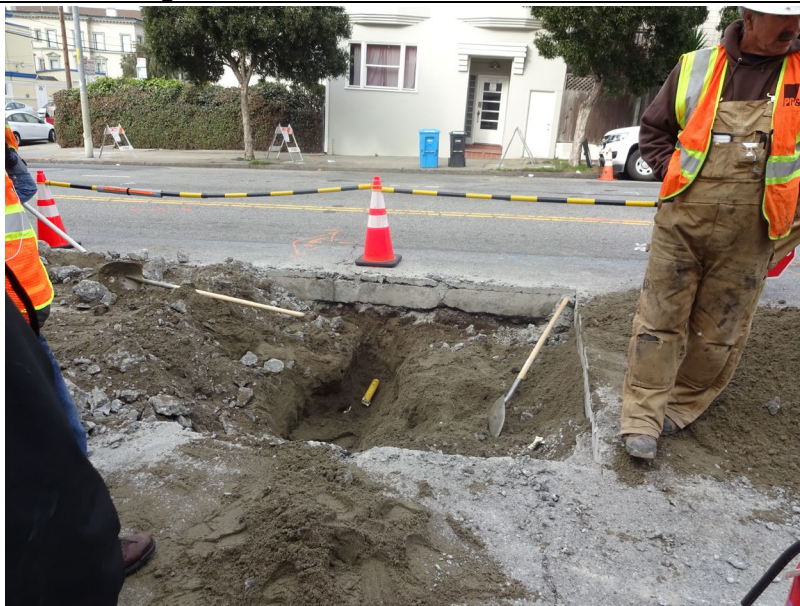
Figure 2. Photo of abandoned service tee location looking northwest towards 3976

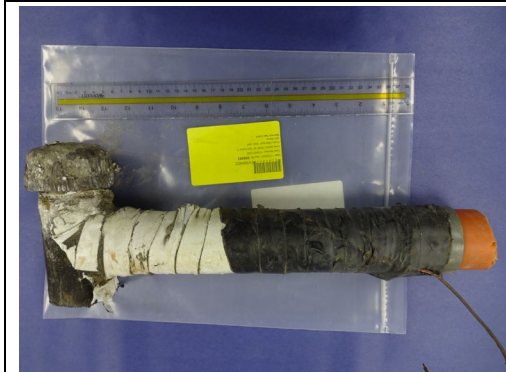
Figure 3. Photograph of Mueller Tee after removal from scene.³

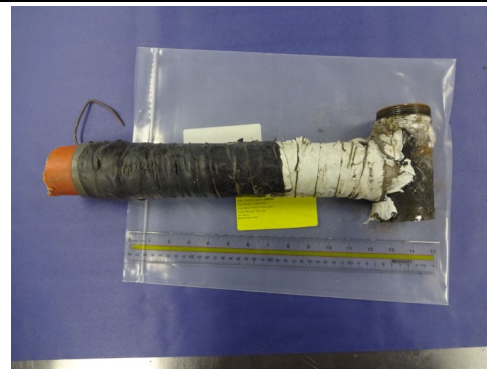
Figure 4. Mueller Tee after removal from scene.³

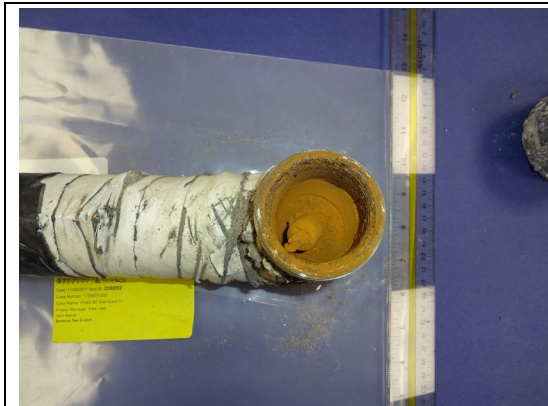
PG&E hired Exponent to investigate the root causes of the incident. PG&E removed the service tee and transferred it to Exponent's lab. Figures 3-6 are photographs of the service tee at Exponent's lab. Figures 5 and 6 show closeups of the expander plug from the top and the bottom in a dislodged state similar to Figure 1.

Figure 5. Top view of Mueller Tee showing top of X-Pando Plug.³

PG&E failed to follow Procedure C-36.1 Rev #00 Gransky Bag Method for Stopping Off Low Pressure Service Tees when it failed to remove the X-pando plug from the service tee. PG&E also failed to follow A-93.2 for failing to use approved mechanical or fusion end caps to seal the cut end. Therefore, SED finds PG&E in violation of Title 49 CFR §192.605(a).

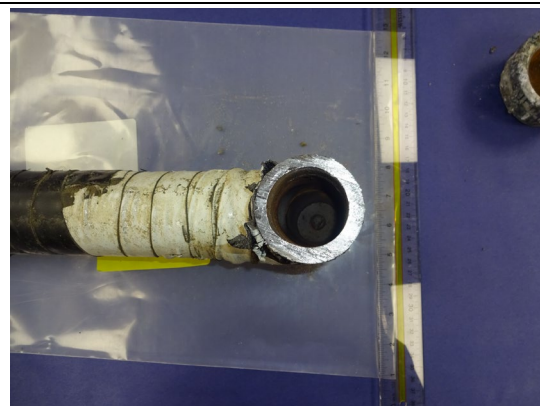
Figure 6. Bottom view of Mueller Tee showing bottom of X-Pando Plug.³

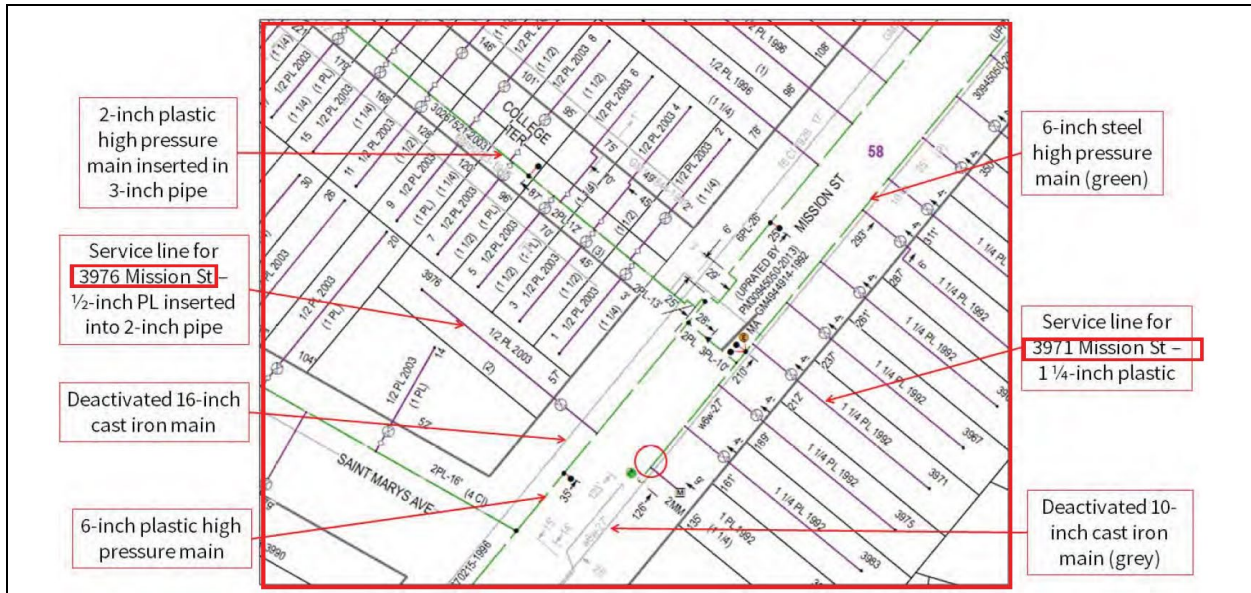
Figure 8. Exponent annotated plat map of area with leak location in red circle⁵
