CALIFORNIA PUBLIC UTILITIES COMMISSION
Safety and Enforcement Division
Electric Safety and Reliability Branch

Incident Investigation Report

Incident Number: E20200915-03

Regulated Entity Involved: Southern California Edison (SCE)

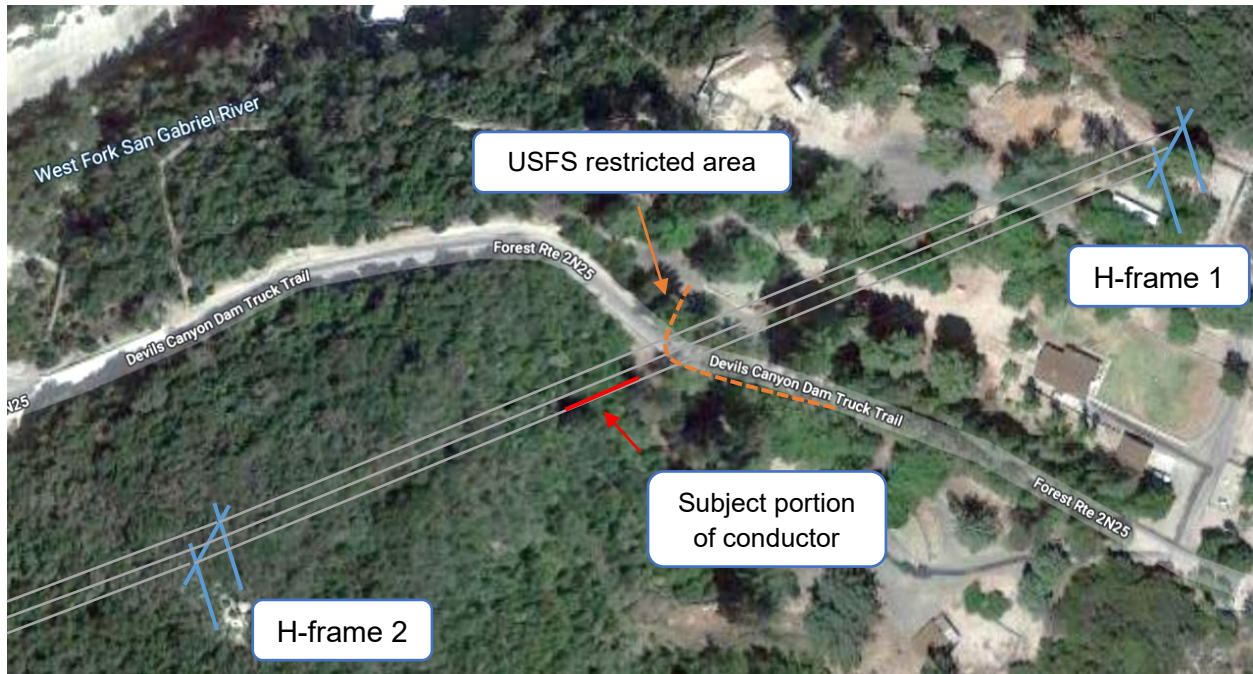
The SCE facility involved in the USFS investigation of the Bobcat Fire is an approximately 23-foot section of primary 12 kV conductor collected from between H-Frame structure comprised of poles 2127468E/1583439E ("H-frame 1") and a second H-frame structure comprised of poles 4786005E/4786004E ("H-frame 2"). H-frame 1, located at the bottom of the hill at the incident site, was comprised of two 40-foot class 5 Douglas Fir poles and was installed in 2019. H-frame 2, located within the USFS restricted area beyond visibility, was comprised of two 50-foot class H1 Douglas Fir poles and was installed in 2009.

Figure 1: Location of the subject conductor within USFS restricted area.

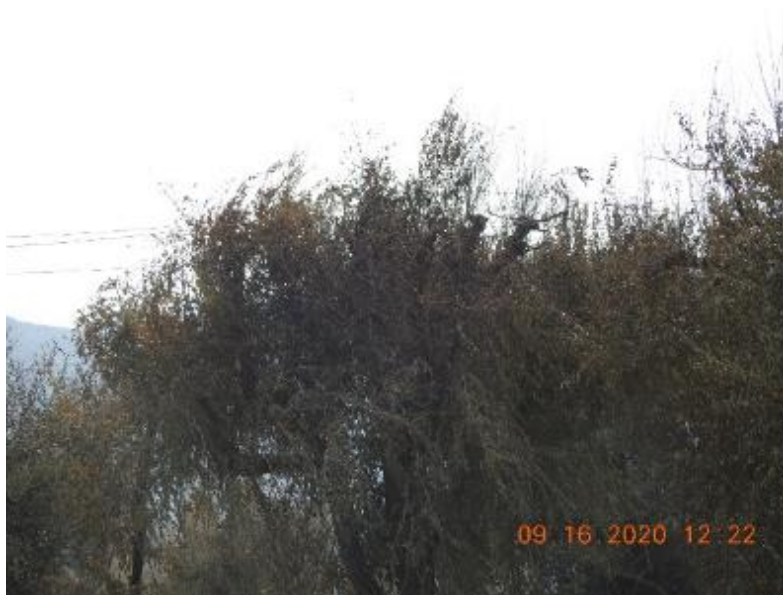
The USFS had cordoned off a section of the forest and denied us access. From outside the area, I noticed three fallen conductors lying across the trees above. Looking into the restricted area, I observed the same conductors lying across the ground. I was unable to observe the condition of the conductors on the ground.

Figure 2: Three fallen conductors between the two H-frame structures resting on the trees below.

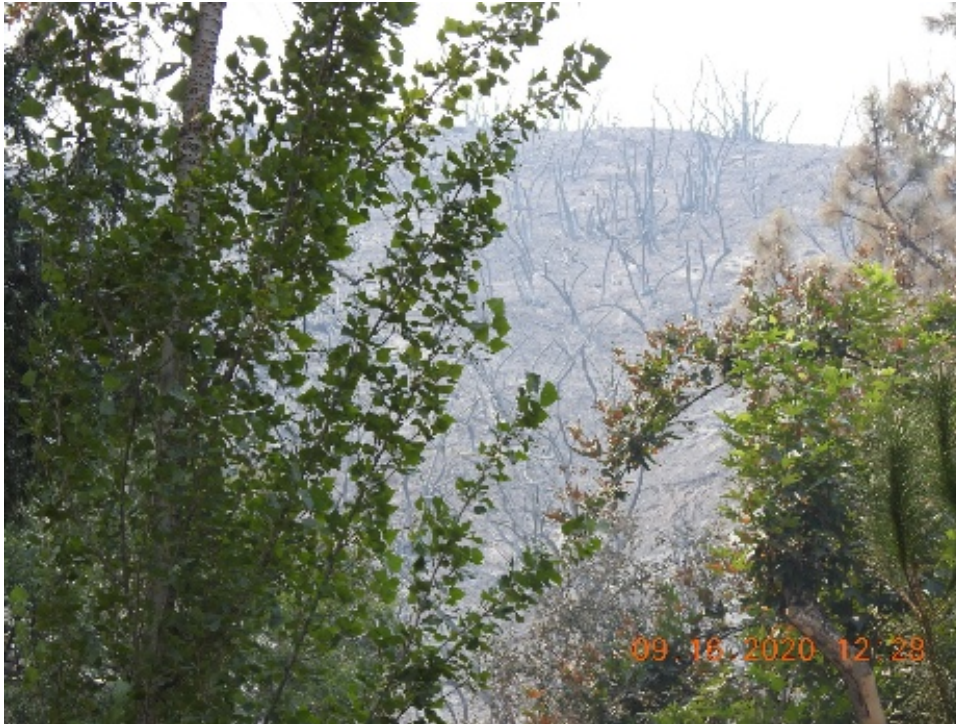
Figure 3: View from outside the USFS restricted area. The subject conductors are no longer supported by the H-frames and are lying across the ground.

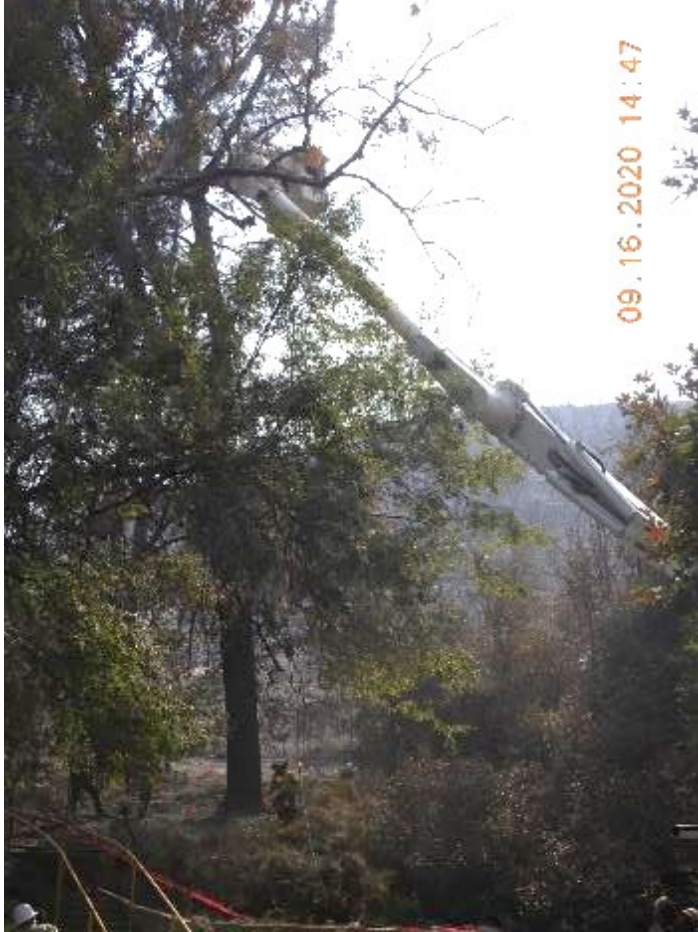
Special Agent Taylor briefly left the area in search of a colleague. During this time, the SCE crew raised a bucket truck and an SCE lineman attached a rope to the area on the subject conductor that the USFS had previously identified. Upon return, Special Agent Taylor stated that the SCE crew had been instructed to standby until she returned. Special Agent Taylor further explained that the SCE lineman had attached the rope in the wrong place, thus damaging the evidence in which the USFS was interested. The view of the contact point between the rope and the conductor was obstructed by surrounding trees. The USFS has declined to provide details to me regarding what was damaged or the nature of the damage¹, therefore I could not determine whether any action by SCE resulted in damage to the evidence.

Figure 4: SCE field personnel preparing to lower the subject conductor.

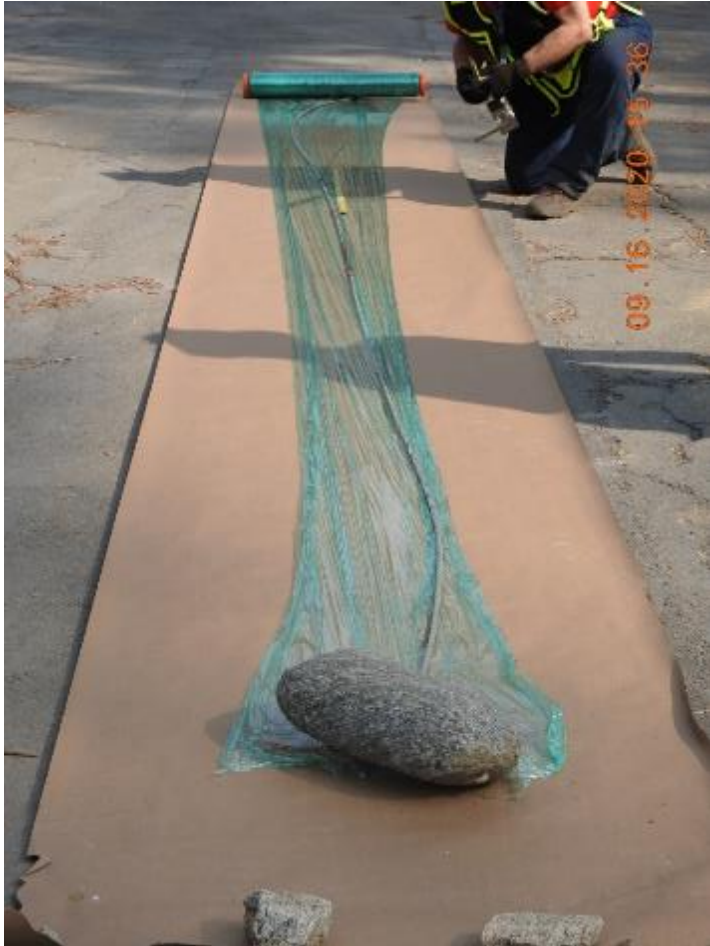
The USFS instructed SCE to proceed in pulling the conductor down to approximately 5 feet off the ground. JHNolt Associates, an independent contractor working on behalf of the USFS, instructed SCE to place five colored tags at various locations on the conductor, as well as the location at which to cut the conductor. USFS declined to share information regarding the placement of each tag. The conductor section measured approximately 23 feet in length. I observed several places on the conductor that were coated in a sticky residue. Some parts of the conductor showed evidence of burning. Due to the heavy slack on the east side of the conductor, it can be inferred that subject area on the conductor could not have been resting on the same tree in its original position before H-frame 2 was no longer supporting it.

Figure 5: The approximately 23-foot section of the subject conductor.

The subject conductor collected was 1/0 ACSR primary 12 kV conductor with a current carrying capacity of 280 amps. SCE was unable to provide an installation date for the conductor. SCE indicates that it does not track the date of installation for conductors.² This is a problematic practice because the majority of GO 95 rules are based on the date of installation. Due to the extensive damage that the Bobcat Fire caused to

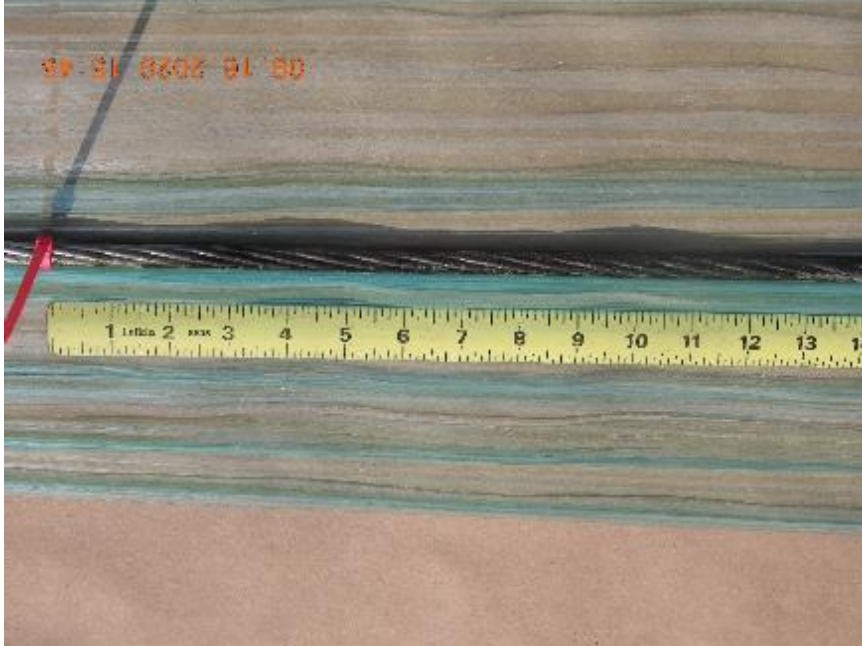
Figure 6: Burn marks on subject conductor.

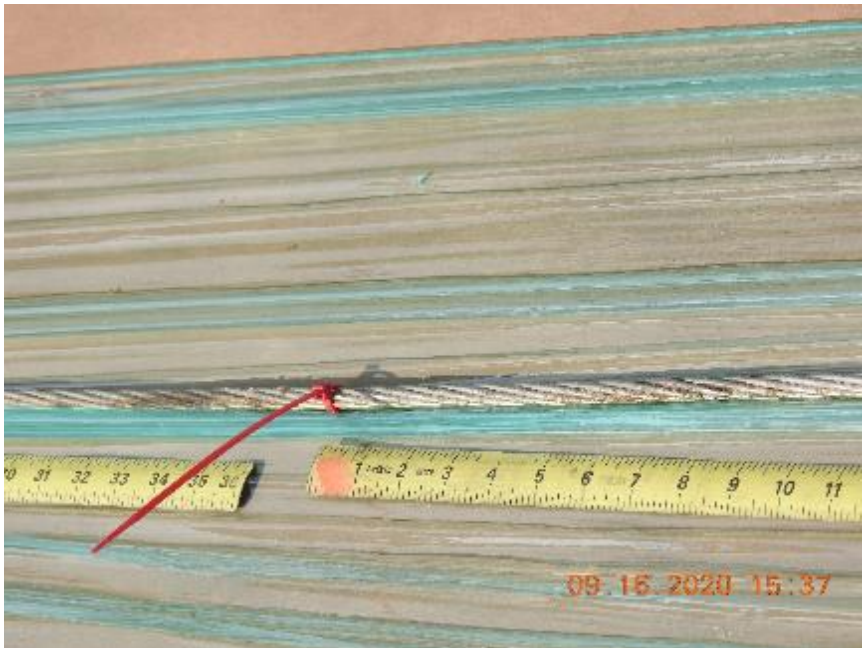
Figure 7: Residue on subject conductor.
