PUBLIC UTILITIES COMMISSION

505 VAN NESS AVENUE
SAN FRANCISCO, CA 94102-3298

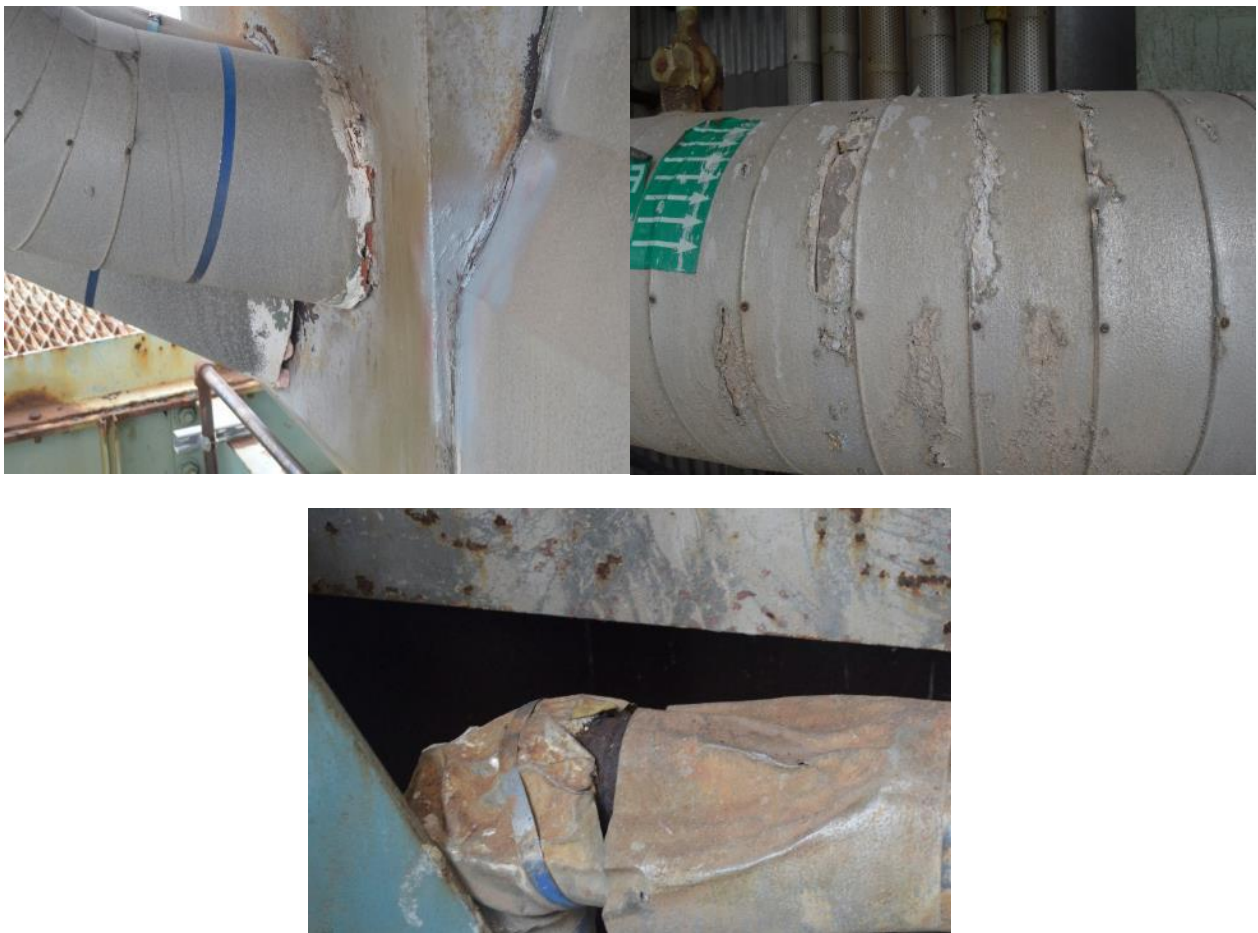
Figure 1: Damaged insulation around the Plant

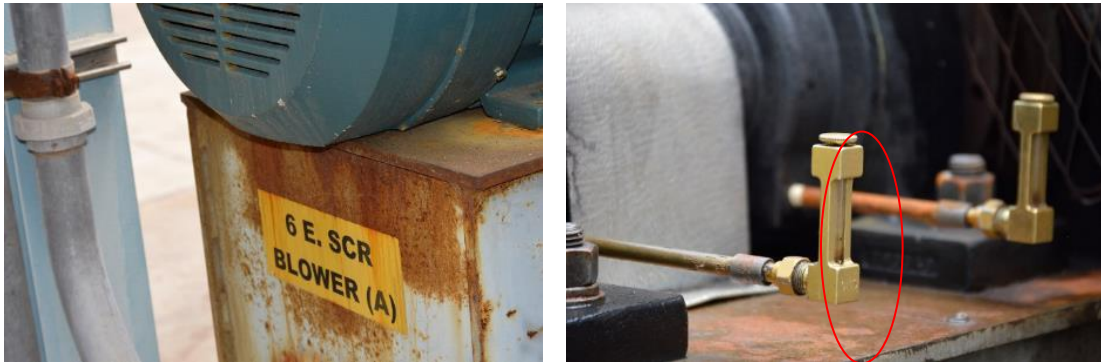
Figure 2: Low lube oil level in 6 E. SCR Blower (A)

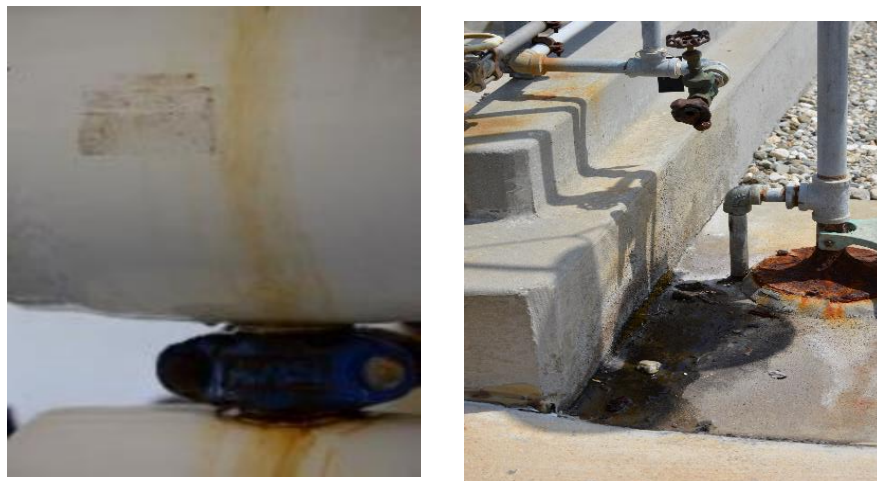
Figure 3: Minor leak in RO truck (left) and another minor leak (right)

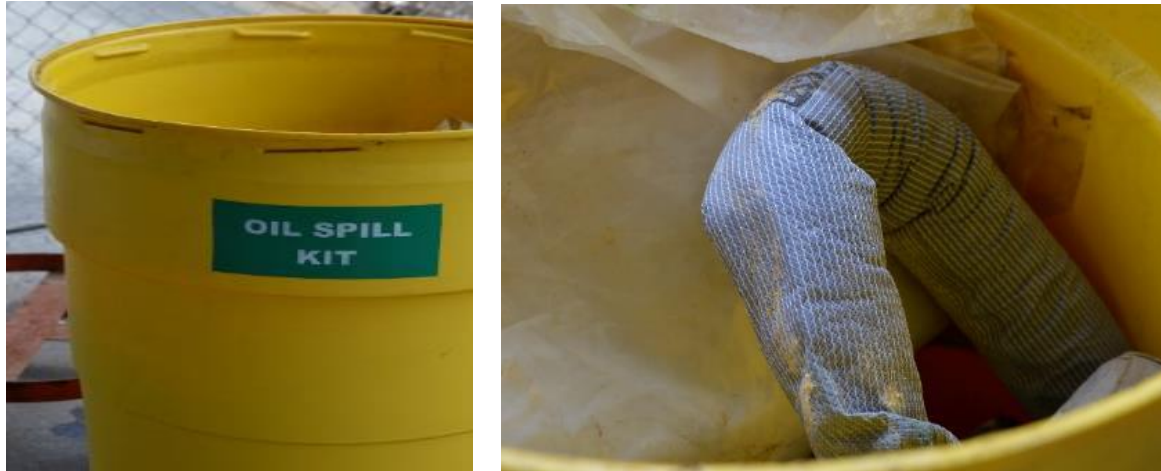
Figure 4: Oil Spill Kit had deteriorated stuff inside due to rainwater entering the drum

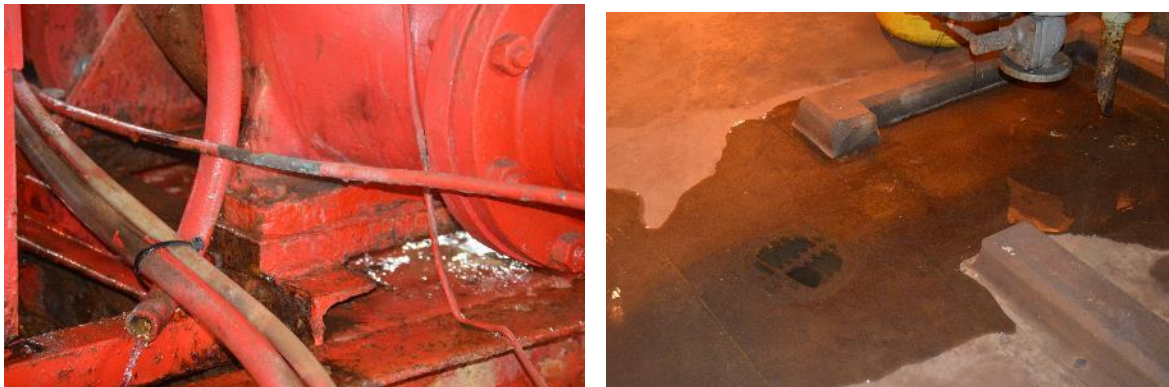
Figure 5: Drain line not properly tied to drain (Left) and a clogged drain resulting in standing water (Right)

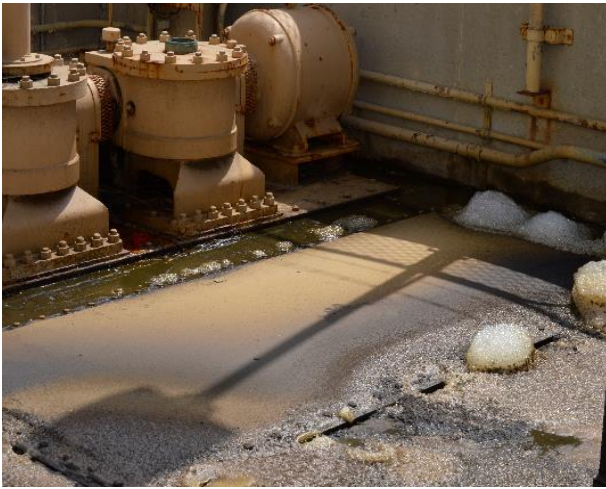
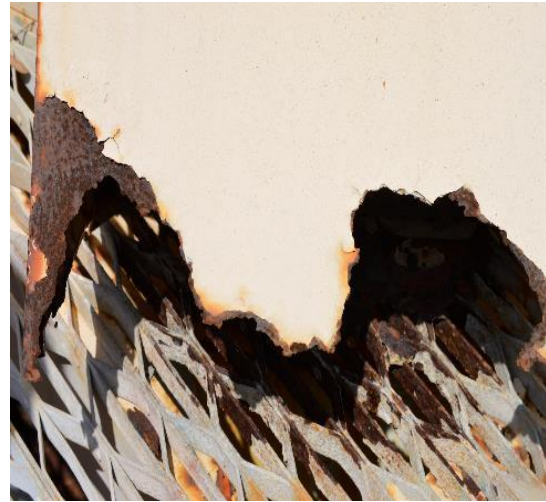
Figure 6: Water leakage (Left) and a damaged sharp edge on abandoned equipment (Right)

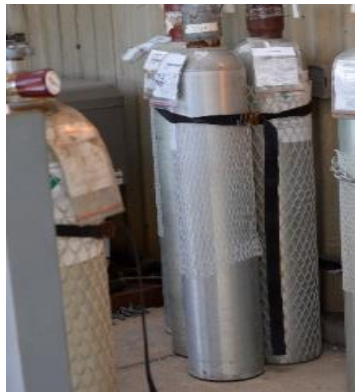
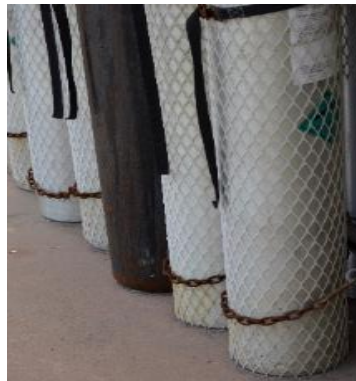
Figure 7: Cylinders missing bottom chain links (Left) and cylinders with proper chain links (Right)

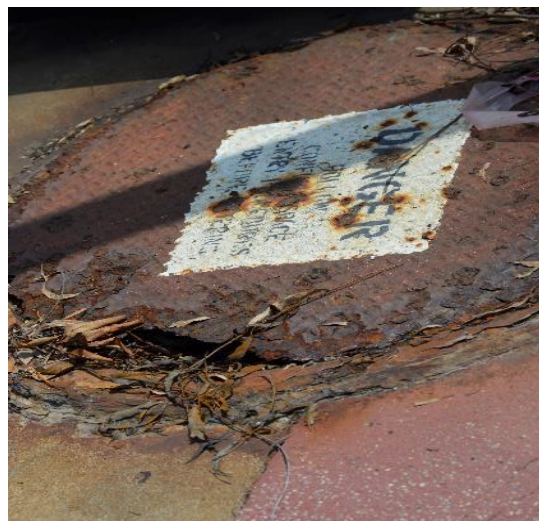
Figure 8: Corroded and damaged Confined Space cover

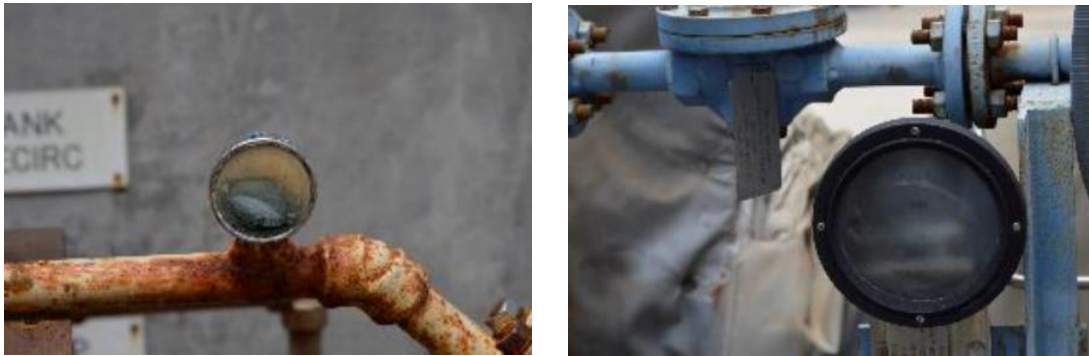
Figure 9: Damaged gauges

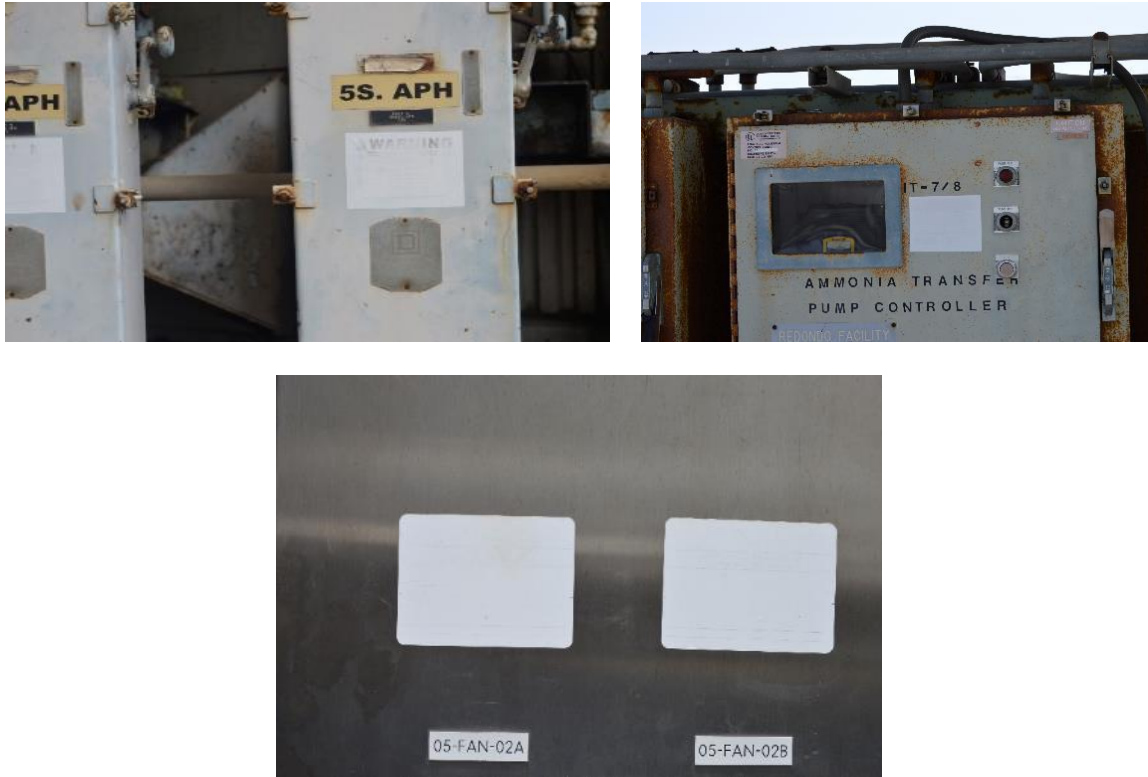
Figure 10: Missing Arc Flash Stickers

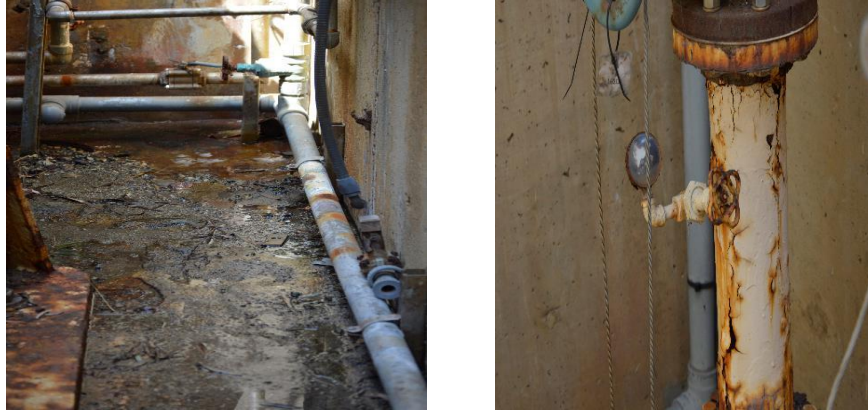
Figure 11: Corrosion in circulating water pump unit

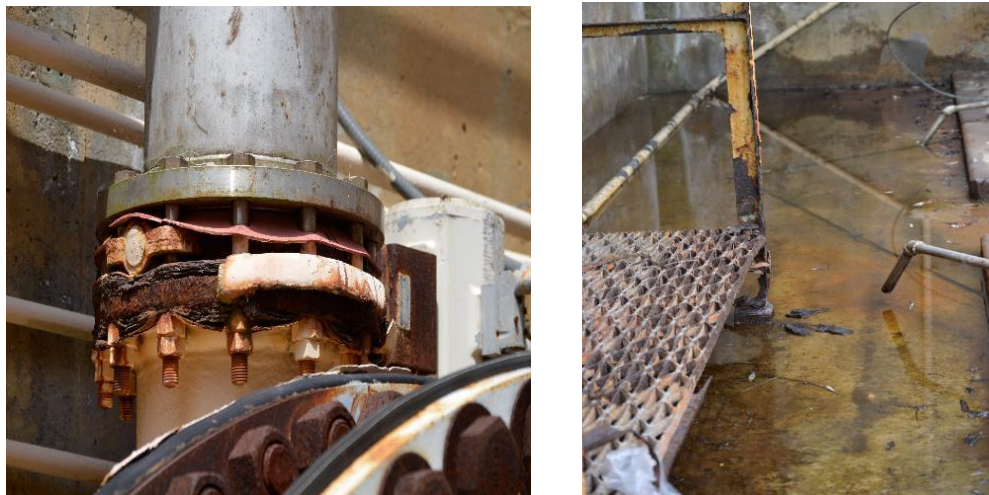
Figure 12: Corrosion in flange (left) and standing water (right)

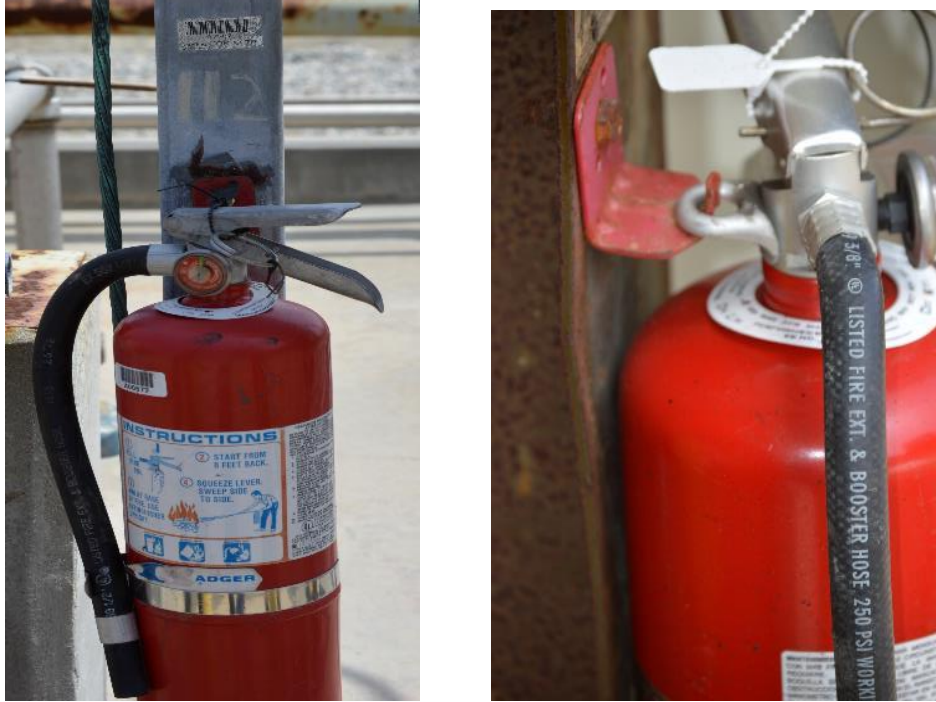
Figure 13: Fire extinguishers with missing current annual inspection tags.

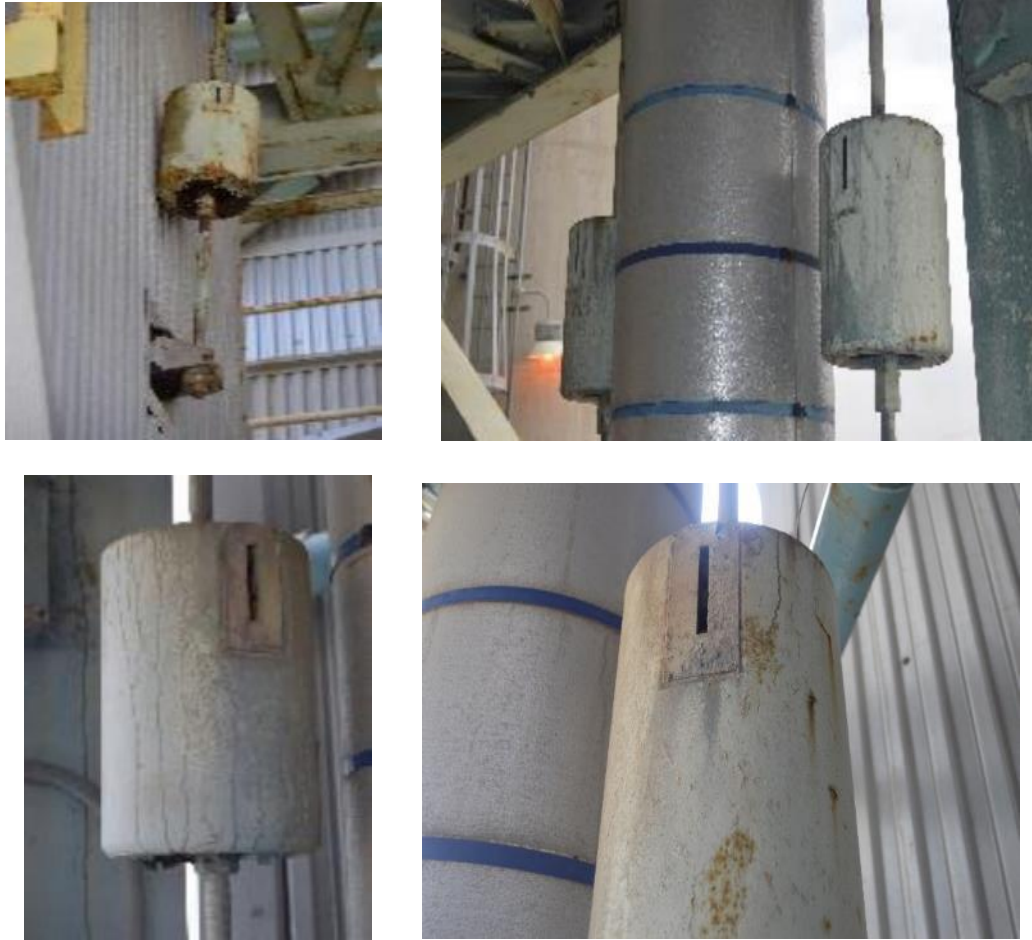
Figure 14: Unmarked HEP supports

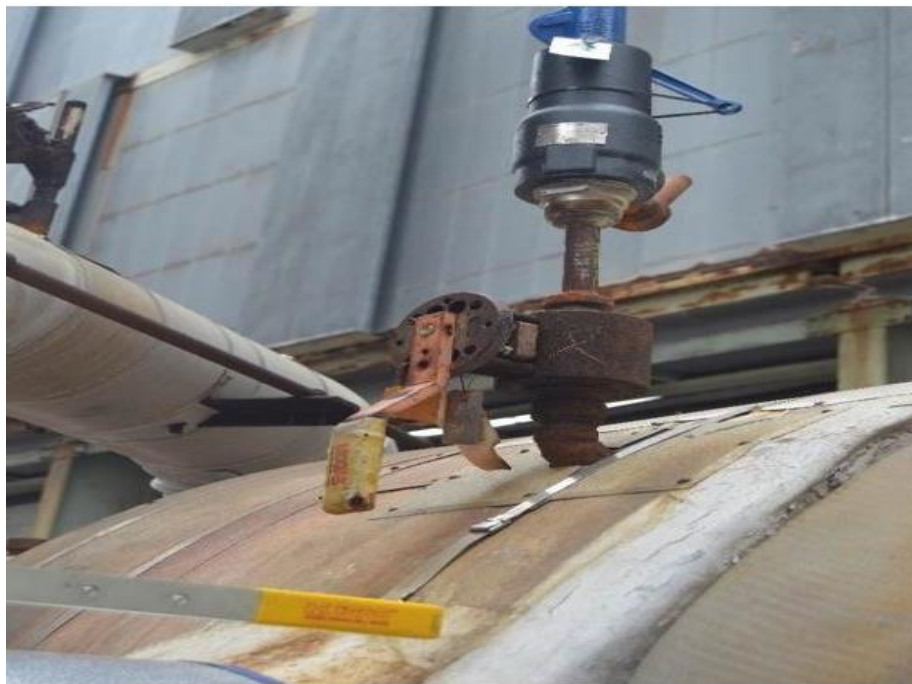
Figure 15: Stop valves installed at upstream of relief valves on heat exchangers
