CALIFORNIA PUBLIC UTILITIES COMMISSION
Safety and Enforcement Division
Electric Safety and Reliability Branch

Incident Investigation Report

Incident Number: E20201026-01

Location of Incident: East Santiago Canyon Road
Silverado, CA
County: Orange

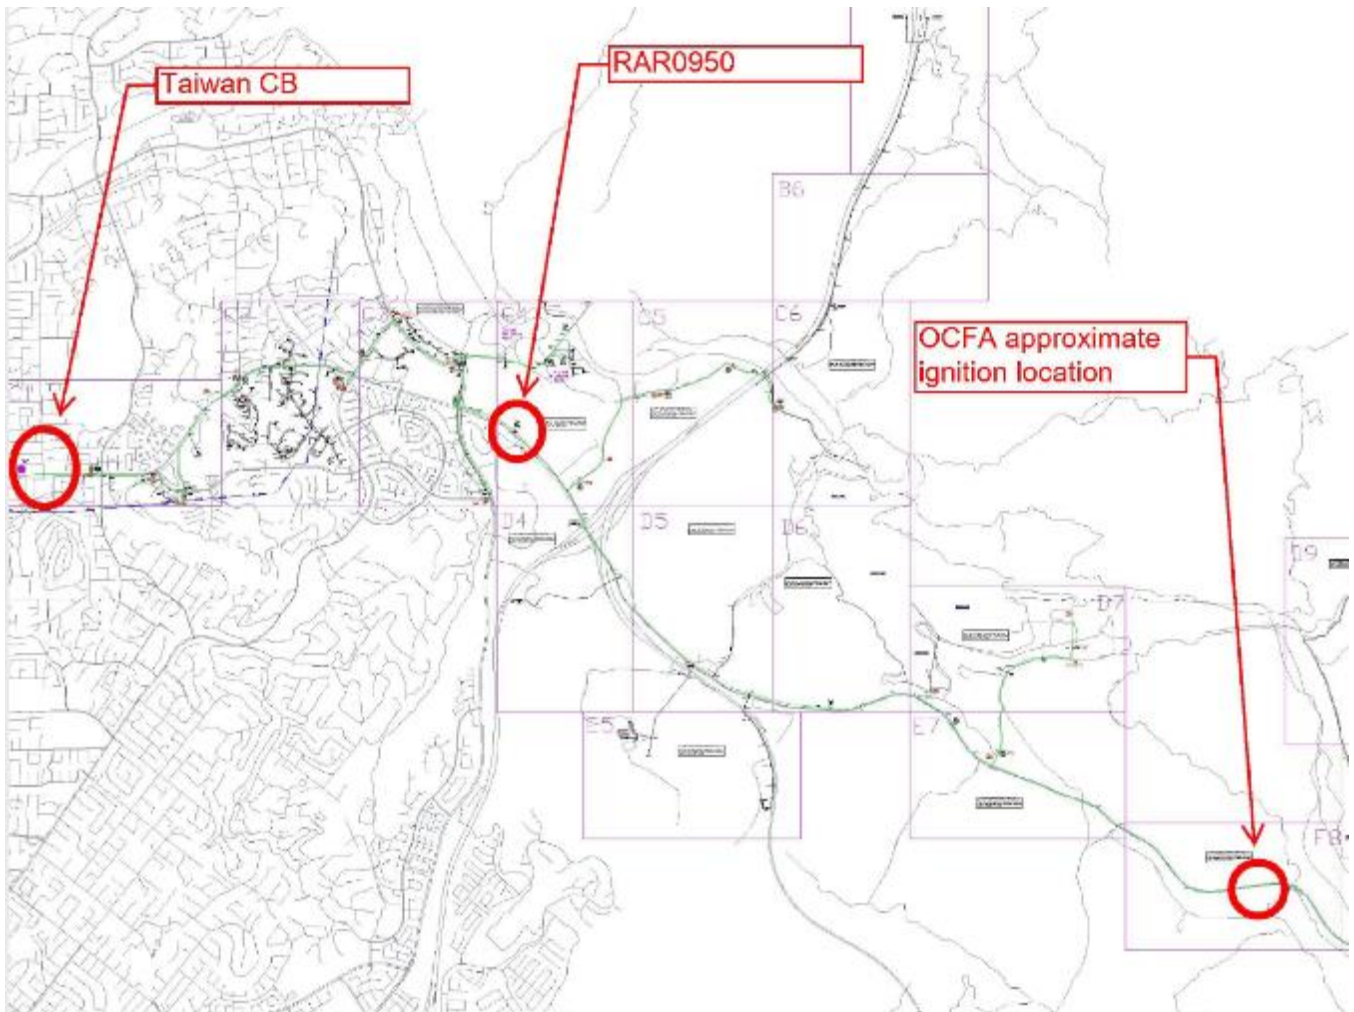
Figure 9: Map showing the approximate locations of the protective devices and Silverado Fire ignition site (SCE)

SCE’s primary conductors between the Subject Poles are protected by a relay protection¹⁷ out of the Modena substation, where the conductors originate, and a 0950 located on pole No. 4812960E (Figure 9). However, no protective devices operated on SCE’s Taiwan 12 kV circuit on October 26, 2020, prior to the PSPS at 7:23 a.m.¹⁸
