# ROOT CAUSE ANALYSIS

VIRTUAL WORKSHOP

DECEMBER 5, 2022

# The 2017 & 2018 Wildfires

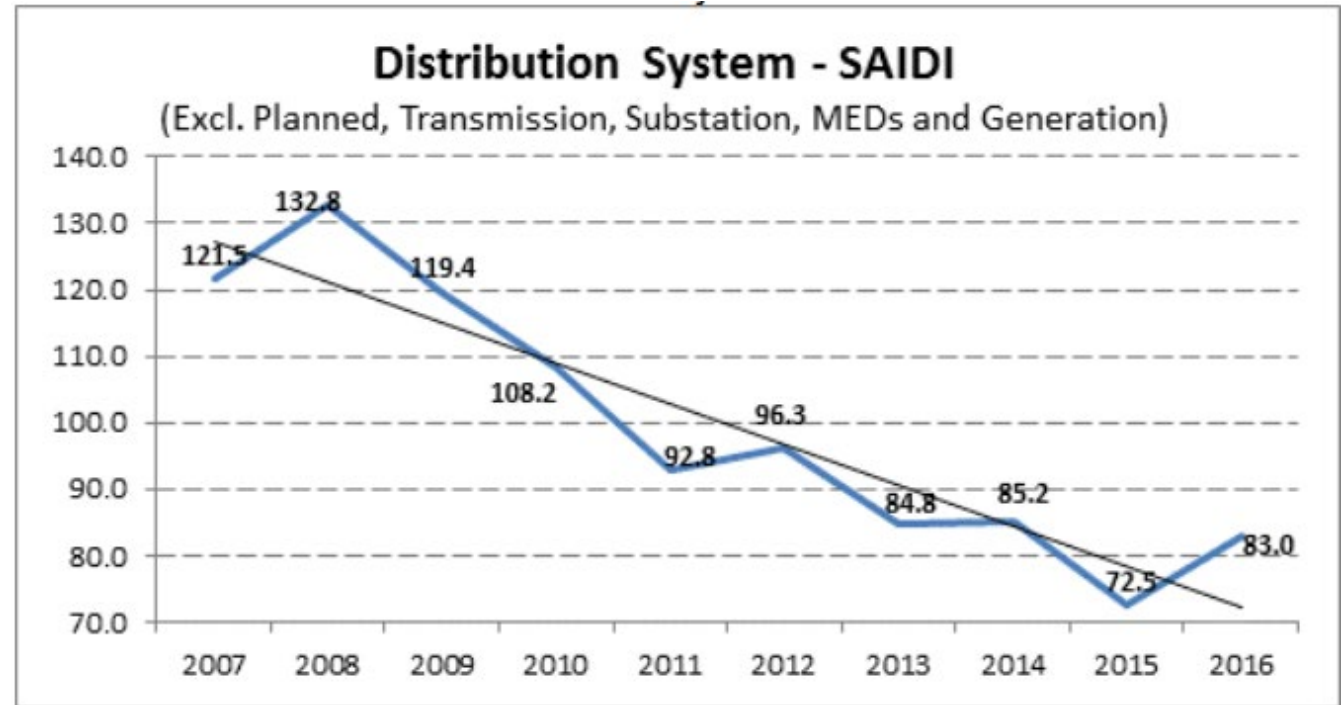
2007 – 2016  
Distribution Systems Indices Trending Favorably

Data from "Pacific Gas and Electric Company 2017 & 2018 Annual Electric Reliability Report", page 13

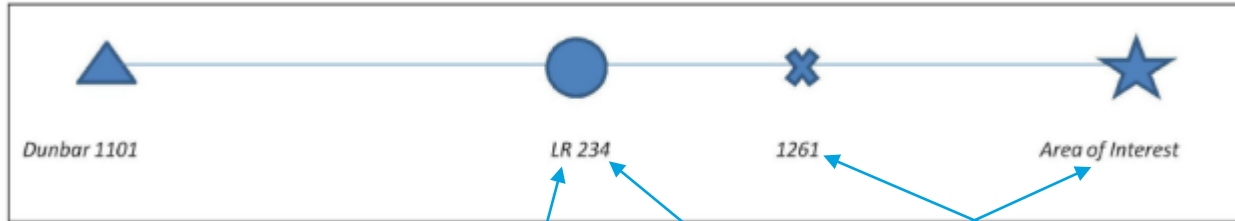
- ▶ Tree Contacted Conductors From 60 Feet
- ▶ Possible Energized Downed Conductor From 8:22 PM–11:35 PM (193 minutes)
- ▶ Possible Failure of Fuse 1261
- ▶ Possible High-Impedance Fault Condition
- ▶ Possible Electrical Back-Feed Conditions

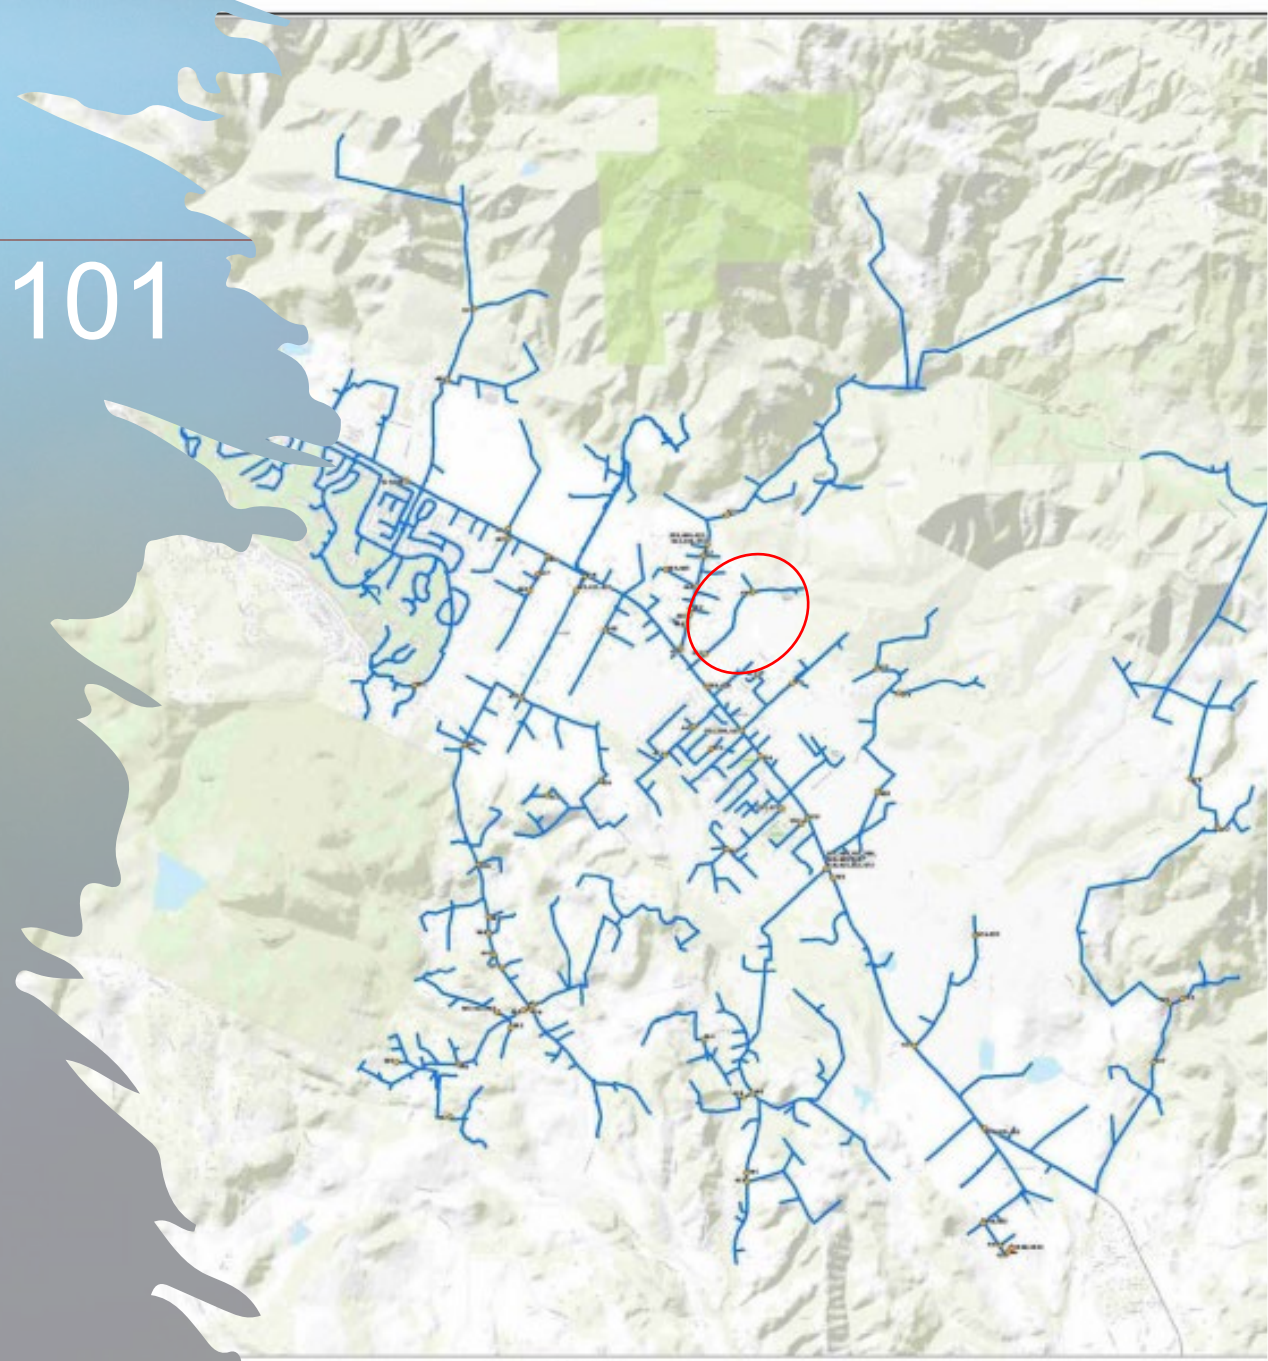
APPARENT CAUSE

LIKELY PROTECTION  
SYSTEM FAILURE?

POSSIBLE HIGH  
IMPEDANCE  
FAULT  
CONDITIONS?

Yes

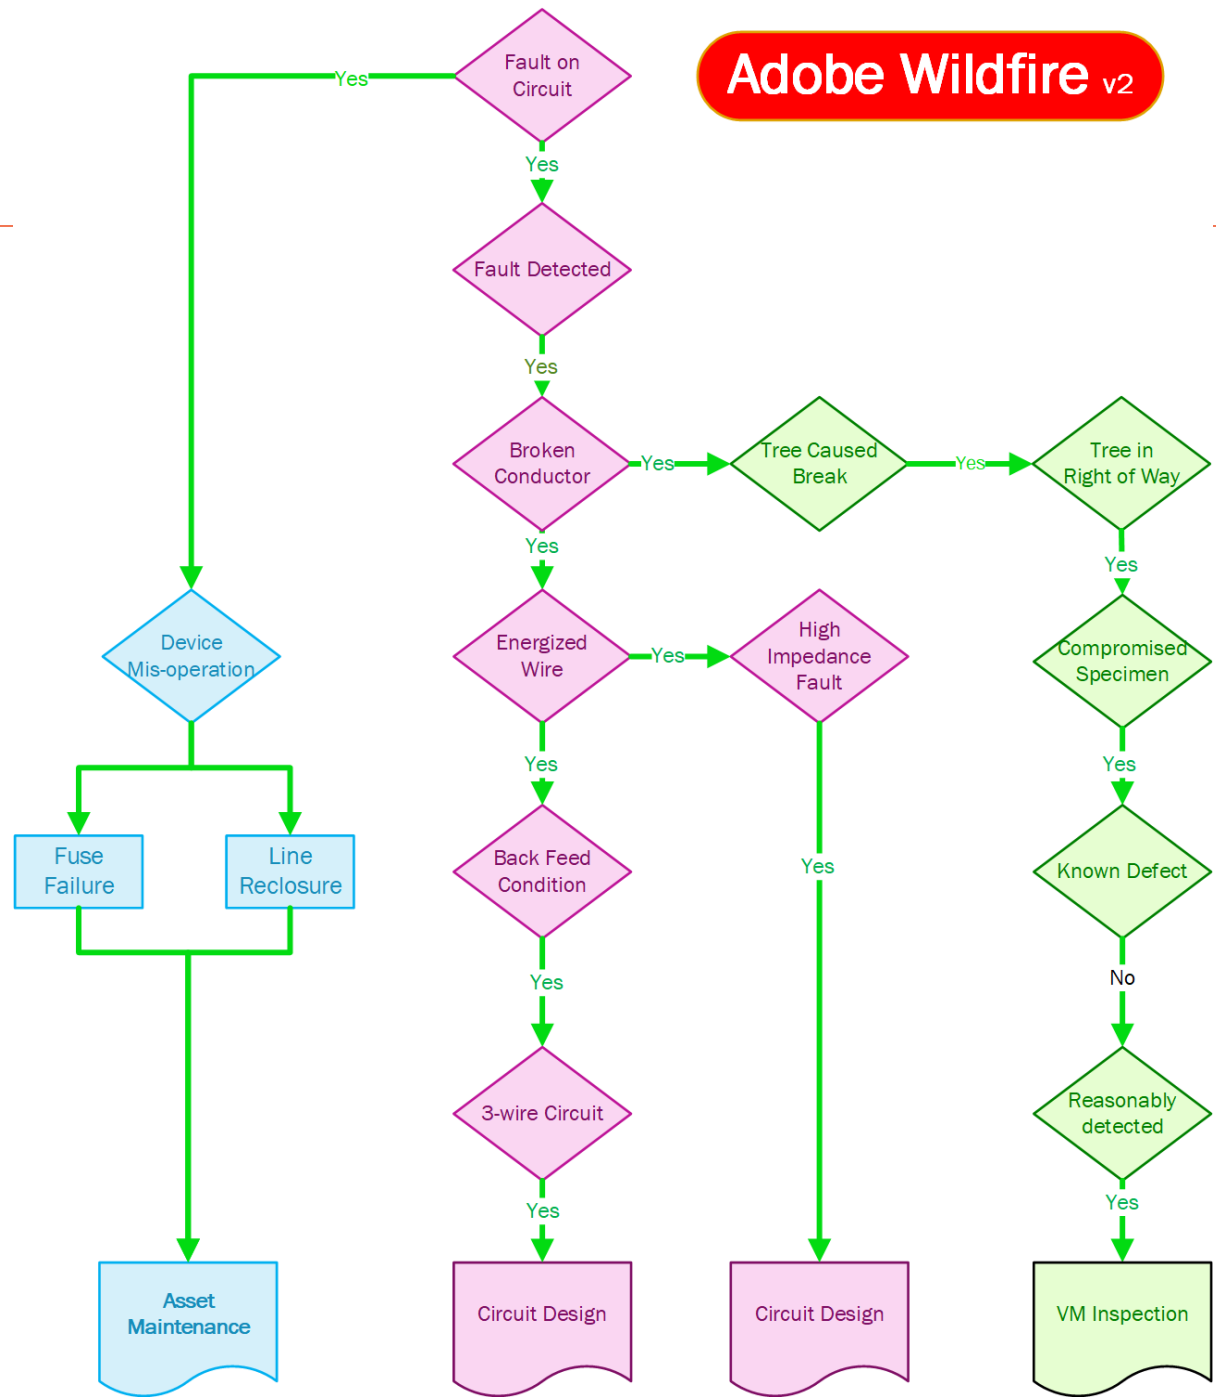
# Adobe Wildfire v2

Criteria 4	Condition	Criteria 5	Condition
Wire Fatigue	No	Protection System Failure	Yes
Wire Type	#4 al	Protection System Failure Device	Fuse &
Insulator Failure	No	Equipment Failure	No
Connector Failure	No	Failed Component	N/A
Connector Type	N/A

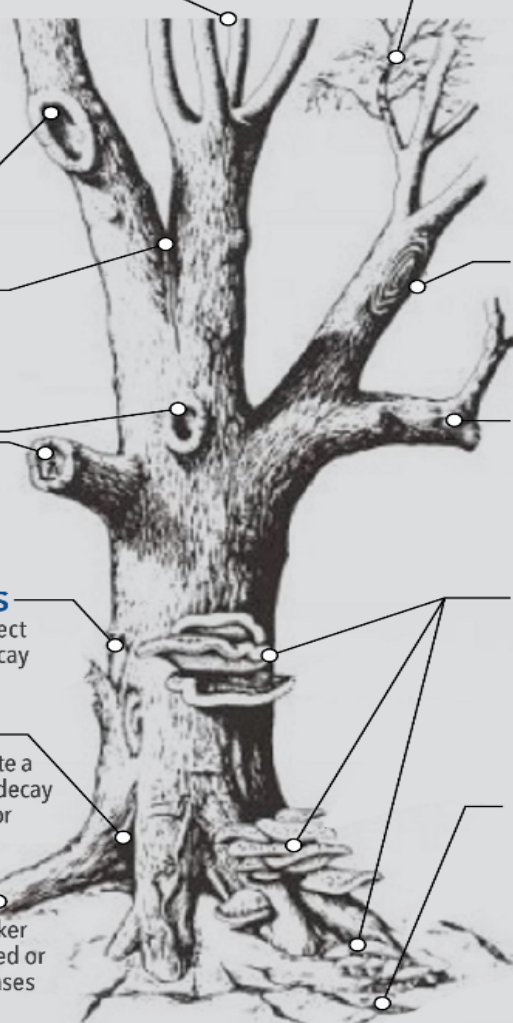
## The Recognition of Hazardous Trees

**TOPPING**  
Often indicated by a sudden change in stem diameter, Weakly attached adventitious branches often leads to the likelihood of failure.

**BREAK-OUT CAVITY**  
Decay may develop in wounds caused by branches breaking.
