FILSINGER ENERGY
P A R T N E R S

PG&E
INDEPENDENT SAFETY MONITOR STATUS UPDATE
REPORT

March 29, 2024

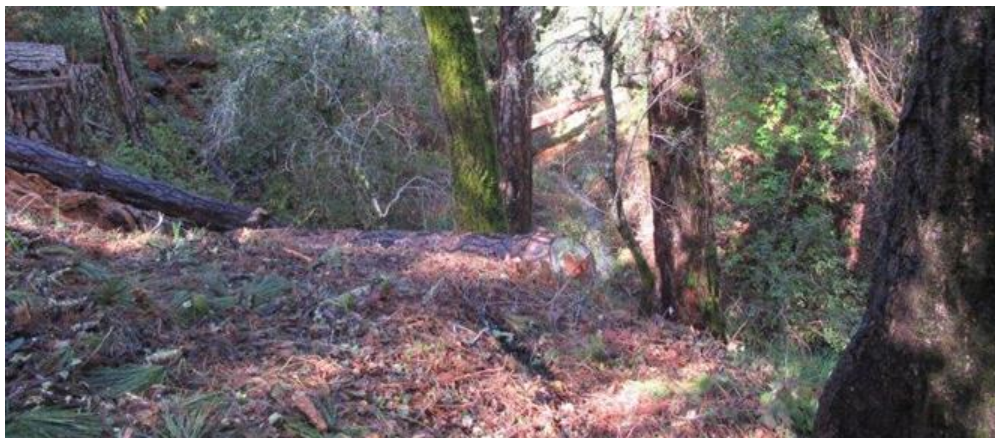
inspections. Figure 22 shows an example of compliant wood management observed by the ISM.

Figure 22: Inspection Area B: compliant wood management showing lopping/scattering of limb slash and disbursement of larger material
